Upper Culebra Watershed Assessment Report

In Progress Draft

Prepared for Costilla County Conservancy District

Tailwater Limited

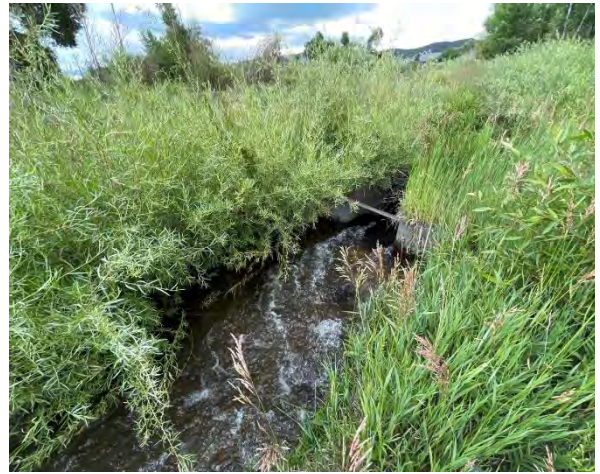
This diversion structure diverts to both the north and south of the creek. The north Parshall flume was clean with a good drop (Figure 6-96). The south Parshall flume had a good drop and some light debris that would affect the accuracy of water measurement (Figure 6-97). The levelness of the structures was not checked during the site visit. The headgate is a concrete structure in good condition. The structure was designed to sweep the channel and had sediment deposition in the structure above gates. Within the channel, the grass is growing below the structure. This structure has an overflow designed to allow flood flows to pass downstream. Overhead structure on the diversion may increase flood elevations around the structure.

Figure 6-97 Vallejos Ditch south Parshall flume some light debris.

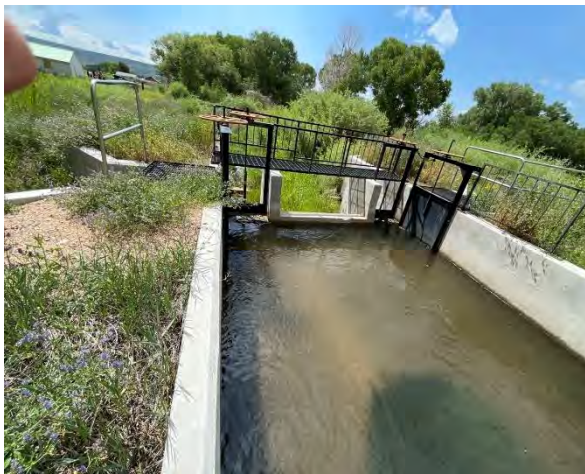
This structure, at times, sweeps Vallejos Creek, including during wintertime for stock water. Below this structure, the creek is severely degraded with only a small defined channel and sparse riparian vegetation (Figure 6-98). Riparian vegetation starts to improve just above County Road 21, where return flows accumulate. The creek is heavily encroached by structures along this reach.

Figure 6-98 Vallejos ditch headgate.

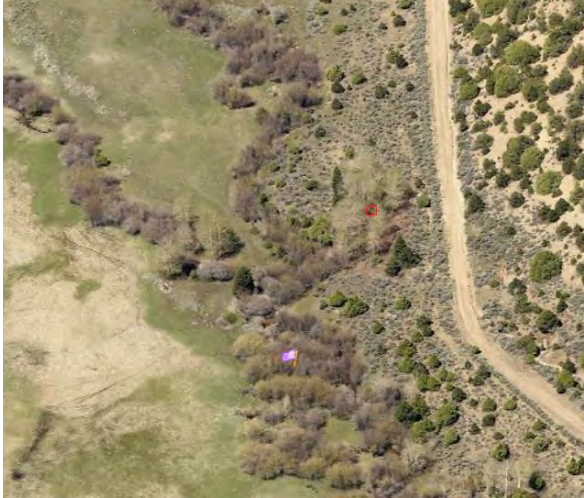
Figure 6-99 Alamosito Diversion Ditch A.

The three diversion structures on Alamosito Creek were recently adjudicated and included Alamosito Ditch Diversion A (Figure 6-99), East Alamosito Ditch Diversion B1 (Figure 6-100), and East Alamosito Ditch Diversion B2 (Figure 6-101). A well-developed active alluvial fan is present at the mouth of Alamosito Creek (Figure 6-102). Maintaining this feature will allow the fan to continue functioning and reduce downstream sedimentation. It is important to avoid channelizing or developing these lands to maintain this function.

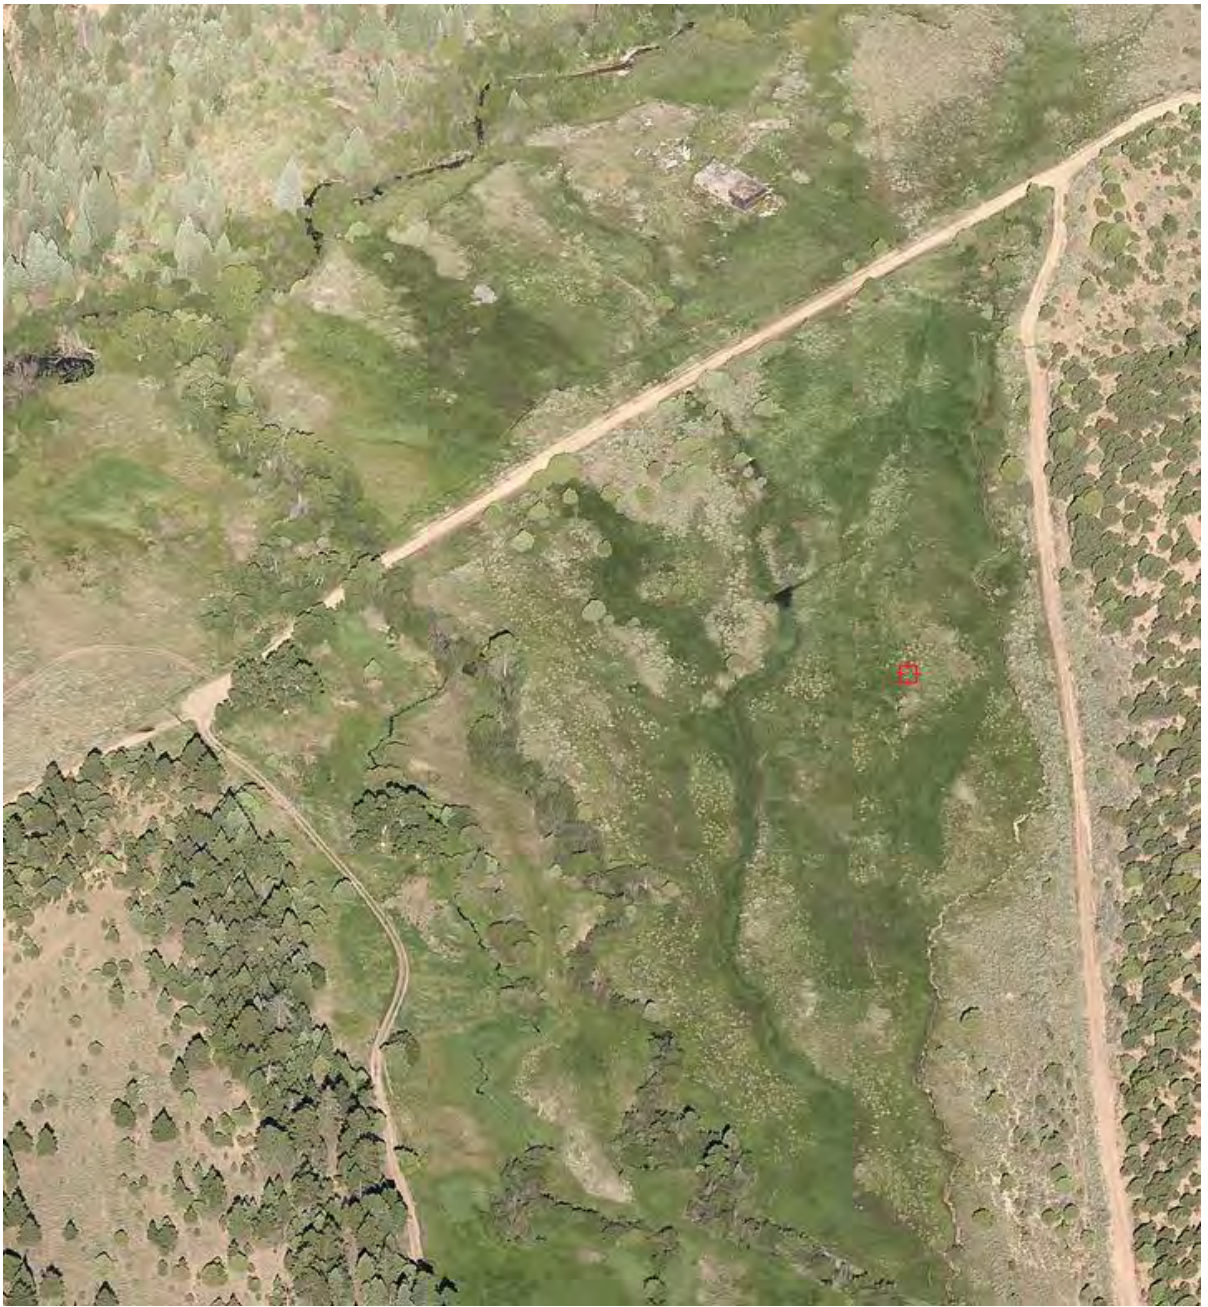
Figure 6-102 Channel braiding in Alamosito Creek alluvial fan. Channel braiding reduces stream energy and allows sediments to be deposited.

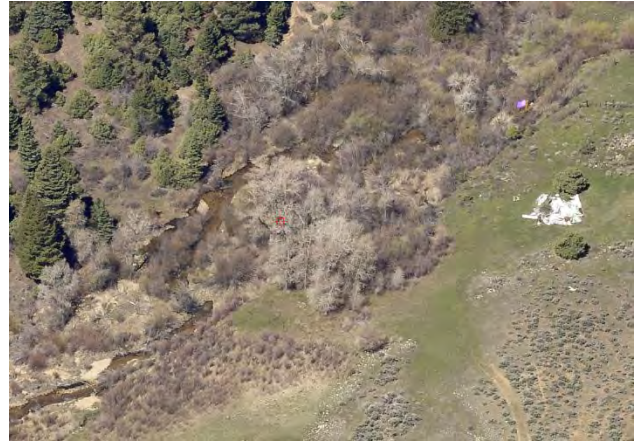
Figure 6-103 Gabriel Medina No. 1 headgate. EagleView Aerial imagery May 13, 2019.

The diversion structure is not visible in the aerial imagery. During interviews, this structure was listed as having issues with administrative requirements, including lockable headgate and/or measurement structure. The stream shows instability along the left edge of the water just above the diversion structure (Figure 102). Bank erosion and mid-channel bars are noted below the structure. No flooding or fish passage issues were noted.

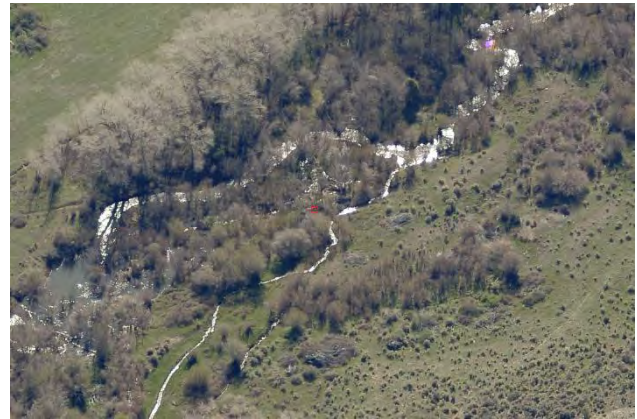
Figure 6-104 EagleView Aerial imagery of Gabriel Medina No. 2.

The Gabriel Medina No. 2 diverts water from San Francisco Creek. During interviews, this structure was identified as having issues with administrative requirements, including a lockable headgate and/or measurement structure. No diversion dam was visible in aerial imagery, and measurement structure was not listed in CDSS or spotted in the available aerial imagery (Figure 6-104). Flooding is likely not a large risk because the area is not developed; however, vegetation encroachment on the floodplain is apparent below the structure.

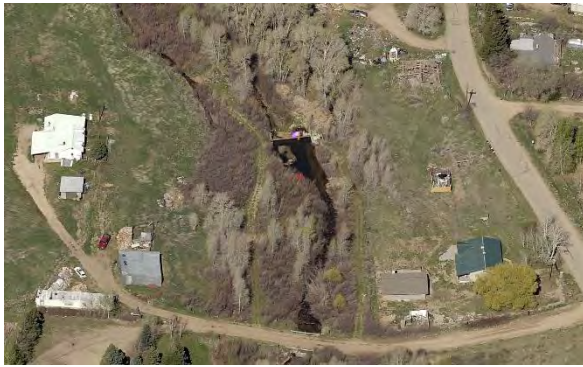
Figure 6-105 San Francisco Ditch from EagleView aerial imagery.

This structure diverts water from both the north and south sides of San Francisco Creek (Figure 6-105). The structure can sweep the creek at times. The stream is overwide at diversion dam with a large drop on the creek that poses hazards to fish passage. The structure has fine sediment deposition, with vegetation growing in the channel in front of the south gate (Figure 6-106). In the winter, the gates on the south side do not close completely, so to prevent downstream flooding, the ditch bank is breached to push water back into the creek. A new measurement flume on the north side of the ditch does not have a staff gage, so the old flume is still in use.

Future projects along the south San Francisco Ditch should consider consolidation with Acequia de Los Cedros and Little Rock to reduce the number of in-stream structures on San Francisco Creek.

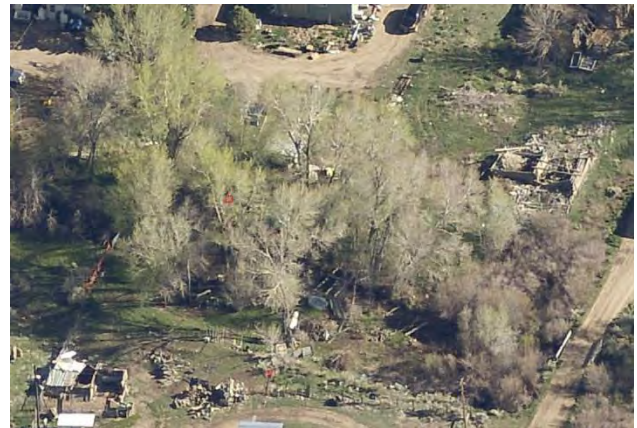
Figure 6-107 Acequia de los Cedros headgate.

The Acequia de Los Cedros diverts water from the left bank downstream of a small private bridge (Figure 6-107). This structure was listed as having deficiencies meeting the locking headgate or measurement structure. There appears to be a splitter box across the stream in the EagleView aerial image dated May 13, 2019. This reach includes many structures near the stream that could be impacted by flooding. Tall riparian vegetation is present along the banks. Fish passage may be an issue at this structure, but this would not be a high priority site due to the creek being frequently dewatered and minimal flows through this reach.

Future projects on this ditch's headgate should consider consolidating the headgates with San Francisco Ditch and Little Rock Ditch to reduce the number of in-stream structures.

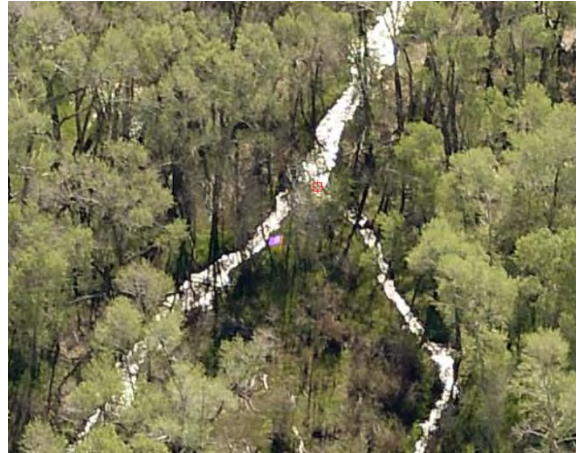
Figure 6-108 Alamo Ditch headgate. Aerial imagery from EagleView June 3, 2019.

The Alamo Ditch diverts water from the south bank of San Francisco Creek in an area with dense riparian vegetation (Figure 6-108). The width of the riparian vegetation is approximately 190 ft near the structure. The diversion dam and measurement structure were not visible in aerial imagery. A lidar profile shows San Francisco creek is against a low terrace to the south in this location. This increases flood risk to structures adjacent to the stream in the event of overbank flows that may not follow the main channel. More detailed analysis around this structure is needed to determine an elevated risk of avulsion.

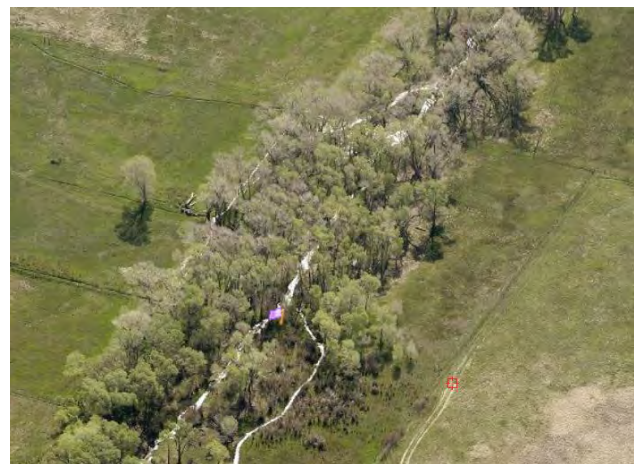
Two diversions were observed in the vicinity of the Emilio Lobato Ditch, and the upper diversion has a splitter box for diverting flows. The structure spans San Francisco Creek and may result in the channel becoming overwide and depositing sediment upstream. No issues were identified with the measurement structure or headgates through interviews. The San Francisco Creek channel is not located in the lowest part of the valley, increasing flood risk for property to the north and east. The channel was likely relocated into this historic channel to increase available head for irrigation. Because the stream is higher than the surrounding terrain, losses through this reach are potentially increased.

Figure 6-109 Multiple diversions from San Francisco Creek in the vicinity of Emilio Lobato. EagleView aerial imagery from June 3, 2019.

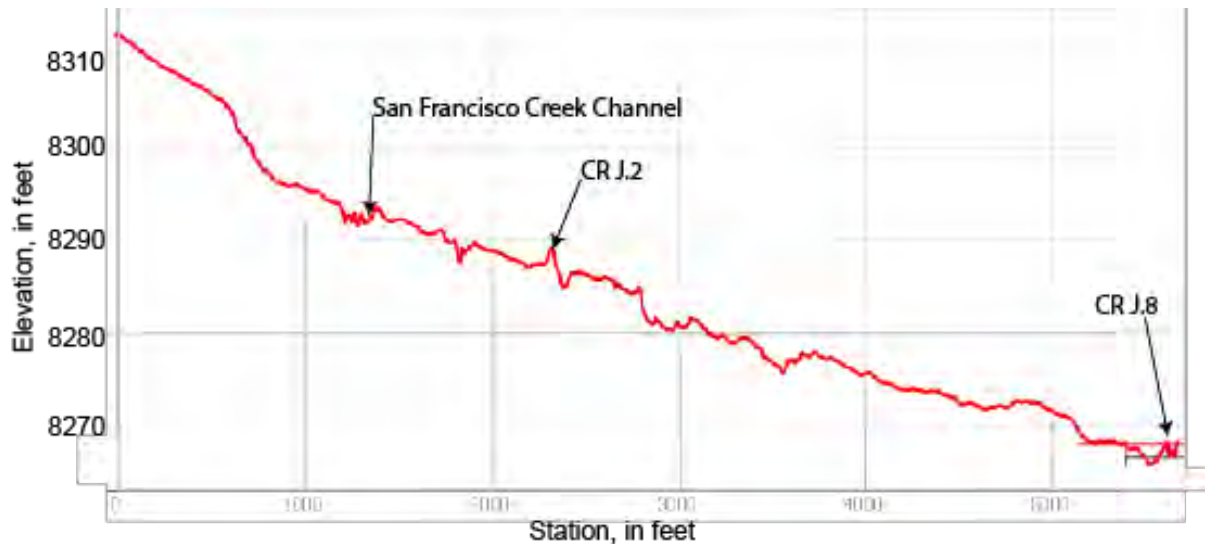
Figure 6-112 Cross-Section profile near Emilio Lobato. San Francisco Creek follows the southern terrace, flood flows in this reach are likely to flow toward the north to the lower portion of the valley.

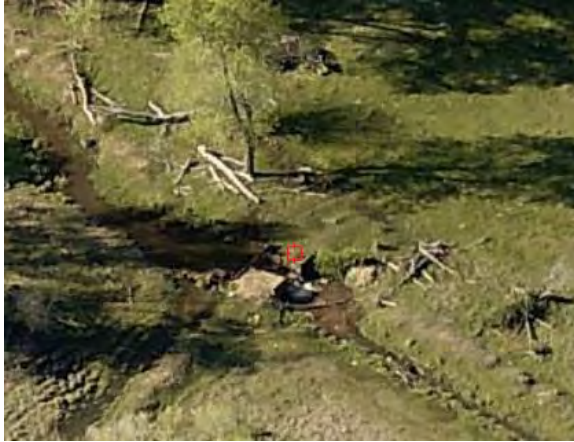
Figure 6-114 Jacquez Ditch headgate. EagleView aerial imagery dated June 4, 2019.

Like the conditions observed at the Emilio Lobato Ditch of the San Francisco Creek near the Jacquez Ditch, it appears that the creek has moved, and it does not flow at the lowest elevation in the valley. This may increase ditch loss around this channel because the stream is raised above the water table. During flood events, flows have a high probability of being conveyed in the channels below the current conveyance channel, and the risk of avulsion is increased.

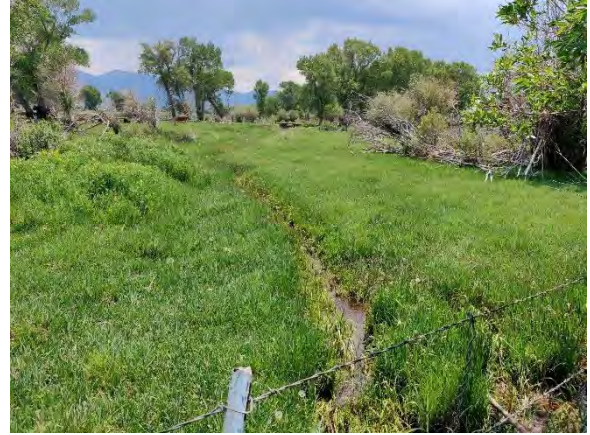
Figure 6-115 Jacquez Ditch diversion structure.

The metal diversion structure has a visible drop below the structure which is an indication that the structure was set too high for geomorphic stability and may cause backwater upstream. Backwater often results in sediment deposition and can cause the channel to become overwide, resulting in bank erosion and additional sediment deposition. The drop below the structure has some erosion on the left bank. Maintaining erosion protection below this structure will prevent scour below the structure and reduce sediment contributions. Riparian vegetation has been removed from banks increasing the risk of channel degradation.

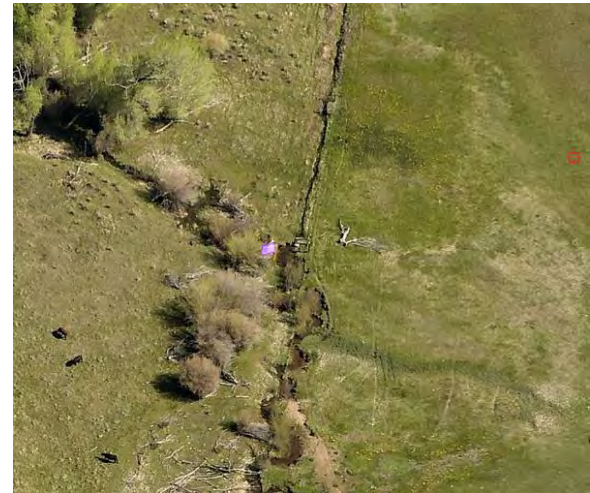
Figure 6-116 Frank Mondragon Ditch 1 headgate and measurement structure.

The Frank Mondragon Ditch 1 and the Frank Mondragon Ditch 2 were listed as seepage rights. This structure has headgates and a measurement flume visible in aerial imagery. The San Francisco Creek channel has sparse vegetation in this reach. Downstream of the diversion, tall riparian vegetation is present, but most other riparian vegetation is not present. Noticeable bank erosion is occurring upstream of the diversion structure. Since this structure receives most of the water from return flows it is one of the structures that will be more impacted by changes in upstream operations including improvements in irrigation efficiency and blocked seepage. No issues with this structure were noted in interviews.

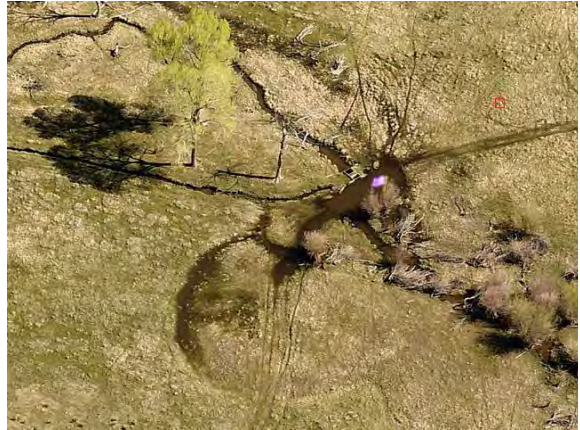
*Figure 6-117 Vigil ditch diversion structure.
EagleView aerial imagery June 3, 2019.*

The Vigil Ditch structure is a small diversion from lower San Francisco Creek. The diversion dam and lack of riparian vegetation are causing the channel to be overwide at this section. A Parshall flume measurement device is visible in the aerial photograph. Minor ditch bank erosion was noted below the flume. The creek has good floodplain access in this reach. The diversion dam likely impedes fish passage.

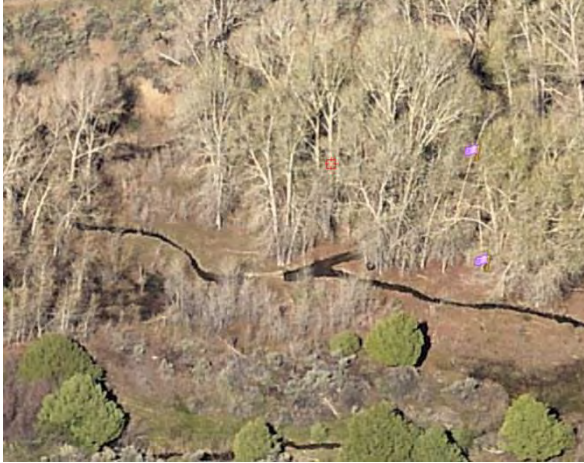
Figure 6-118 Splitter on Torcido Creek.

The Abundo Martinez ditch has a historic structure that no longer exists. Diversions for the water along Torcido Creek for these two water rights occur at the canyon's mouth. The water diverts through numerous channels to irrigate fields over the alluvial fan. Issues were noted with this structure concerning measurement structures and locking headgates. This reach may have some slight flooding risk to ranch infrastructure but is otherwise not developed, and it does not appear to increase flood risks to adjacent lands. This area would benefit from restoration to reduce channel incision to increase water table and sub-irrigation. Restoration to this reach could improve meadow quality, wildlife habitat, and water delivery to downstream water users. This area would also be an area that could benefit from electronic recording devices to reduce water commissioner workload and improve record accuracy. Improvements could include telemetry and streamflow gaging near this location would benefit water administration.

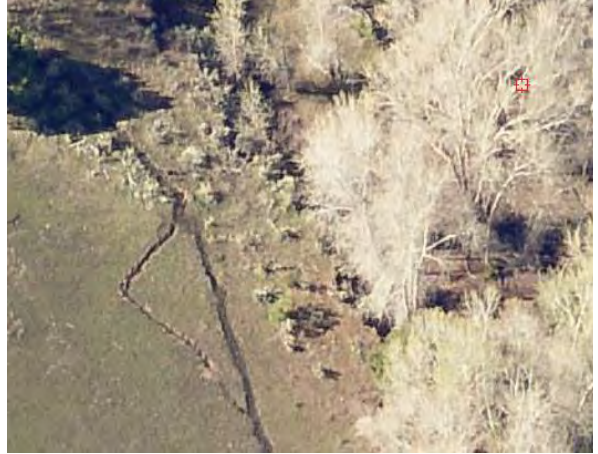
Figure 6-119 Incision on Torcido Creek.

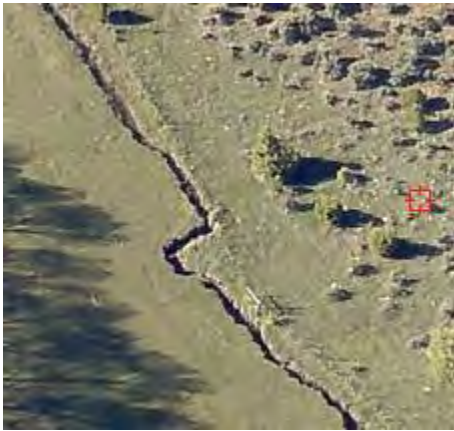
Figure 6-120 Incision along ditch.

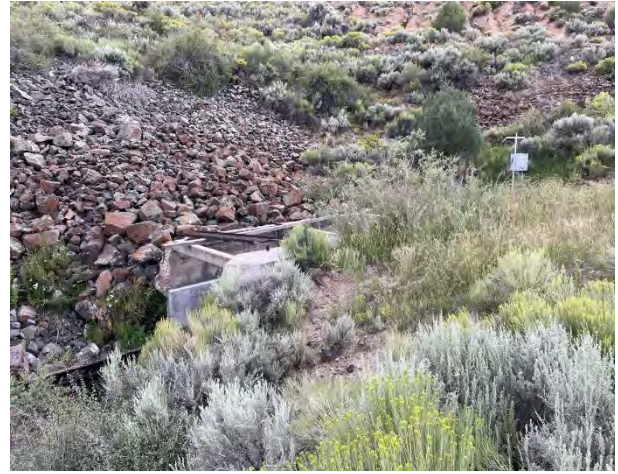
Figure 6-121 Outlet works of Sanchez Reservoir.

During our evaluation of the infrastructure associated with Sanchez Reservoir, safety hazard near the outlet works were observed. No cover or safety rail is present to prevent falling into the stream, and an unlocked ladder was present at the upstream left side of the outlet works. Safety railing and warning signs should be placed to prevent accidents (Figure 6-121). The outlet for Sanchez Reservoir was recently rehabilitated. Bringing the structure up to safety standards with handrails, signage, and confined space entry protection measures would reduce hazards in this area.

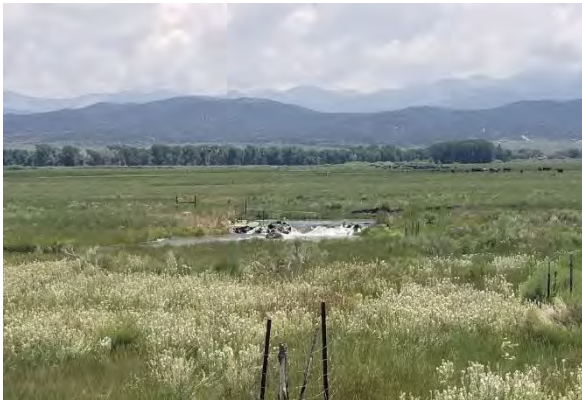
Figure 6-122 J.M. Maes Ditch diversion dam.

The J.M.J. Maes ditch diversion dam is a rock drop structure with a significant drop below the structure (Figure 6-122 and Figure 6-123). Aerial imagery from EagleView shows significant bank erosion on the right bank above the structure within a tight meander pattern. This structure likely poses issues with fish passage.

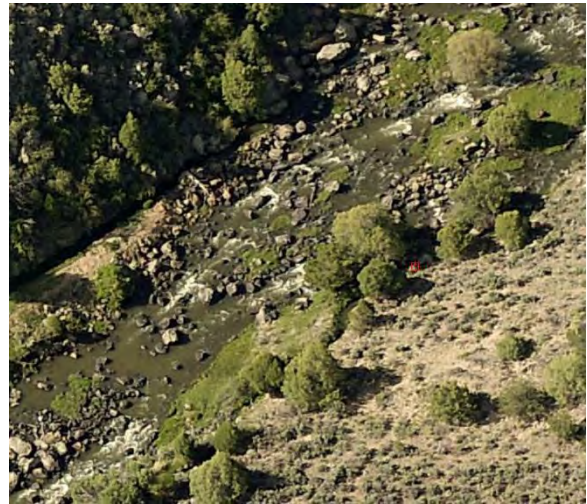
North Ventero Ditch diverts directly below the Sanchez Reservoir outlet. This small ditch does not increase flood risk. Fish passage was not evaluated because of the proximity to Sanchez Dam. No issues with headgates or measurement structures were identified during interviews. Ventero creek is likely overwide for the hydrology within the reach, with no well-defined low flow channel as it emerges from the canyon. Diversions were noted on both banks of the channel in this location (Figure 6-124).

Figure 6-124 North Ventero Ditch diversion. Water being diverted on both north and south side of Ventero Creek. Ventero Creek flowing from left to right in photo.

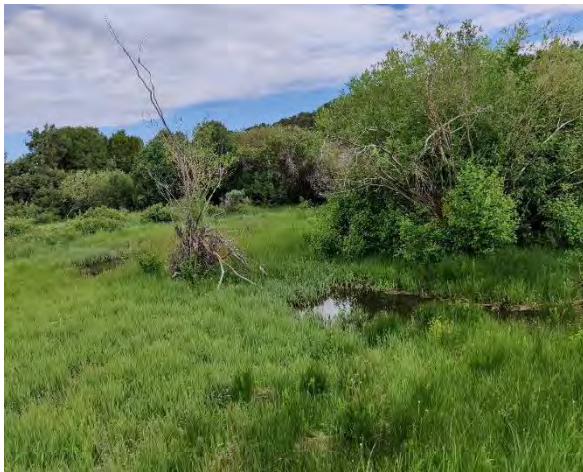
The Jaroso Creek assessment began at the mouth of the canyon. This assessment included the measurement of geomorphic cross-sections and a site walk along the channels. Ditches were observed along both the north and south sides of the valley. The floodplain was connected in the upper reaches (Figure 6-125), and although the diversion box structure did divide the water somewhat, it appeared the flow paths were comingled below this structure. The channels were walked to try to locate the measurement flume, but this was not found. A historic dam was identified within the valley (Figure 6-126).

Figure 6-125 Floodplain inundation along Jaroso Creek.

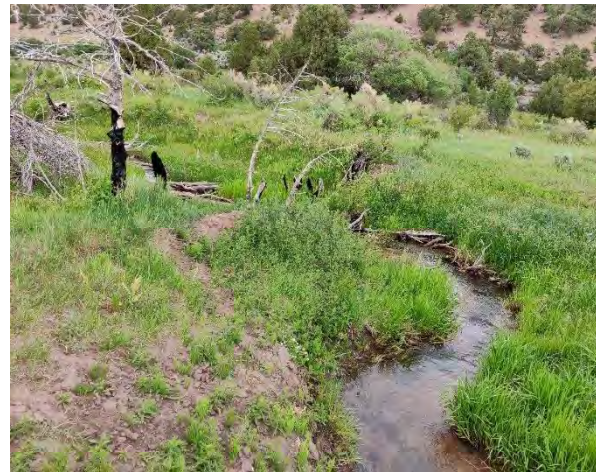
Figure 6-126 Historic dam along main Jaroso Creek channel

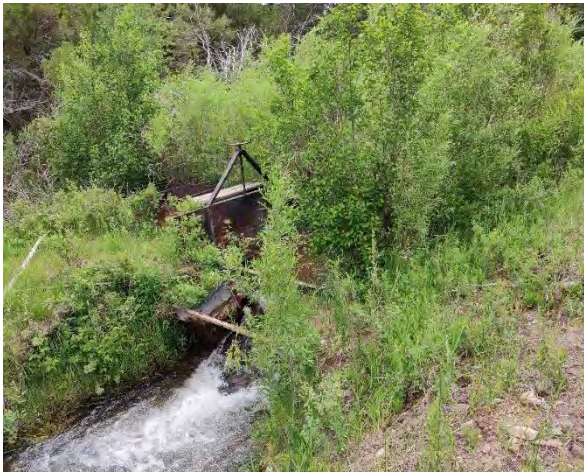
The Choury Ditch headgate is an in-line 3 ft box (Figure 6-127). Scour was noted below the structure, and water was leaking through the closed gate. The ditch along the south side of the channel and the channel were walked, and no flume was not found, although it is listed as having a 2-foot Parshall flume. Water was observed leaking out of the ditch and returning to the channel. Portions of the ditch have been lined (Figure 6-128). An incision was noted

Figure 6-127 Choury Ditch diversion structure.

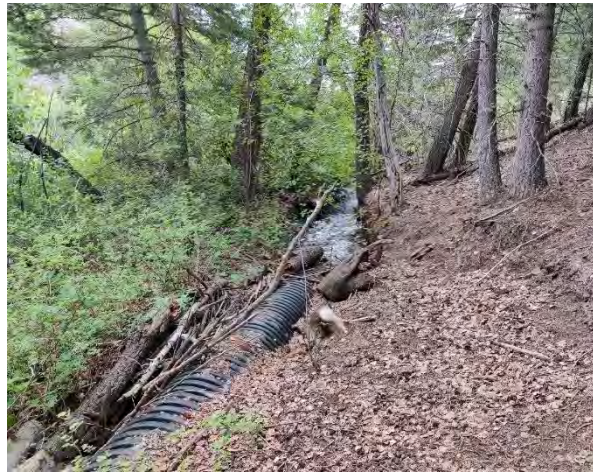
Figure 6-128 Choury ditch flowing on south side of valley Jaroso Creek.

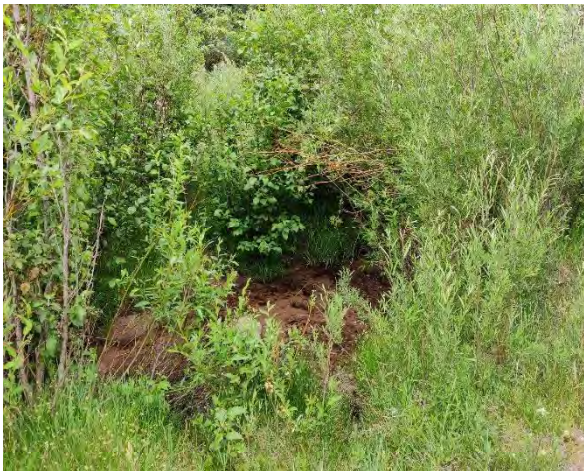
in both the ditch (Figure 6-130) and the channel (Figure 6-131) with areas of fine sediment deposition (Figure 6-129). Farm ditches began below ditch and channel incision (Figure 6-132).

Figure 6-129 Sand in channel below Choury Ditch diversion structure.

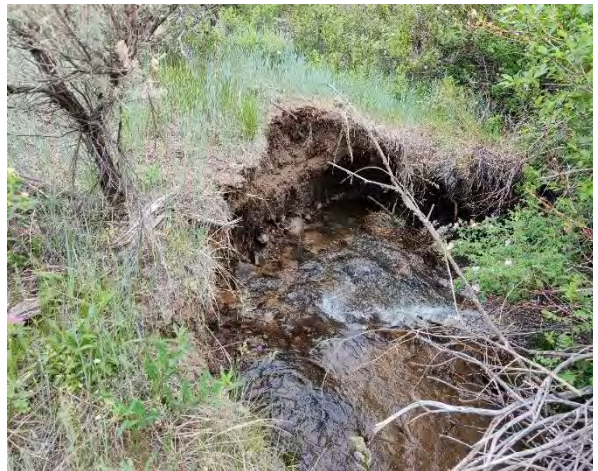
Figure 6-130 Cut bank in Choury Ditch.

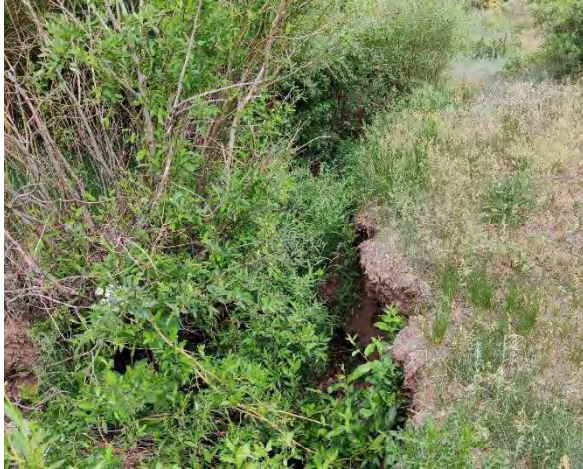
Figure 6-131 Channel incision Jaroso Creek.

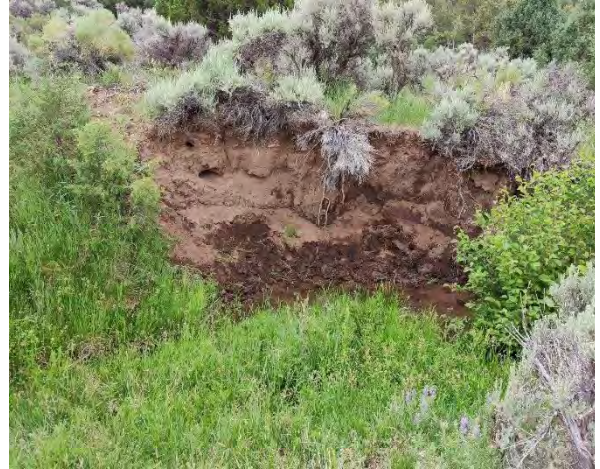
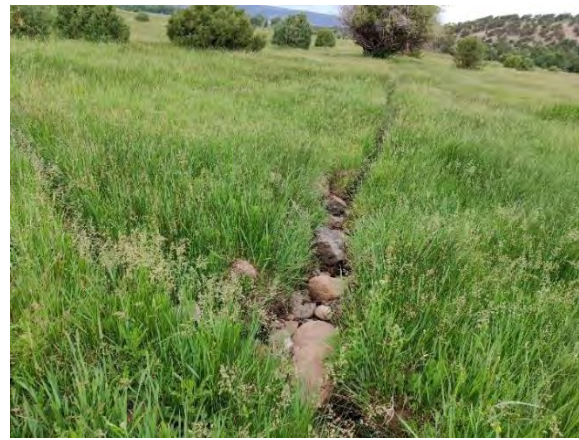
Figure 6-132 Farm ditches began where the ditch was no longer incised.

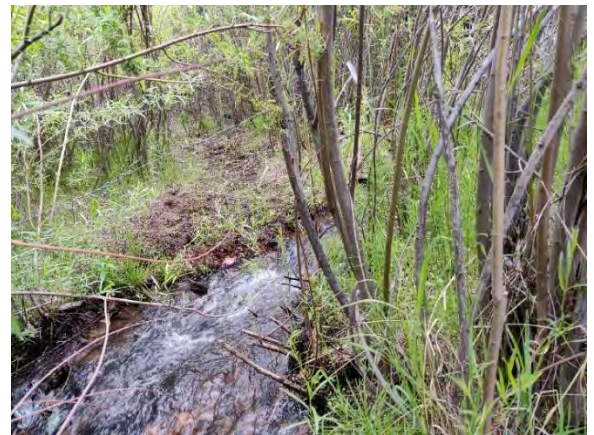
The channel observed on the north side of Jaroso Creek was lined with willows (Figure 6-133) and had many areas that were well connected to the floodplain just below the in-line box structure. Some erosion was noted along the splitter box (Figure 6-134).

Figure 6-133 North side ditch.

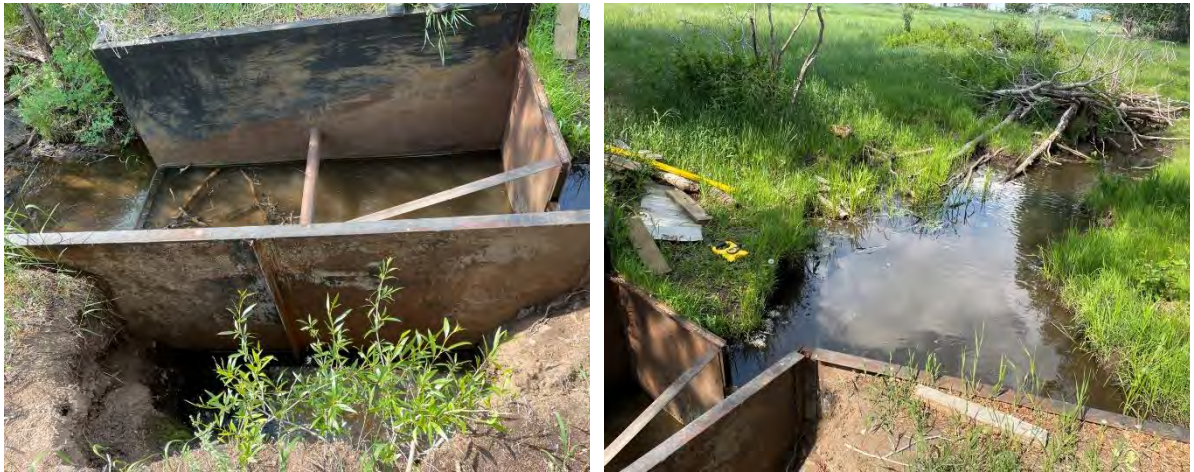
Figure 6-134 Jaroso Ranch ditch splitter structure with erosion on left edge.

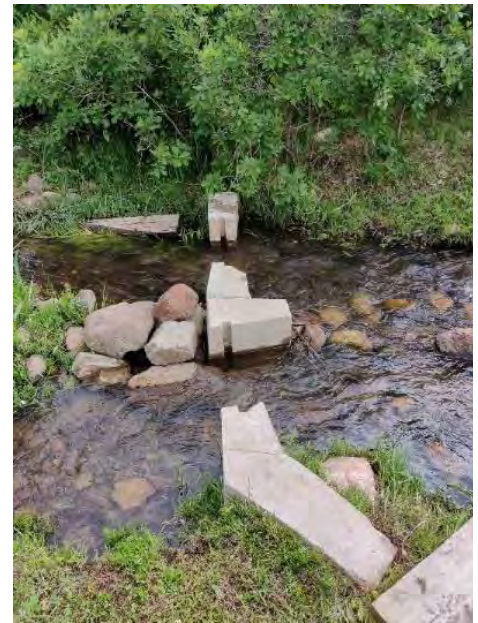
Diversion structures on North and South Cuates Creeks are generally considered to be in acceptable condition for the purpose of water administration except for the Arellano Ditch. Installing electronic recording devices on these structures could reduce water commissioner efforts in administering these structures and provide a complete record of diversions. Streamflow gaging on upper Cuates Creek would benefit water administration, provide valuable information for understanding the Rio Grande Cutthroat trout population and climate risks, and improve water administration.

Figure 6-135 Diversion dam on upper Cuates Creek for Arellano and Cuates Ditch No. 2.

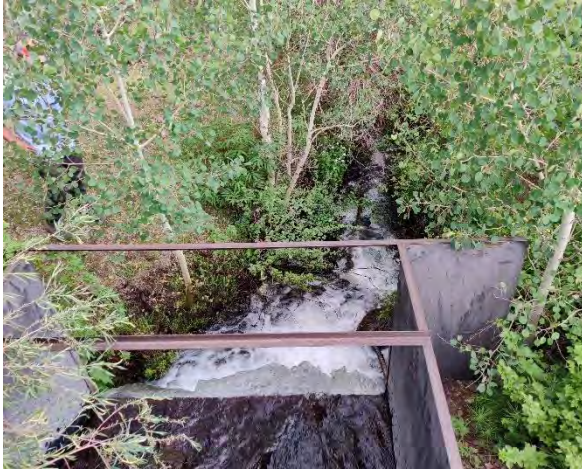
Figure 6-136 Large drop below splitter box on Cuates Creek diversions, preventing fish passage and increasing risk of structure failure.

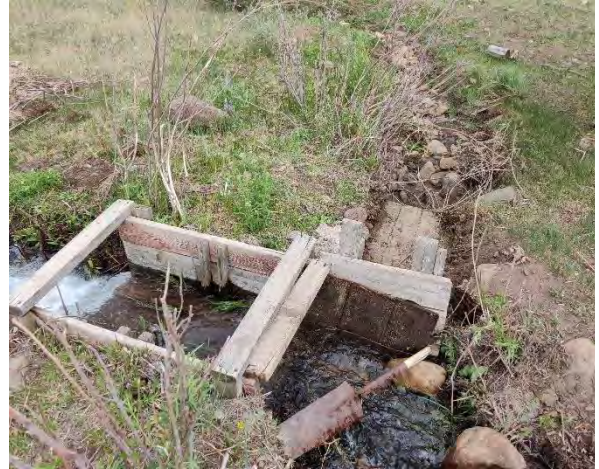
In addition to the diversion structures, splitter boxes on Cuates Creek near County Road 21 were evaluated. The flumes in this area were generally level, some did not have staff plates.

Figure 6-137 Wood splitter box on Cuates Creek.

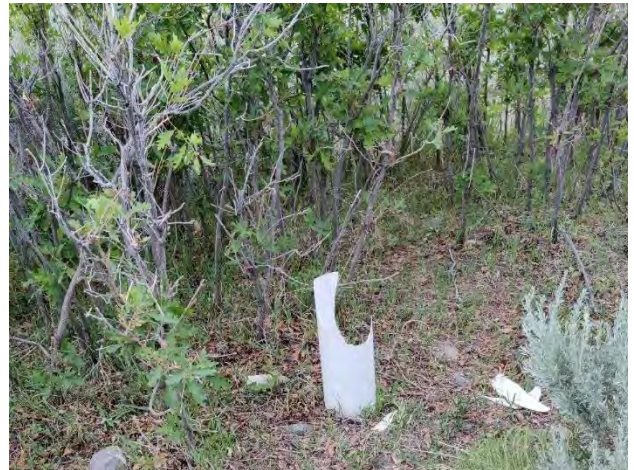
During the assessment, it was noted that many of the air release pipes for this pipeline were broken and none of these were screened. Screening the air release pipes, for a relatively low cost, could reduce future maintenance issues by preventing large debris and small animals from entering the pipeline.

Figure 6-138 Cuates Creek Pond Supply Pipeline.

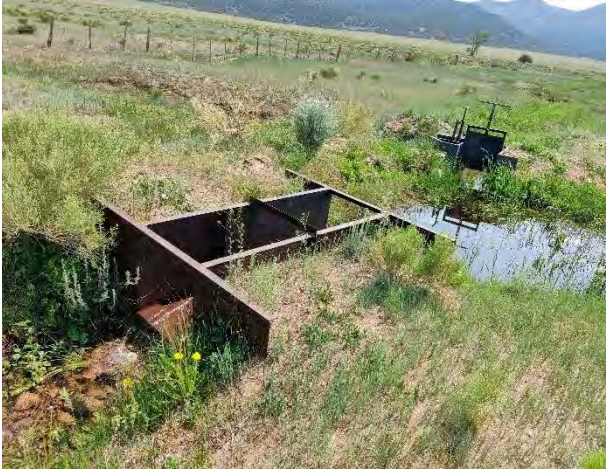
No issues with measurement structures of headgates were identified through interviews at this location. The North flume was level with grass at the entrance during the site visit, affecting performance. The South flume was also level with some grass in the entrance. A third flume was found with no staff plate. This flume was mostly level front and back with light debris in

front. Culverts under County Road 21 are at risk of filling with debris, plugging, and potential flooding on County Road 21.

Figure 6-139 Maestas Ditch splitter boxes at County

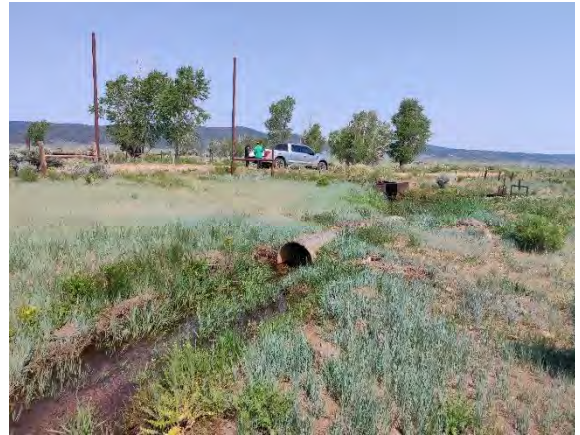
Figure 6-140 Splitter boxes and headgates Maestas Ditch South.

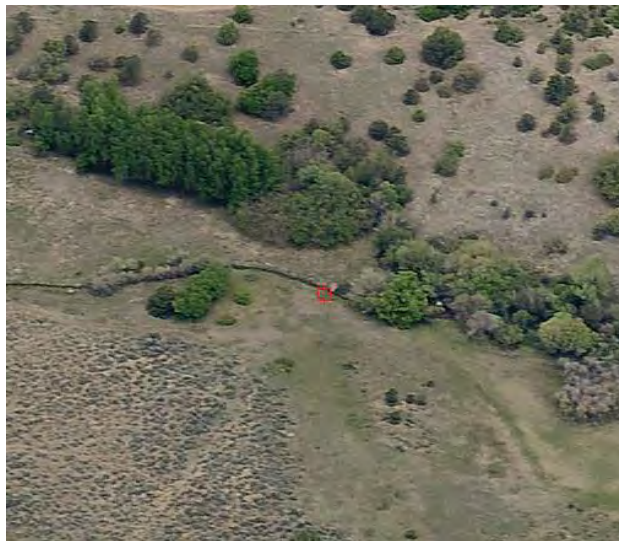
The Fares Jaquez Ditch is diverted from Willow Creek (S. Cuates Creek). Willow Creek is located within the alluvial fan as Willow Creek traversed the foothills. Riparian vegetation is dense in this area, although it decreases just downstream of the structure. No issues with the structure were identified through interviews. The structure does not appear to increase the risk of flooding. Fish passage was not evaluated at this location.

Figure 6-141 Fares Jaquez Ditch headgate. EagleView aerial imager June 20, 2019.

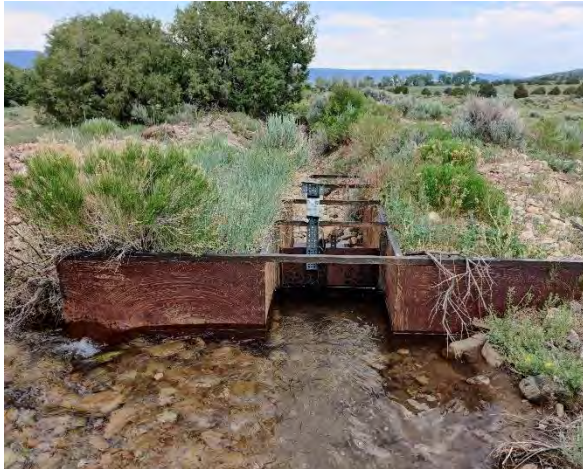
The W.F. Meyer had a lockable slide gate at the headgate Figure 6-142. The W.F. Meyer structure had a levee on the right edge of water downstream of the structure to prevent water from leaving the channel. A 1-foot Parshall flume was observed on site (Figure 6-143).

Figure 6-142 W.F. Meyer diversion structure from Willow Creek.

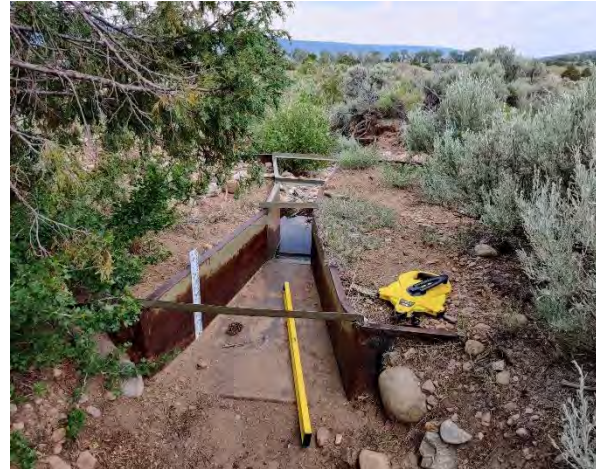
Figure 6-143 W.F. Meyer measurement flume. Downcutting noted in channel below structure.

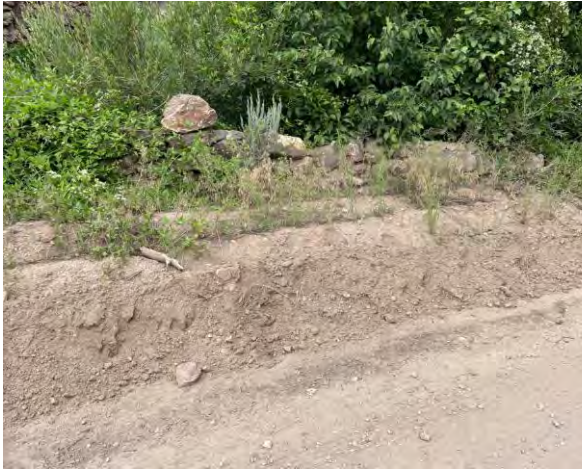
Figure 6-156 Road grading around crossing on Rito Seco creek shows the creation of berms that prevent water from running off the road as sheet flow (37.2531, -105.3336).

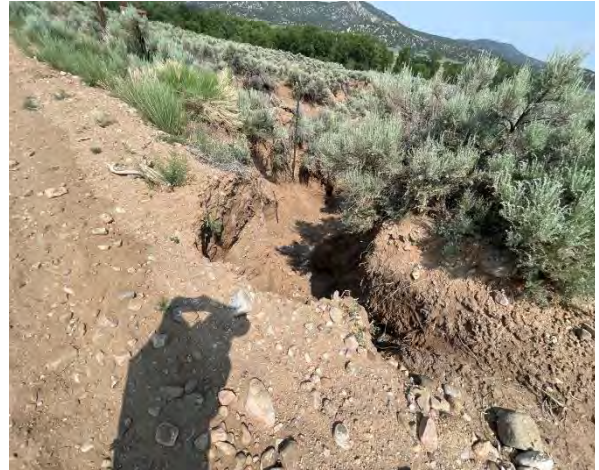
Figure 6-157 County Road M.5, water concentrated from road is the probable cause of gully erosion.

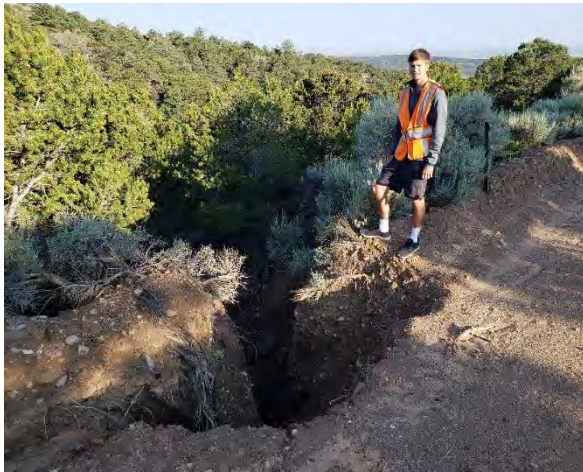
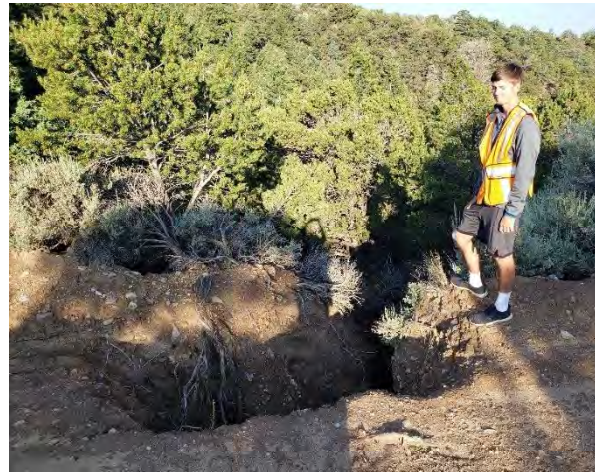
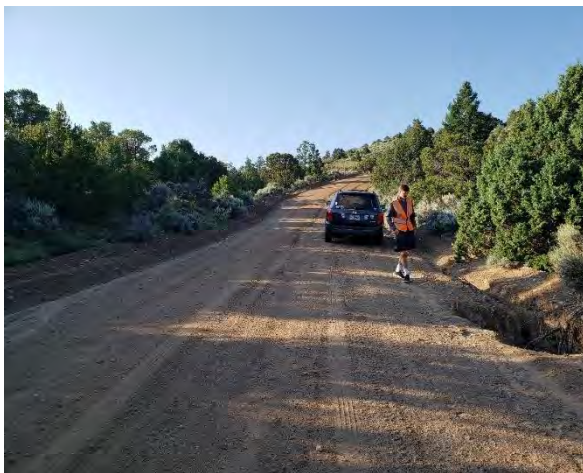
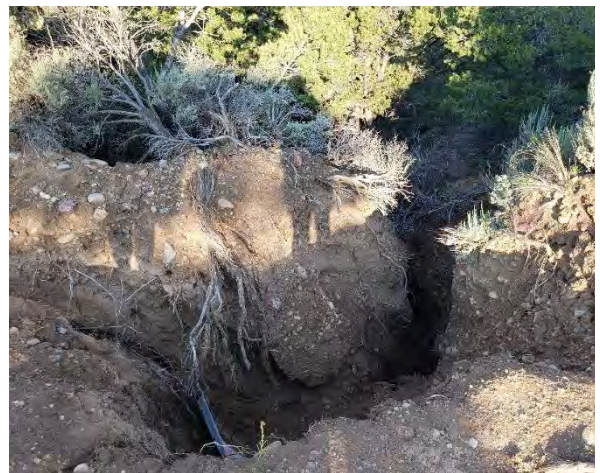
Figure 6-158 Skidmore Road head cut, Note concentrated flow down road (lower left) culvert remnant (lower right).

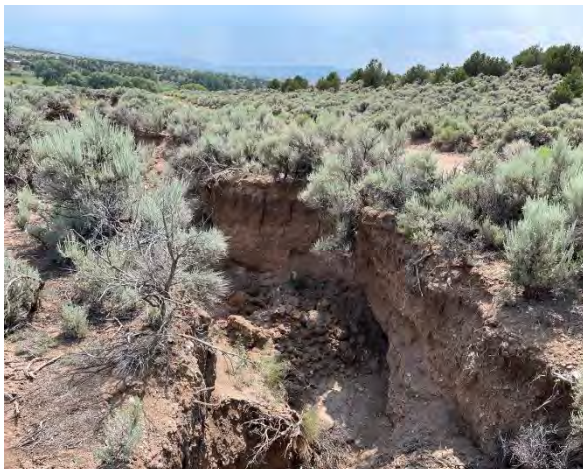
Figure 6-159 Head cut on unnamed road west of Sanchez Canal and north of County Road K.5

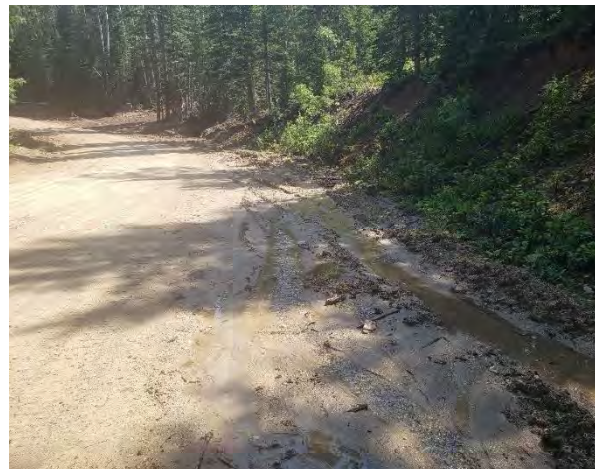
Figure 6-160 Water flowing down Forbes Rd.

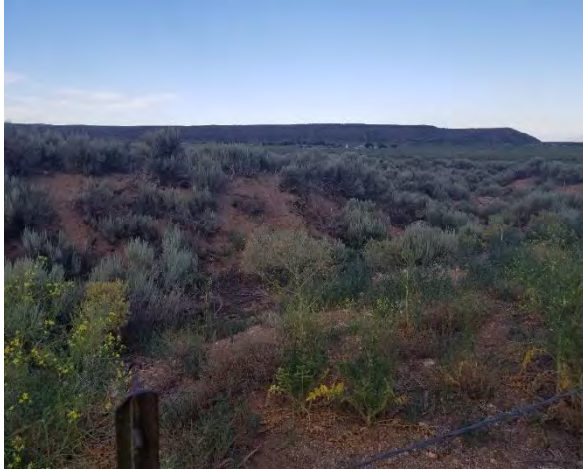
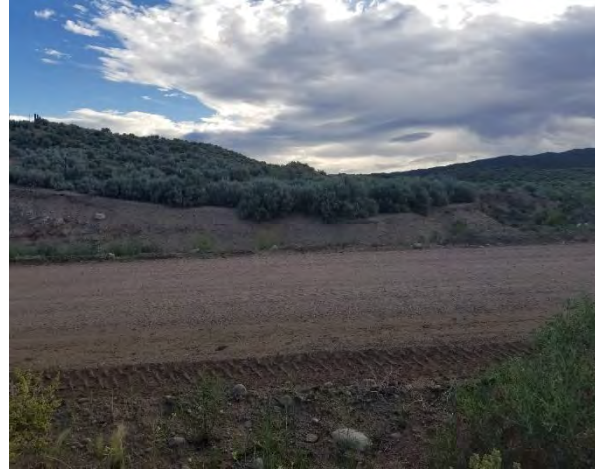
Figure 6-161 Arroyo crossing County Road R. Culvert was blocked upstream of the road.

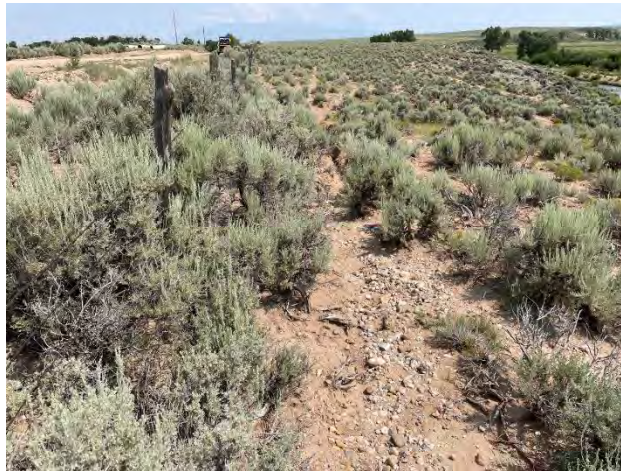
Figure 6-162 Minor gully erosion observed around County Road 16.

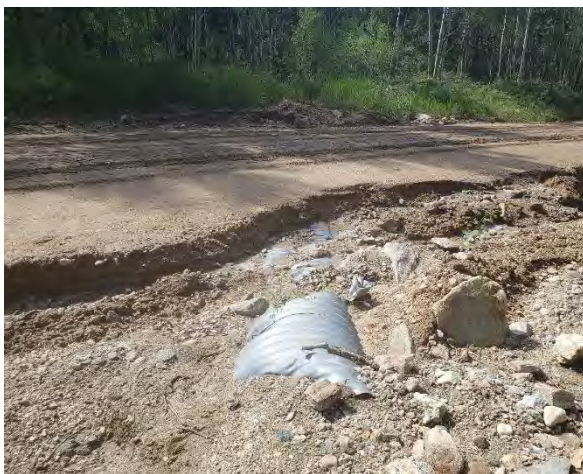
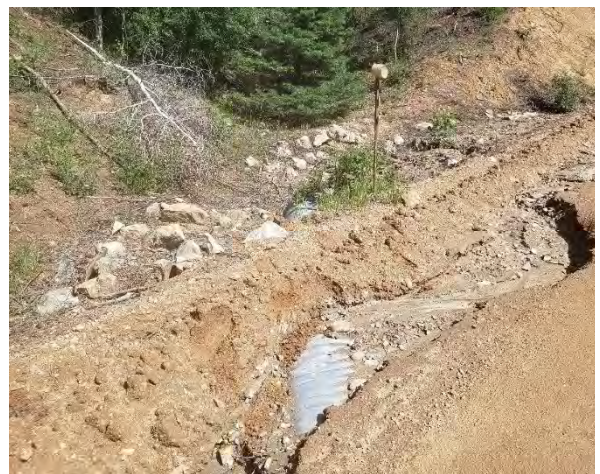
Figure 6-163 Two plugged culverts and roadway erosion on Forbes Road.

A culvert inspection and maintenance program can significantly reduce the risks to public roadways and repair costs by detecting issues at culverts before excessive erosion (CDOT, 2019). Monitoring of existing degraded crossings can be used to identify areas of critical concern for maintenance prioritization.

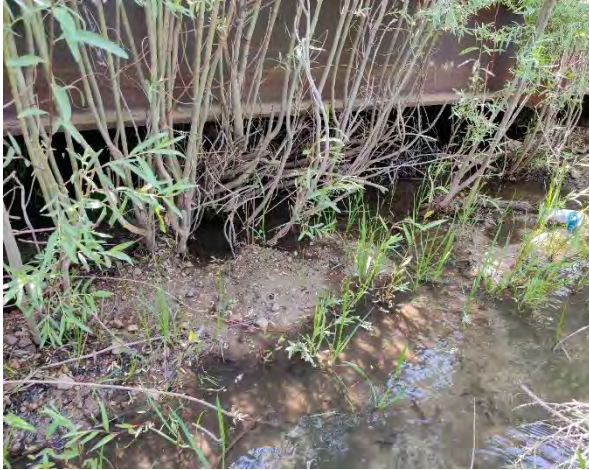
At the bridges, especially within the lower basin where creeks are typically dewatered, vegetation has grown within the channel, reducing the conveyance of water through the structures. An example of this is shown in Figure 6-167. In this area, it is possible that the channel was widened from the historic channel to reduce the required height of the bridge. In some locations, the road is not aligned with the creek; an example is shown in Figure 6-167 and Figure 6-168. The structure shown in Figure 6-170 may also pose as a fish passage barrier during high flows if water is confined to the metal pipe, causing a significant increase in channel velocity. Except for the new bridge across Hwy 159, existing structures are typically set to pass bankfull flows, which are typically associated with the 1 to 2-year flood recurrence and will back up water for flows greater than these. Many of the roadways have been built up within the upper valleys, eliminating the stream's access to the floodplain. These low bridge structures are at risk of catching debris, elevating flood stage, or having water flow around the structure when the floodplains are active. A detailed hydraulic analysis would be required to determine the extent of flooding near these structures.

Figure 6-167 Jaroso Creek at County Road 21 bridge partially blocked by sediments and willows.
