Upper Culebra Watershed Assessment Report

In Progress Draft

Prepared for Costilla County Conservancy District

Tailwater Limited

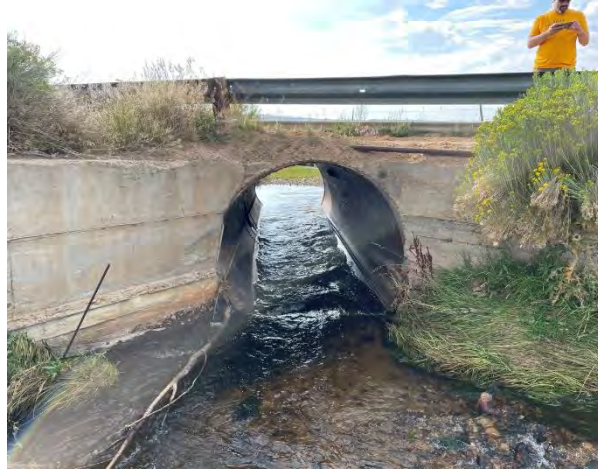
Figure 6-168 Culebra Creek County Road L.5 bridge. This bridge is not aligned with the creek. Some seepage noted on left edge.

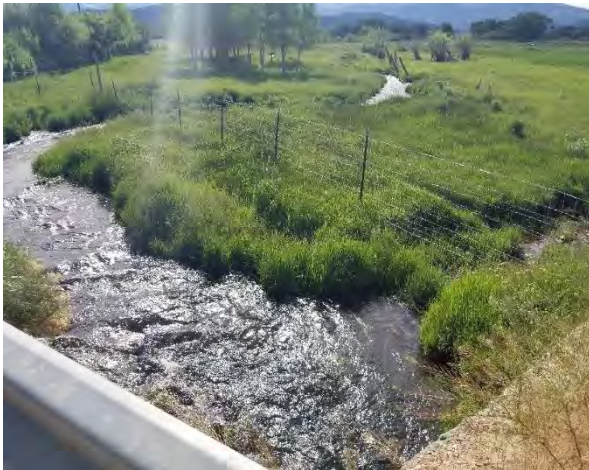
Figure 6-169 Bridge not aligned with creek.

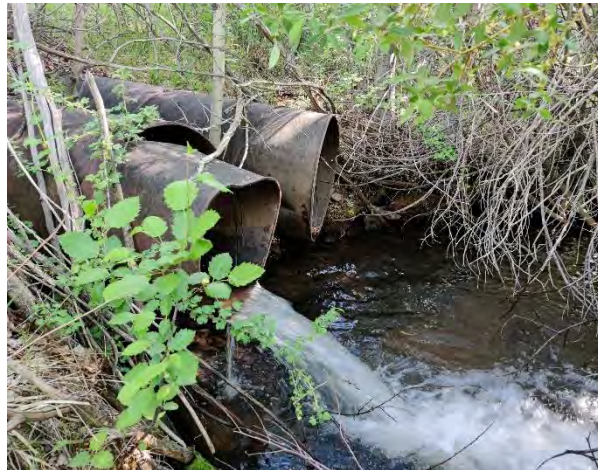
Figure 6-170 Culverts causing degradation in the stream and reducing fish passage on Torcido Creek.

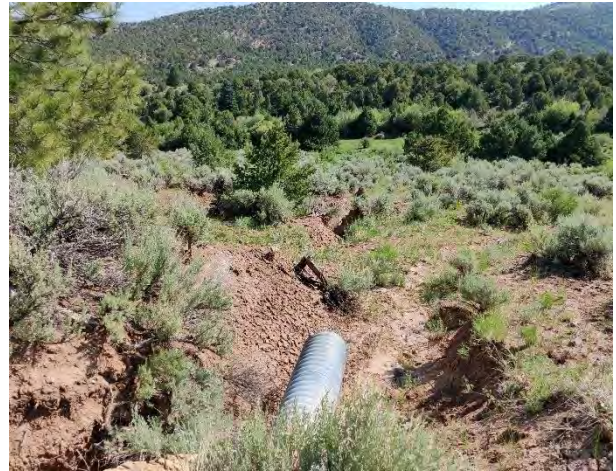
Figure 6-171 Culvert outlet causing downstream erosion due to large drop below outlet.

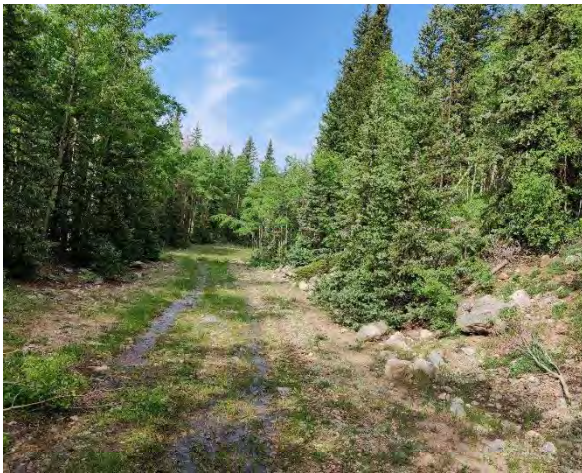
During field observations, many occurrences of water flowing down roadways was observed (Figure 6-172-Figure 6-176). The result of this is increase run-off velocity. This increase in water velocity typically increases peak flows while decreasing base flows. The runoff from the roads increases sedimentation in the stream and may increase stream water temperatures. In areas where herbaceous plants have regrown, flows are slowed and have increased opportunity to infiltrate, thus increasing travel time and decreasing sediment loading and temperatures (Figure 6-174).

Figure 6-172 Water flowing down road along El Valle Creek.

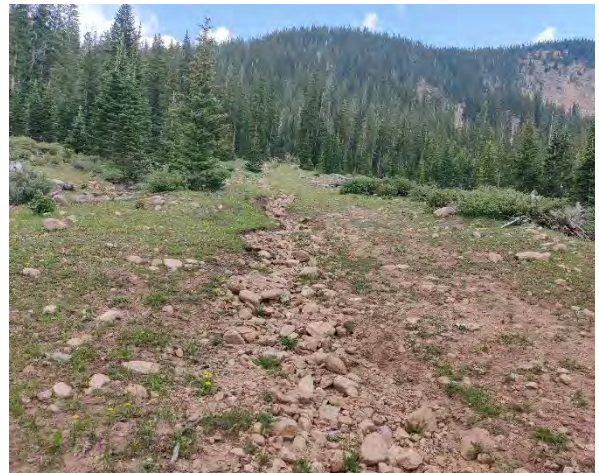
Figure 6-173 Channel along road Jaroso Creek drainage.

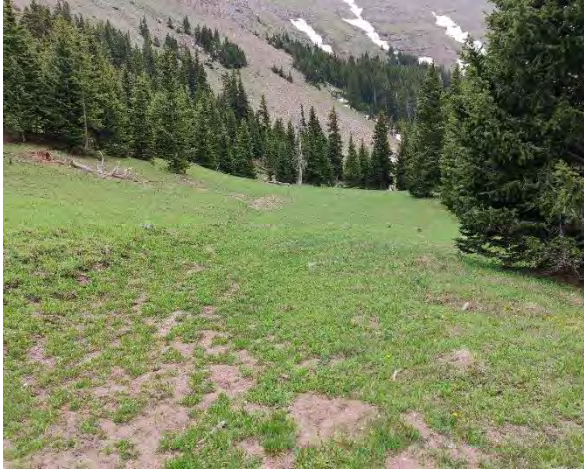
Figure 6-174 Grass growing along the only road in upper El Valle basin. Spring flow through the hillslope on left side of photo.

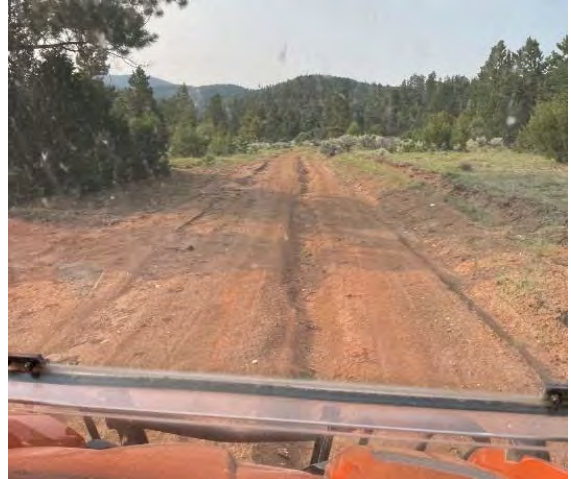
Figure 6-175 road rutting, San Francisco Creek drainage.

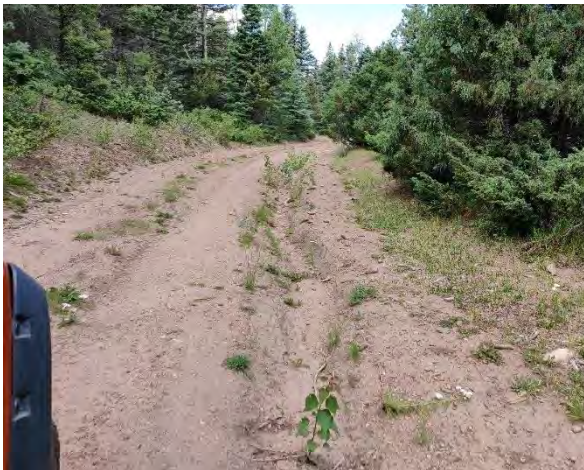
Figure 6-176 Road rutting Vallejos Creek drainage.

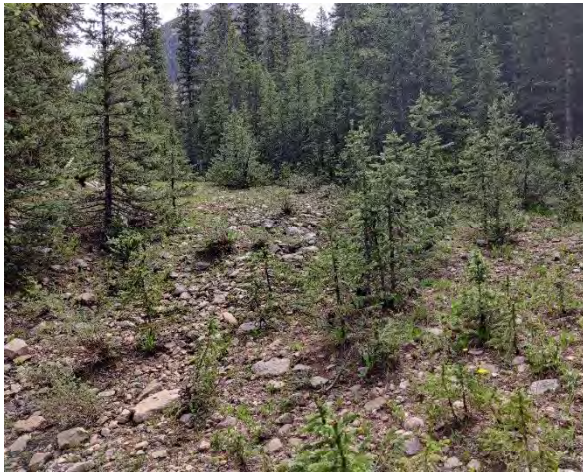
Figure 6-177 Trees growing in old logging road.

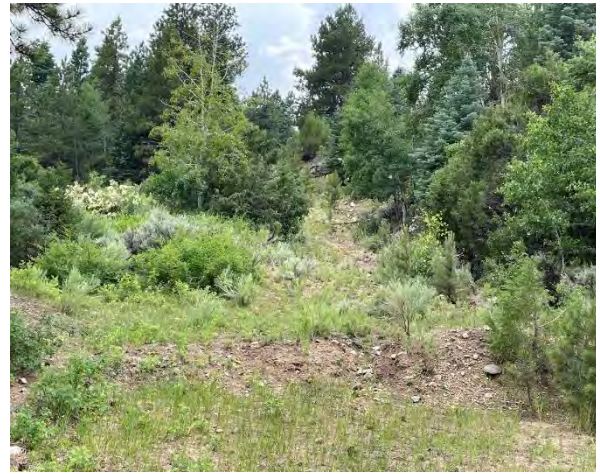
Figure 6-178 Vegetation on old logging road San Francisco Creek drainage.

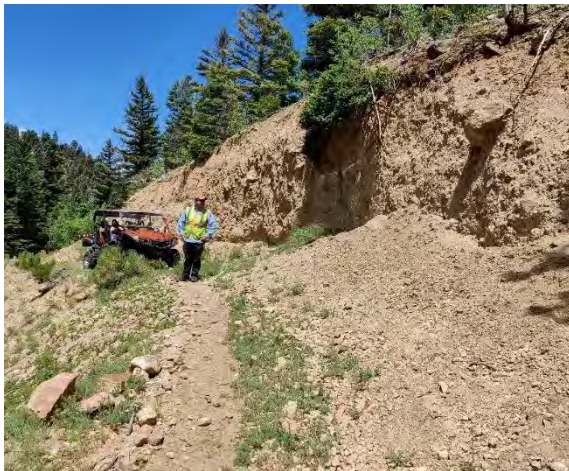
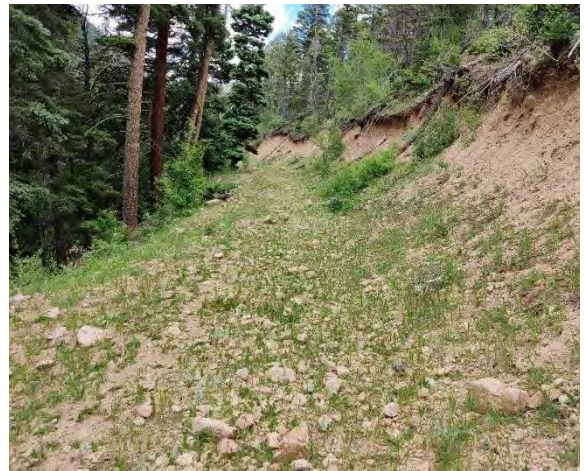
Along San Francisco Creek, roads that were cut through steep hillslopes were failing. The road was not safely passable by UTV (Figure 6-179). Below this road cut, channel aggradation was observed. This reach had some channel stabilization (Figure 6-180). Low water crossings in a variety of conditions were observed. Most of the crossings were like the crossing from Rito Seco shown in Figure 6-181. This crossing occurs where the channel is slightly overwide, reducing flow depths. Fine sediment inputs may be occurring at steep banks. Sediment contribution volume depends on traffic volume. However, a few of the crossings were areas where sediment inputs were not stabilized by the cobble streambed like the crossing shown in Figure 6-182. This crossing causes the channel to be significantly overwide with a substrate as road base rather than the stream bed. Fine sediments from the roadway are likely to be tracked into the stream. Over widening reduces flow depths such that fish passage is not possible.

Figure 6-179 Hillslope failure up San Francisco Creek. Left shows north side of valley, right shows south side of valley.

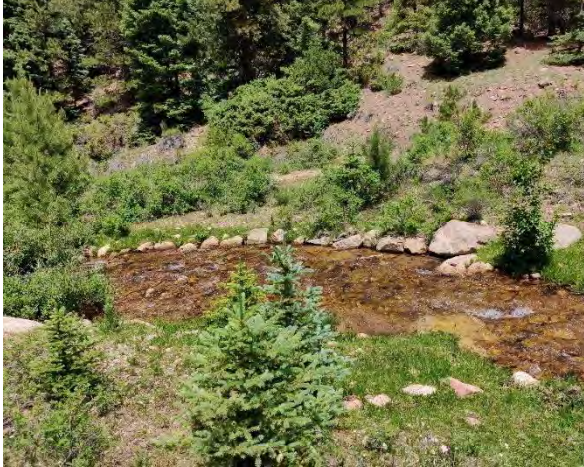
Figure 6-180 Stream channel stabilization below area of extensive hillslope erosion.

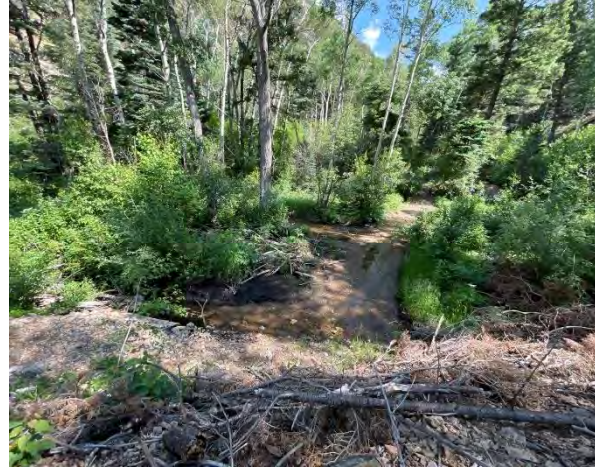
Figure 6-181 Low water crossing, Rito Seco drainage causing stream to be over wide and fine sediment deposition which could be disturbed when vehicle crosses.

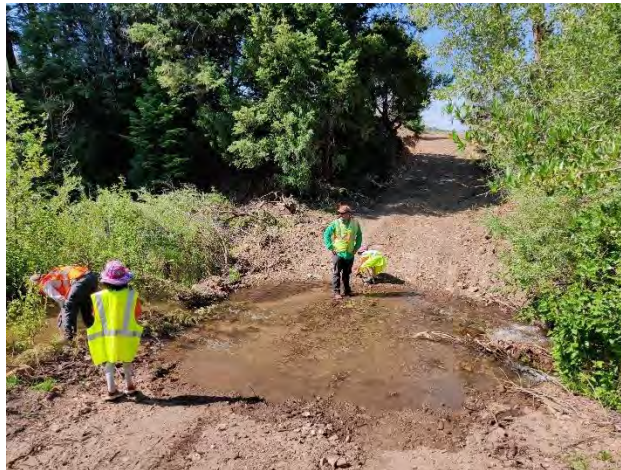
Figure 6-182 Low water crossing that is not stabilized by streambed.

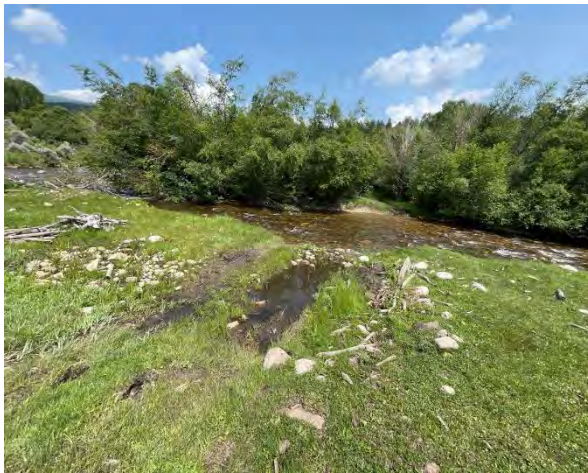
Often farm equipment travels across streams via low water crossings because bridges are not present or do not have the capacity to carry the heavy loads. Figure 6-183 is an example of a low water crossing that results in fine sediments being transported into the creek, thus causing the creek to be overwide. These factors will cause the channel to become destabilized. Sediments are tracked from the floodplain ruts into the stream as vehicles cross the channel.

Figure 6-183 Example of low water crossing, this crossing is from El Poso Creek, but many such crossings are present within the basin.

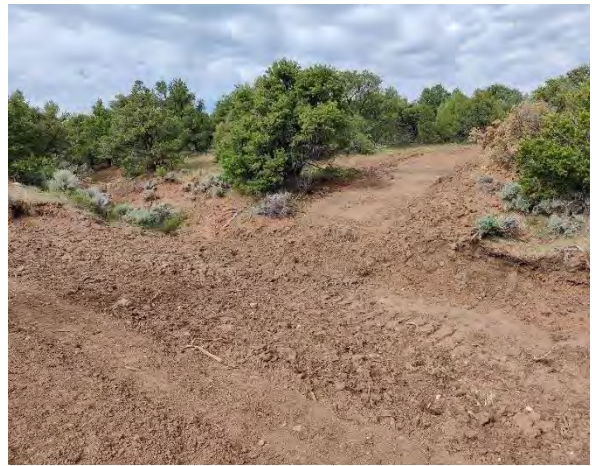
Newly constructed roads that did not consider water conveyance were observed, such as the road shown in Figure 6-184. Equipment was used to make roadway while covering smaller drainages with road base and fill. Filling these drainages will result in either water running down the road, causing rutting, or a headcut forming below the road because of the change in slope, eventually threatening the road.

Figure 6-184 Recently constructed road in Jaroso Creek drainage.

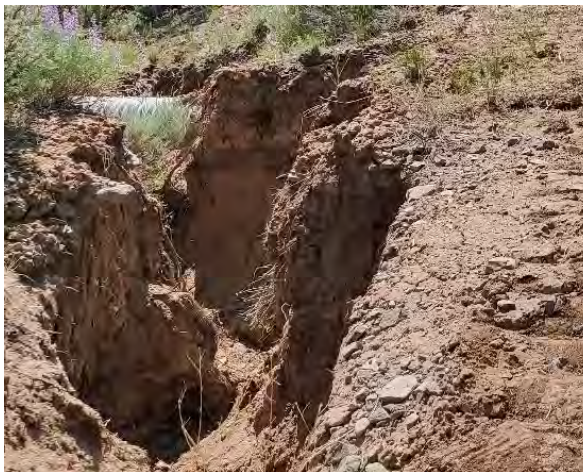
Culvert installation issues are highlighted across the arroyos. Figure 6-185 highlights the headcut occurring near a culvert that had been plugged by sediment. Water, unable to reach the drain, found a path downhill along the road embankment and not the channel. Figure 6-186 shows the downstream end of this culvert, which likely was plugged shortly after installation because the channel does not appear to be significantly degraded below the pipe, despite the lack of erosion protection below the significant drop.

Figure 6-185 Headcut up road ditch near culvert.

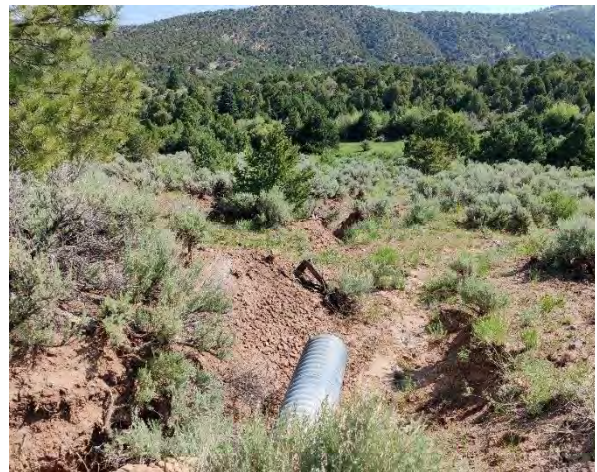
Figure 6-186 Downstream end of culvert that is buried upstream in Jaroso Creek drainage, headcut along road embankment shown in Figure 6-185..

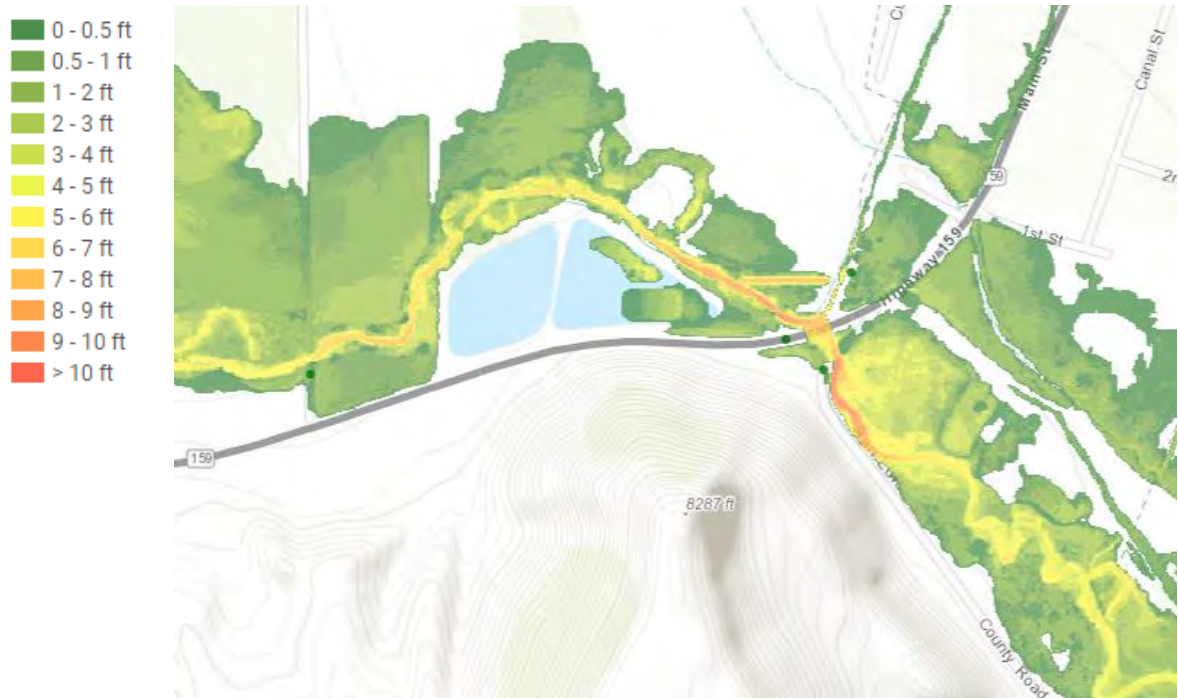
Adjacent to the San Luis Wastewater Treatment Plant, Culebra Creek has been straightened in addition to portions of the treatment facility being located within the 1% depth grid (Figure 6-188).

Figure 6-188 San Luis Wastewater Treatment Plant Preliminary 1% Depth Grid from Colorado Hazard Mapping and Risk Portal accessed October 29, 2021.

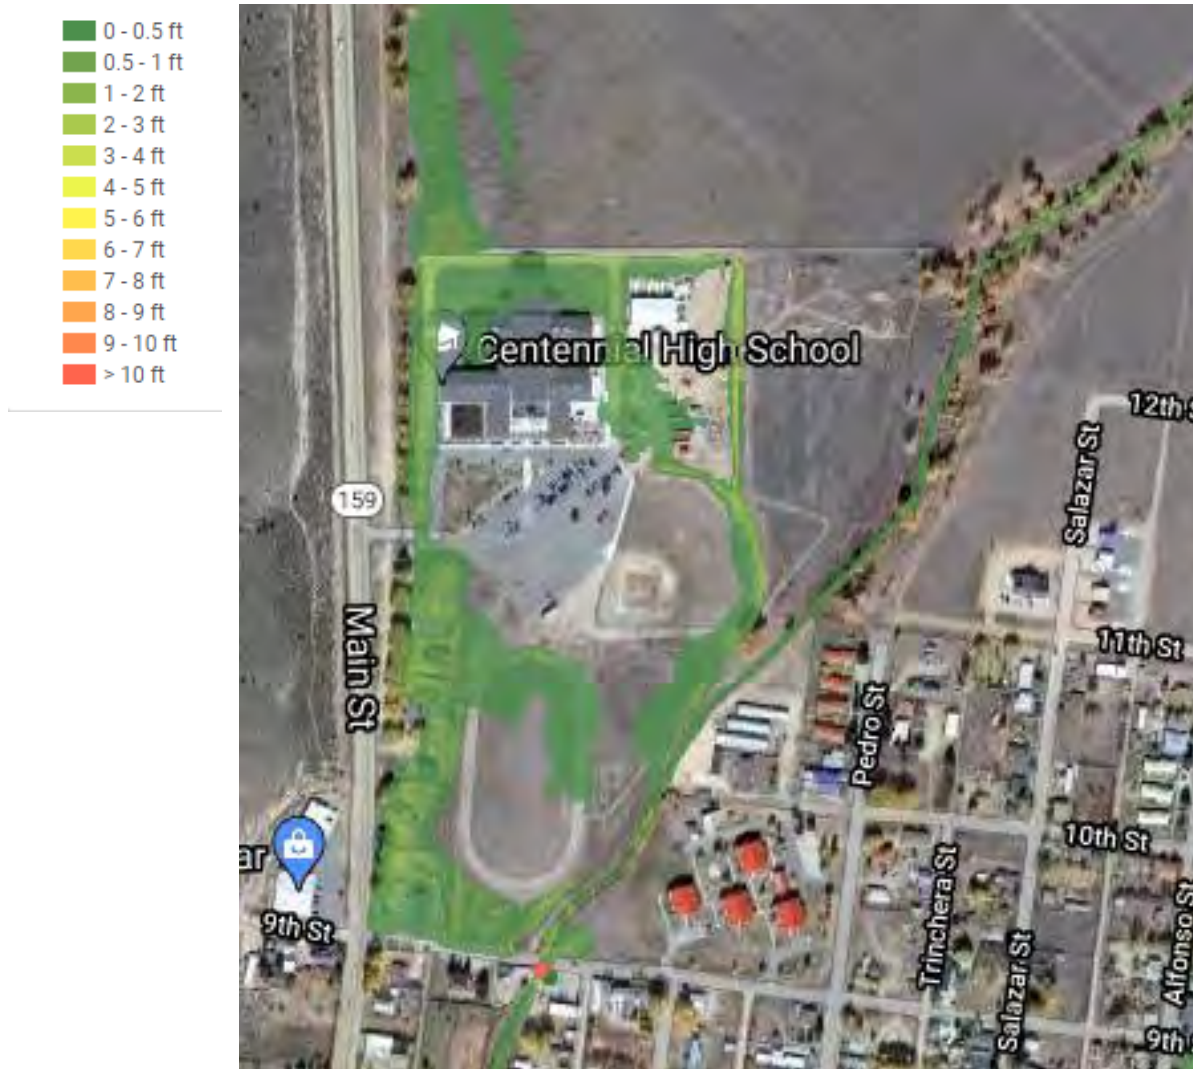
Centennial school, including portions of the building and track, were mapped within the 1% depth grid, which is the estimated depth of the water during the 100-year flood event (Figure 6-189). While the majority of flows from Rito Seco were mapped to the east of town, a portion of the flows was mapped going through the Town of San Luis. These flows are in addition to flows from Salazar Reservoir and another upstream dam. Much of San Luis is at the lower end of the Rito Seco alluvial fan, where flow path mapping may be limited due to the potential for an avulsion.

Figure 6-189 Centennial School Preliminary 1% Depth Grid from Colorado Hazard Mapping and Risk Portal accessed October 29, 2021.

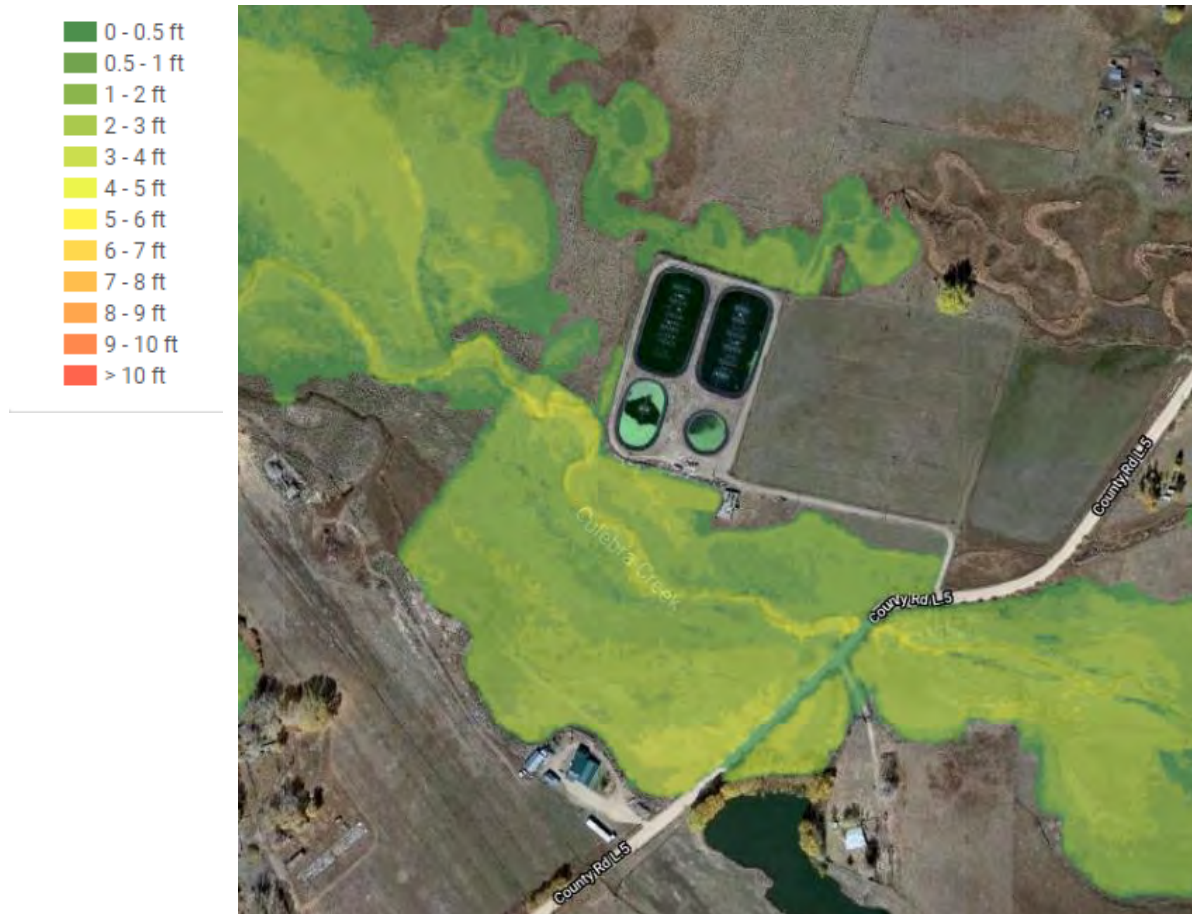
Costilla County Wastewater Treatment Plant was not included within the 1% depth grid or within the 0.2% annual chance floodplain (Area X) (Figure 6-190). However, this facility is located between Culebra Creek's active channel and the historic Culebra Creek Channel, to the north and east, below the levees on Culebra Creek, increasing the fluvial hazard risks to the Costilla County Wastewater Treatment Plant.

Figure 6-190 Costilla County Wastewater Treatment Plant. Preliminary 1% Depth Grid from Colorado Hazard Mapping and Risk Portal accessed October 29, 2021.

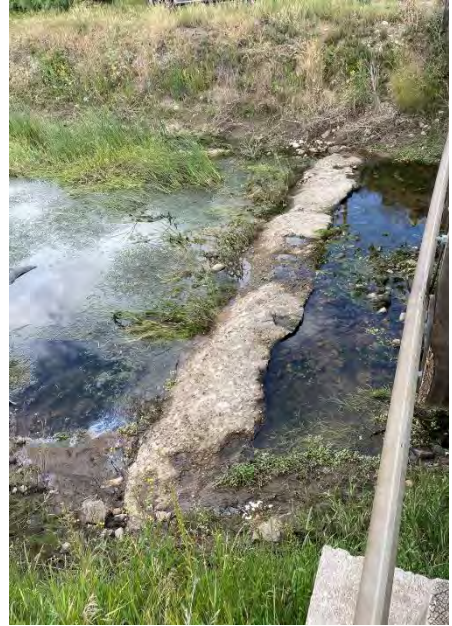
Potential erosion issues with sewer lines in Sanchez Canal (Figure 6-191) was observed. Depth of the actual sewer line is unknown, but these crossings should be monitored for erosion and if necessary additional protective measures taken to protect the sewer.

Figure 6-191 Sewer line crossing Sanchez Canal near County Road J.2 August 19, 2021.

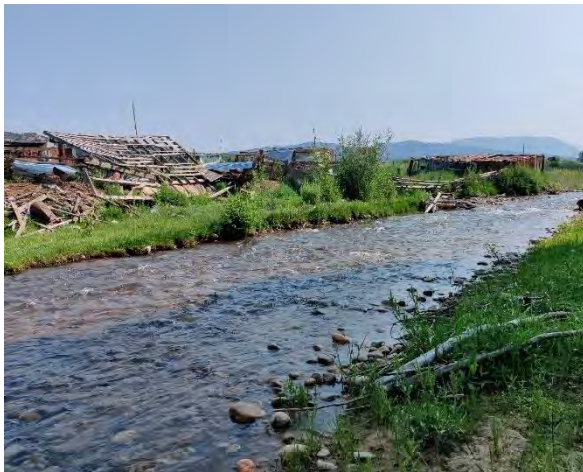
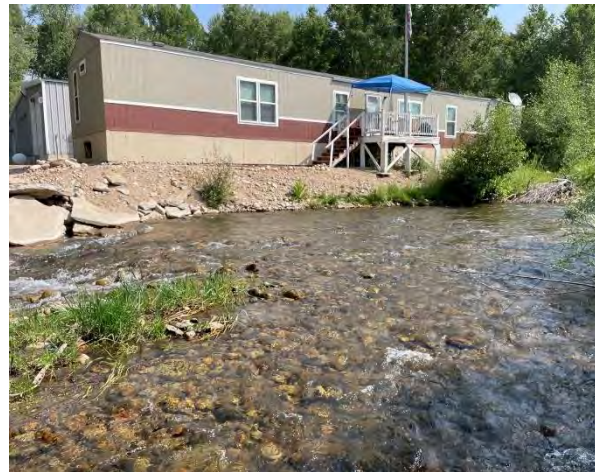
In addition to infrastructure within the floodplain, many instances of structures and personal property within the floodplain were observed. Development within the floodplain increase flood risk and damage by reducing the floodplain capacity (Figure 6-192 and Figure 6-193), increasing the risk of water quality degradation from chemicals leaching through the ground to the waterway, and may increase flood risk downstream as debris is caught on bridges and other structures if mobilized by floodwaters.

Figure 6-192 Structures in floodplain including livestock shelter, storage, and residential structures.

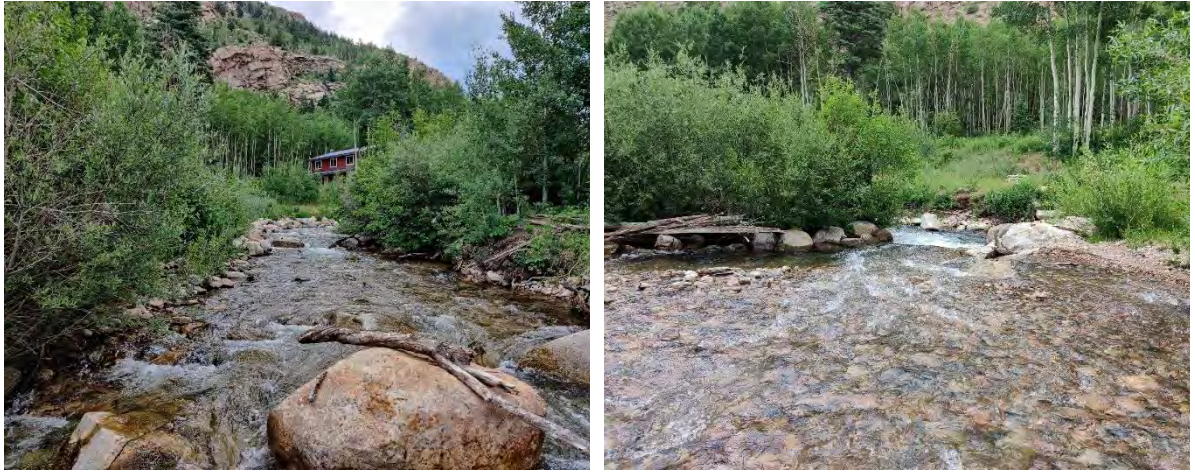
Figure 6-193 Boulder toe stabilizing channel around houses along El Poso Creek (left) and channel stabilization work resulting in a large drop in a channel that is causing excessive erosion downstream and high probability of head cut upstream after toe failure in a channel (right).

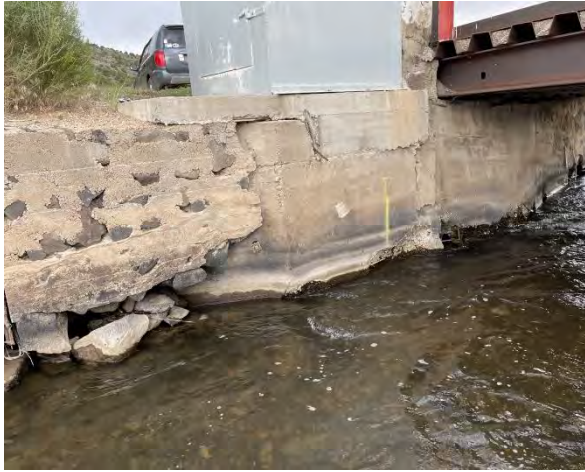
The streamflow gage Culebra at San Luis (CULSANCO) was evaluated and functioning at-risk. The streamflow gaging station is located at a 12-foot concrete flume that operates within the current flow regime. The roadway into the property from the east creates a dam forcing flows through the flume. The left wall of the flume was found to be spalling with exposed rebar. The gaging station has small inlets that are prone to plugging with no flush risers present to remove sediment from the stilling well. Gage is subject to confined space entry hazards which provide additional hurdles to quality streamflow records.

Figure 6-195 Left edge of water gaging station stilling well and flume wall.

- Replace gaging station on Culebra River near San Luis with a functioning stilling well with operable flushing capabilities. Records at this gage are generally good, as long as the water in the stream does not frequently freeze. Ideally, this gage would be replaced with a structure that can be operated without confined space entry hazards.

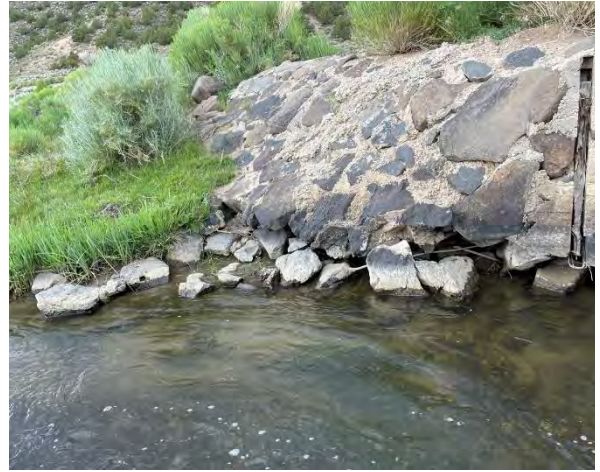
Figure 6-196 Exposed rebar on left edge of water Culebra Creek at San Luis streamflow gage.

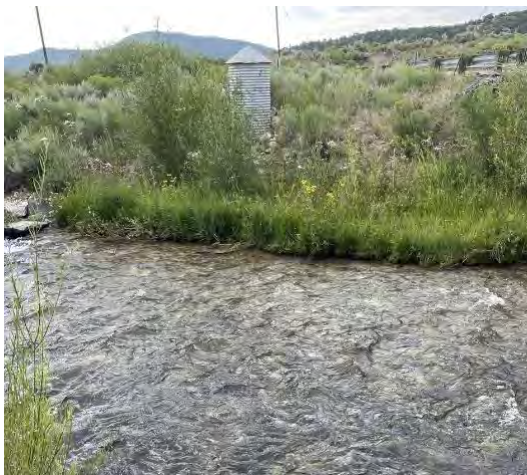
Culebra near Chama streamflow gage was evaluated with a site visit and discussions with representative personnel. The telemetry at this site is provided through a cellular modem that users may call to retrieve the current stage, which must be converted to discharge via a rating table. The control section for the gage is a rock weir with a large, approximately two-foot drop. The control section is at risk of failure due to downstream scour. This gage is operated for administrative purposes only and does not receive routine measurements or calibration. Colorado Division of Water Resources hydrography website indicates the user should direct questions regarding station to U.S. Geological Survey. The Division of Water Resources shows 39 measurements have been made at the station over the past 10 years (10-1-2010 to 09-30-2020), averaging 4 measurements per year. No rating curve or shift application information was available on the Colorado Decision Support System Station interface.

Figure 6-197 Culebra near Chama Streamflow gage.

- Watch control structure at Culebra near Chama, and if necessary, perform stream restoration to repair damage around gaging station. The station is subject to some filling that will result in rating curve shifting that may go unrecognized due to minimum measurement frequency. Recommend upgrading the telemetry data availability through standard user interfaces (Division of Water Resources) or a common community resource.

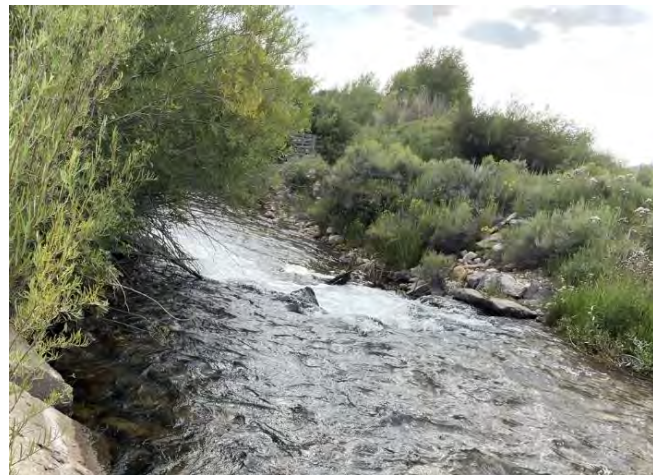
Figure 6-198 Culebra River looking downstream at Culebra Chama control.

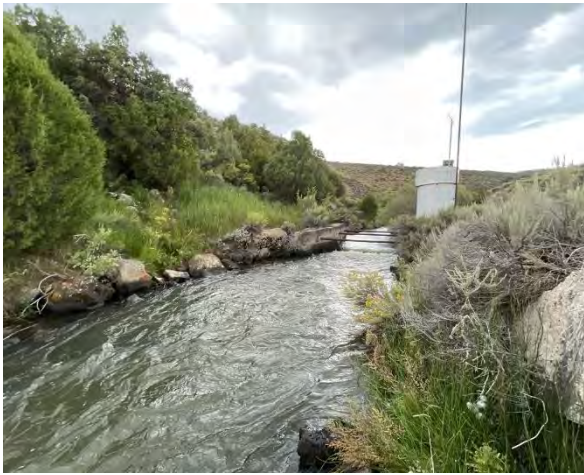
The Ventero below Sanchez Reservoir gage is a stilling well located at a 10-foot Parshall flume. Pipes with a swinging metal arm were found at the upstream left edge of the flume. A

Figure 6-199 Looking upstream at Ventero below Sanchez Reservoir.

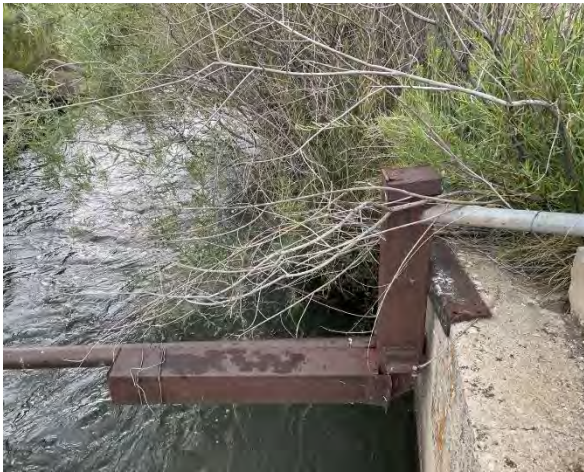
Figure 6-201 Device located near flume at Ventero below Sanchez Reservoir.

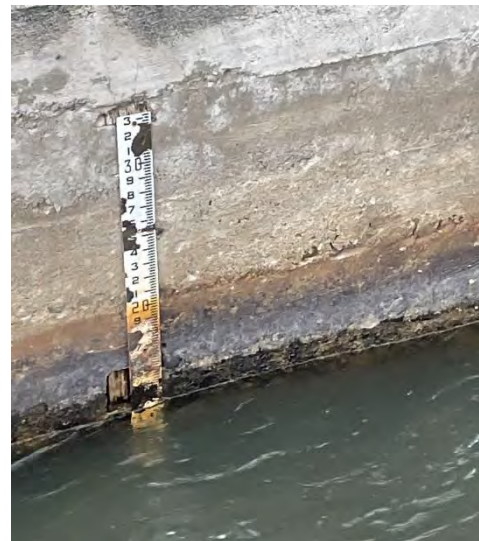
staff plate was located on the right edge of water across from stilling well and was unreadable. The operations of this station were evaluated as part of the flow regimes section of this report.

Figure 6-202 Ventero below Sanchez Outside Staff Gage.

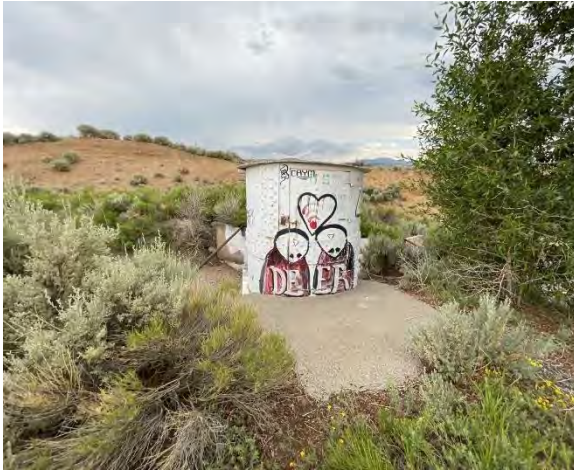
During the field investigations, the measurement flume above Sanchez Reservoir, measuring the deliveries from Sanchez Canal, was evaluated (Figure 6-203). This structure is referred to as Sanchez Canal at Sanchez Reservoir. This structure is a 12-foot concrete Parshall flume. Interviews with the Sanchez Ditch and Reservoir Company are still monitored with a paper chart recorder with a 30-day clock. The structure was clean and free of debris (Figure 6-204). The structure showed evidence of degradation downstream that

Figure 6-203 Sanchez Canal at Sanchez Reservoir.

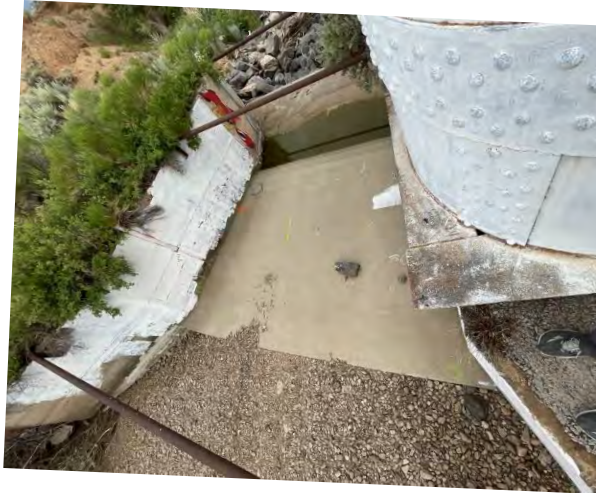
Figure 6-204 Flume clean and relatively free of debris. Staff plate has been vandalized.

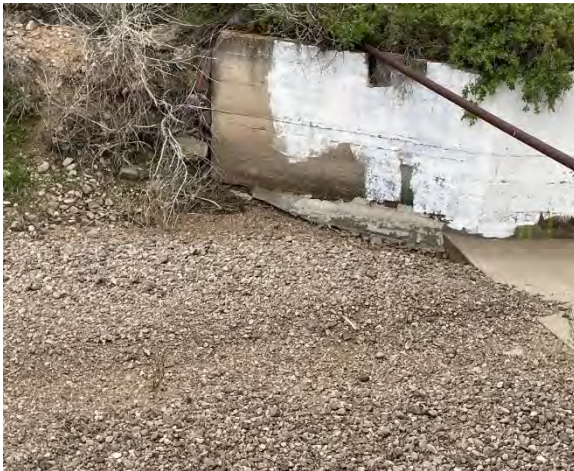
has been mitigated through riprap placement (Figure 6-206). The upstream left edge wing wall showed erosion and potential seepage (Figure 6-205).

Figure 6-205 Some scour noted on upstream left edge of flume.

- Outlet works below Sanchez should be modified to have handrails and other hazard protection mechanisms.
- Monitor upper-left edge of flume wall at the end of Sanchez Canal. Seepage may be occurring here that could eventually undermine the structure. If additional gaging is implemented upstream, it may be prudent to evaluate the removal of the structure and restoration of the reach to include sediment retention forebay to reduce sediment loading in Sanchez Reservoir.

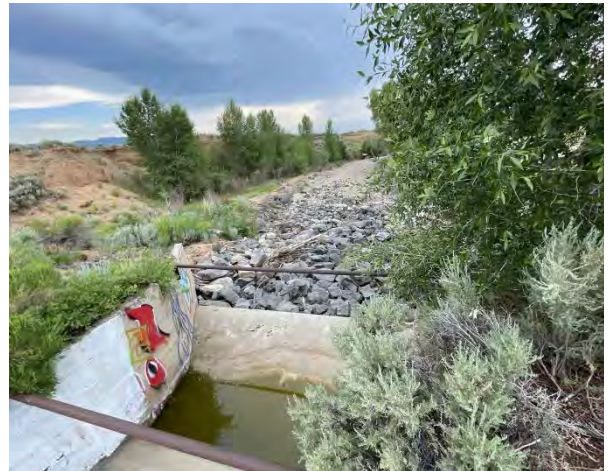
Figure 6-206 Downstream riprap placed to prevent erosion.

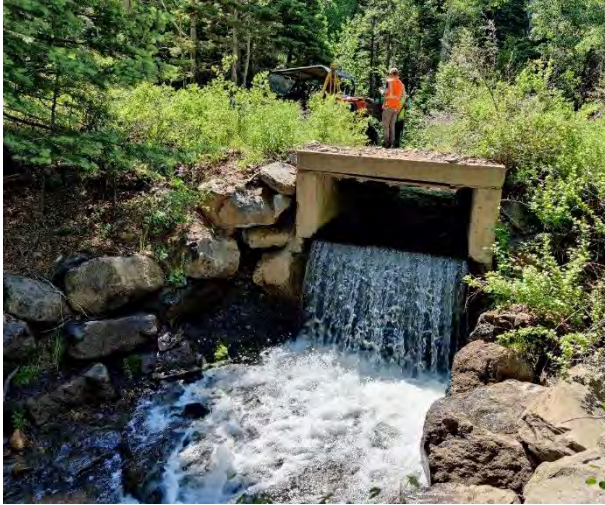
On Jaroso Creek, one six-foot-wide fish barrier structure was found in good condition. Cuates Creek fish barrier is a boulder drop structure that appears to be functioning (Figure 6-208).

Figure 6-207 Jaroso Creek fish barrier.

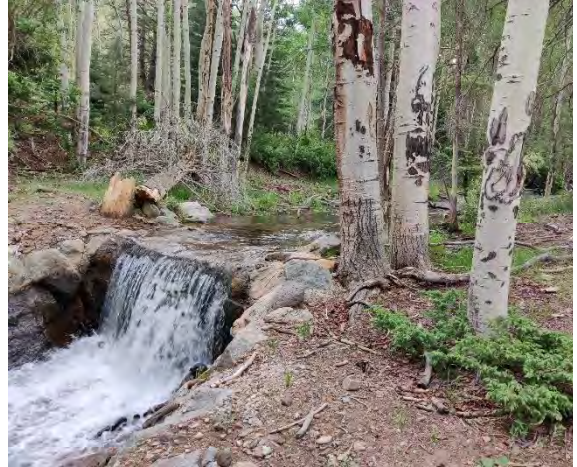
Figure 6-208 Cuates Creek fish barrier structure.

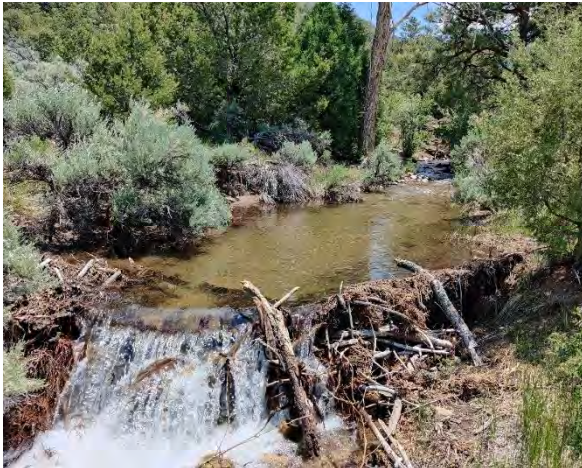
The fish barrier on Willow Creek is constructed from fence posts and hog wire to create a drop (Figure 6-209). Willow Creek fish barrier showed some flow along the left edge of water during high flow 2021 (Figure 6-210). The structure is catching fine sediments and debris, which eventually results in the structure's failure. The channel downstream of the structure appears to be in good condition (Figure 6-211).

Figure 6-209 Looking upstream at Willow Creek fish barrier.

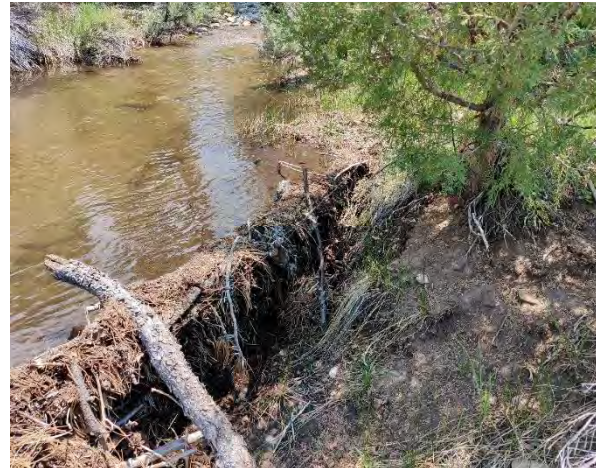
Figure 6-210 Flow along left edge of water of Willow Creek fish barrier.

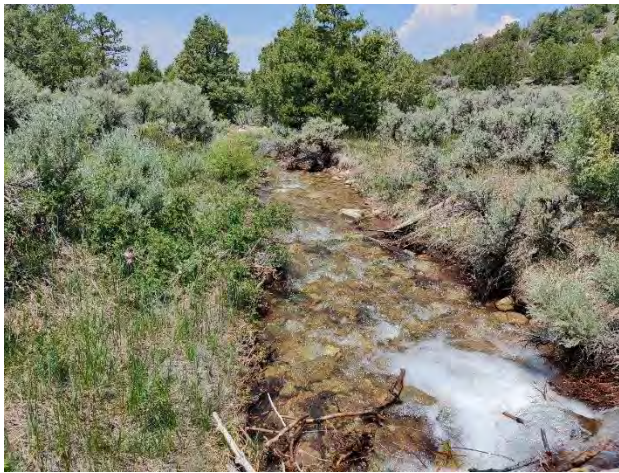
Figure 6-211 Looking downstream from Willow Creek fish barrier.

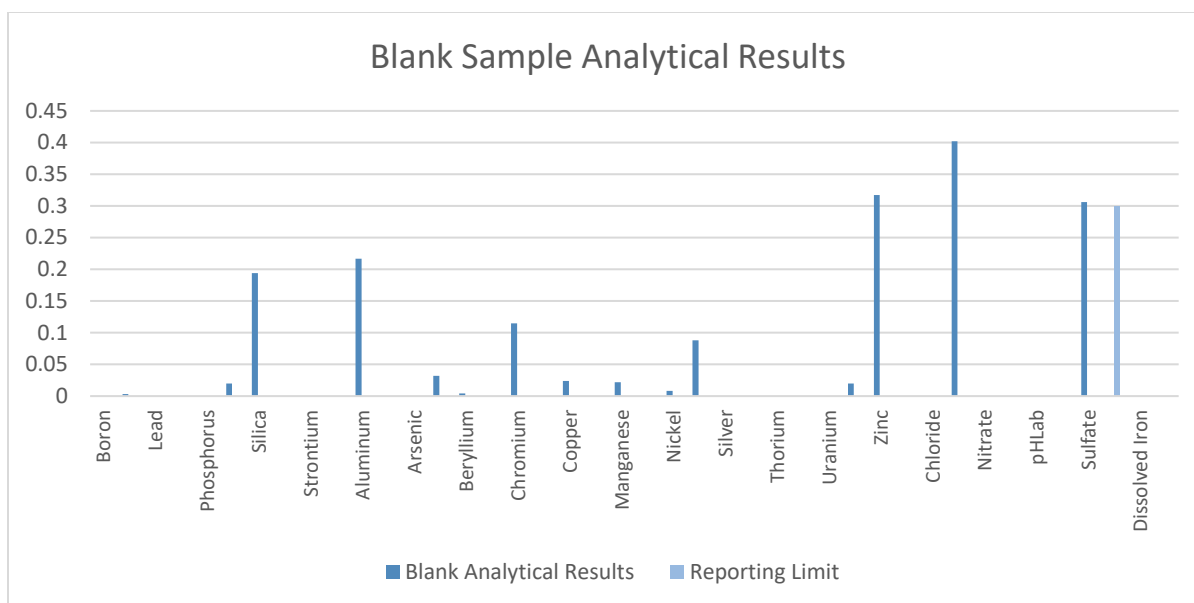
One replicate and one blank sample were collected and analyzed along with the grab samples. The replicate sample was collected at Torcido Creek and the Blank sample was bottle at the Culebra at San Luis gage. The blank sample reported results greater than the reporting limit for zinc, fluoride, sulfate, and silica see Figure 7-14.

Figure 7-14 Blank sample analytical results compared with analytical reporting limits. Blank concentration exceeded reporting limit for Silica, Zinc, Fluoride, and Sulfate.

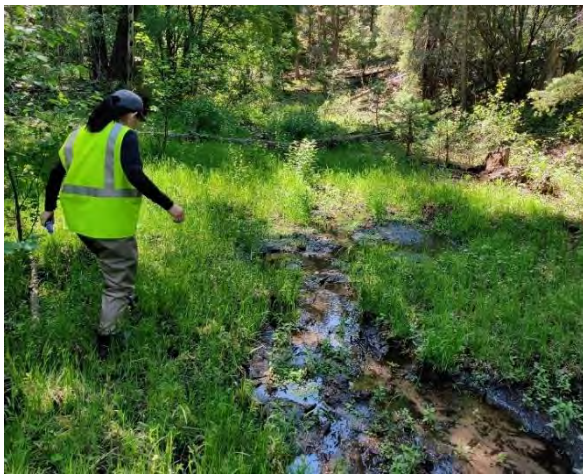
Specific conductance and pH were measured opportunistically with other field measurements for aquatic habitat, infrastructure, and geomorphology. These measurements are shown in Figure 7-17 and Figure 7-18. The purpose of this sampling was to evaluate if changes were occurring in the watershed with changes in land use. Baseline conductivity and pH is determined by baseline geology, Nelson and others (2011) correlated changes in both sloped wetland and stream water chemistry to changes in overlying geology. The highest conductivity was measured in a sloped wetland at the top of El Valle Creek (Figure 7-20), similarly an elevated specific conductance (138 us/cm vs 40 us/cm) was observed in a wetland adjacent to Jaroso Creek (Figure 7-19).

Figure 7-19 Sloped wetland adjacent to Jaroso Creek. Specific Conductance 138 us/cm in wetland and 40 us/cm in stream.

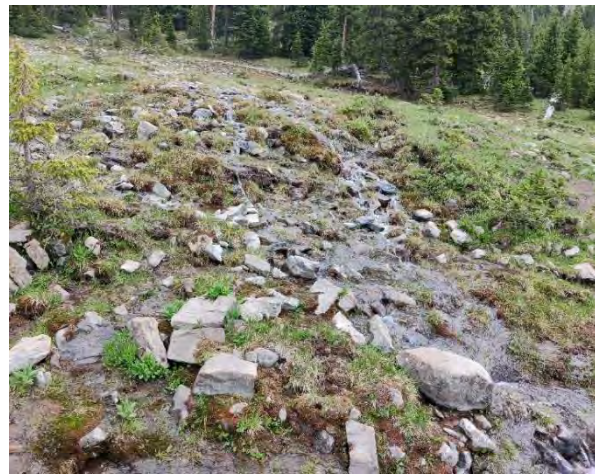
Figure 7-20 Sloped wetland on El Valle Creek. Specific Conductance 402 us/cm. Stream below 226 us/cm.

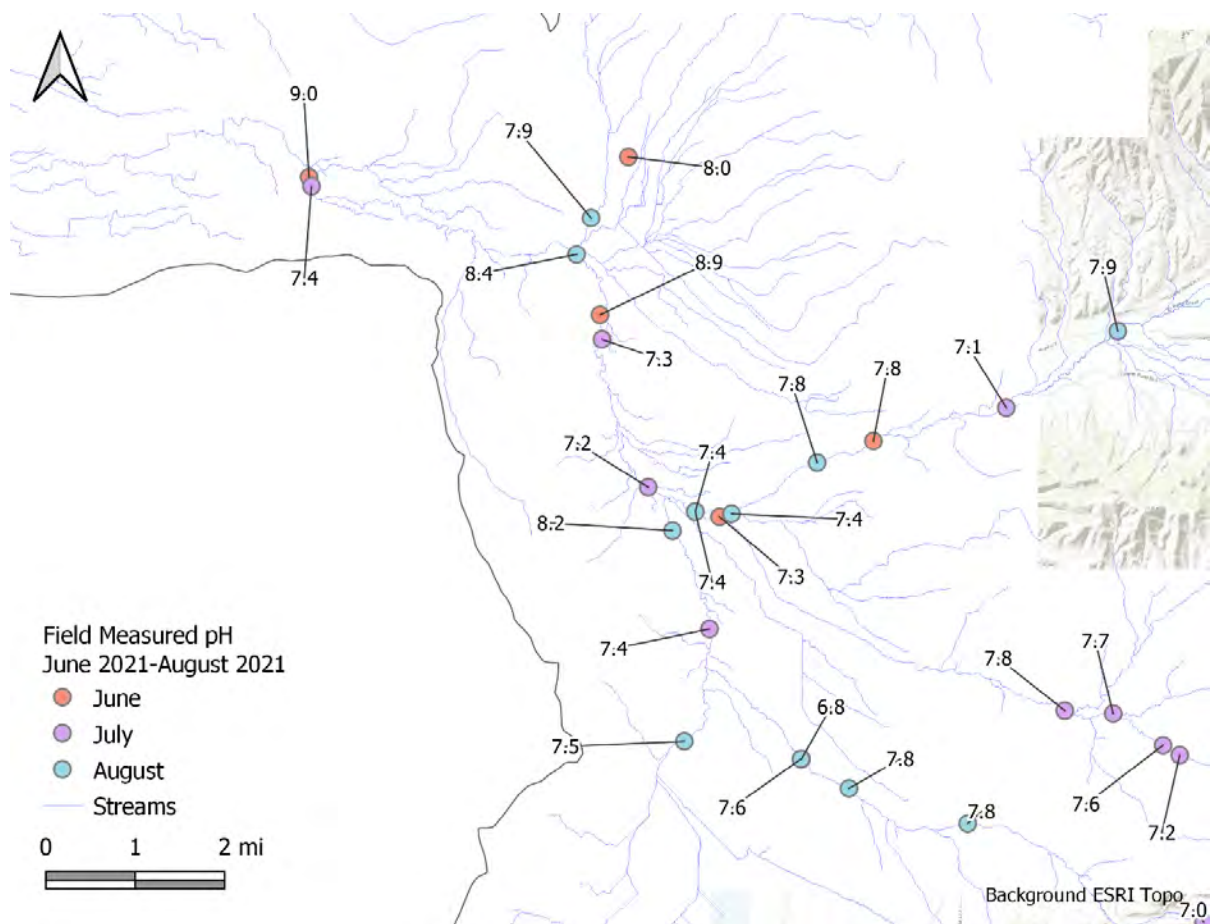
The pH along Culebra Creek from the confluence with Ventero Creek down to Eastdale Canal was further investigated after the initial water quality sampling due to the observed elevated pH on the Culebra above Eastdale Canal. The pH values for this region are categorized by sampling month and shown in Figure 7-21. For reference the flows from Culebra Creek at San Luis and Ventero Creek below Sanchez for this period are shown in

It is apparent that the water chemistry is fluctuating through this reach of Culebra Creek and Ventero Creek. Initial observations from the August sampling would suggest that the pH is being increased within this zone and not by the flows from Sanchez Reservoir.

Figure 7-21 pH measurements below Sanchez Reservoir classified by sampling month.

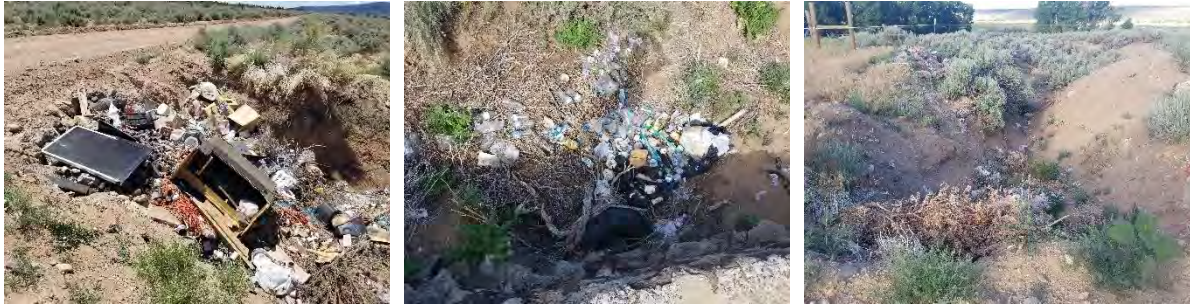
During the field assessments many arroyos and areas were observed to have significant volumes of residential waste dumped into them. In many locations carcasses were observed along with household waste. A detailed assessment of dump area contents was not performed but residential wastes may include electronics; petroleum products; paint (lead based and non-lead based); Mercury containing items such as Fluorescent and Ballast light bulbs, some thermostats, and thermometers; batteries; etc. Distance to the nearest landfill is the San Luis Valley Regional Landfill which is 59 miles from San Luis with an estimated travel time of 69 minutes.

Figure 7-81 Dumping in arroyos and open lands.

Transfer station operates with limited hours and may be difficult for some residents to access. Improve and keep updated online information including location of transfer station, load requirements, and fee schedule.

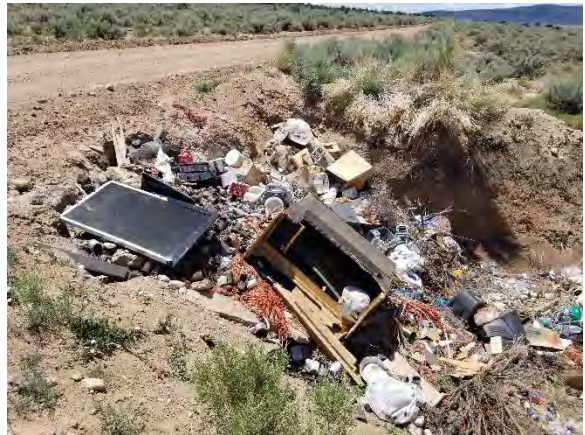
Figure 7-82 Roadside “dump” potentially contributing to the quality of water in the Culebra Basin.

- Teach basin residents about proper trash disposal. Provide resources to make it possible. Research has shown that reducing the perception of the acceptability of dumping is effective in reducing illegal dumping (APSOS, 2020).
- Improve and maintain online information related to transfer station hours, cost, and requirements.
- Provide training to county staff on roadway maintenance.
- Provide training for farmers on nutrient and sediment reduction practices.
- Replace signage discussing Mercury in fish at Sanchez Reservoir and develop outreach program to educate residents on Mercury consumption.
