Upper Culebra Watershed Assessment Report

In Progress Draft

Prepared for Costilla County Conservancy District

Tailwater Limited

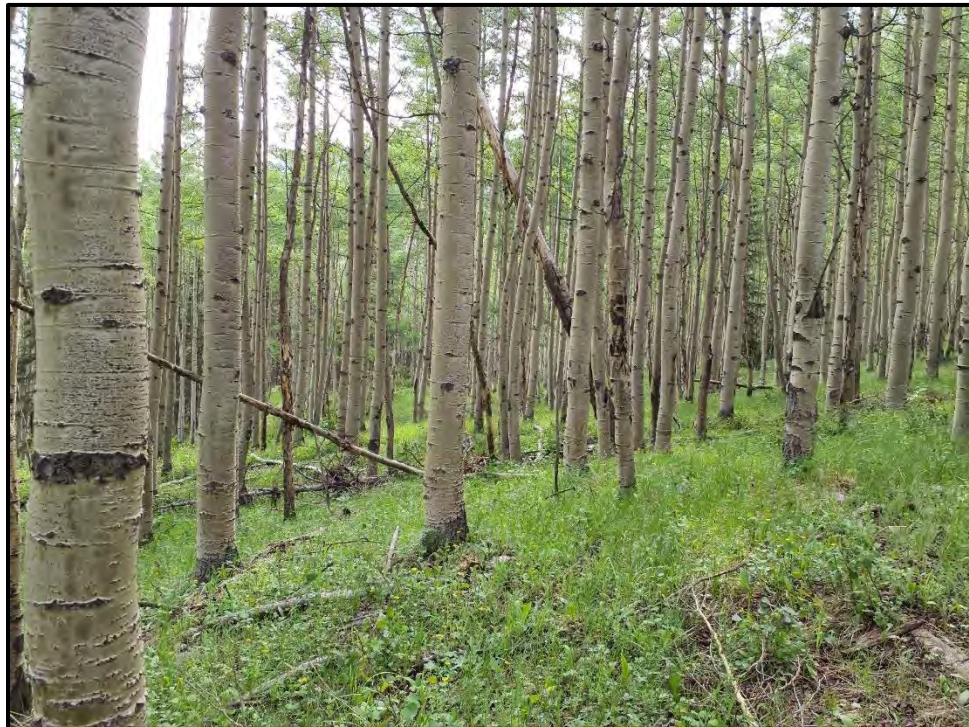
The pure aspen stands in the UCW are predominantly affected by insects, disease, and ungulates. Field crews consistently observed ungulate damage within even-age aspen stands in the analysis area. In addition, defoliation due to the western tent caterpillar (*Malacosoma californicum*), *Cytospora* cankers, and *Ceratocystis* cankers is prevalent within the analysis area.

Figure 10-11 View of the aspen woodland cover type.

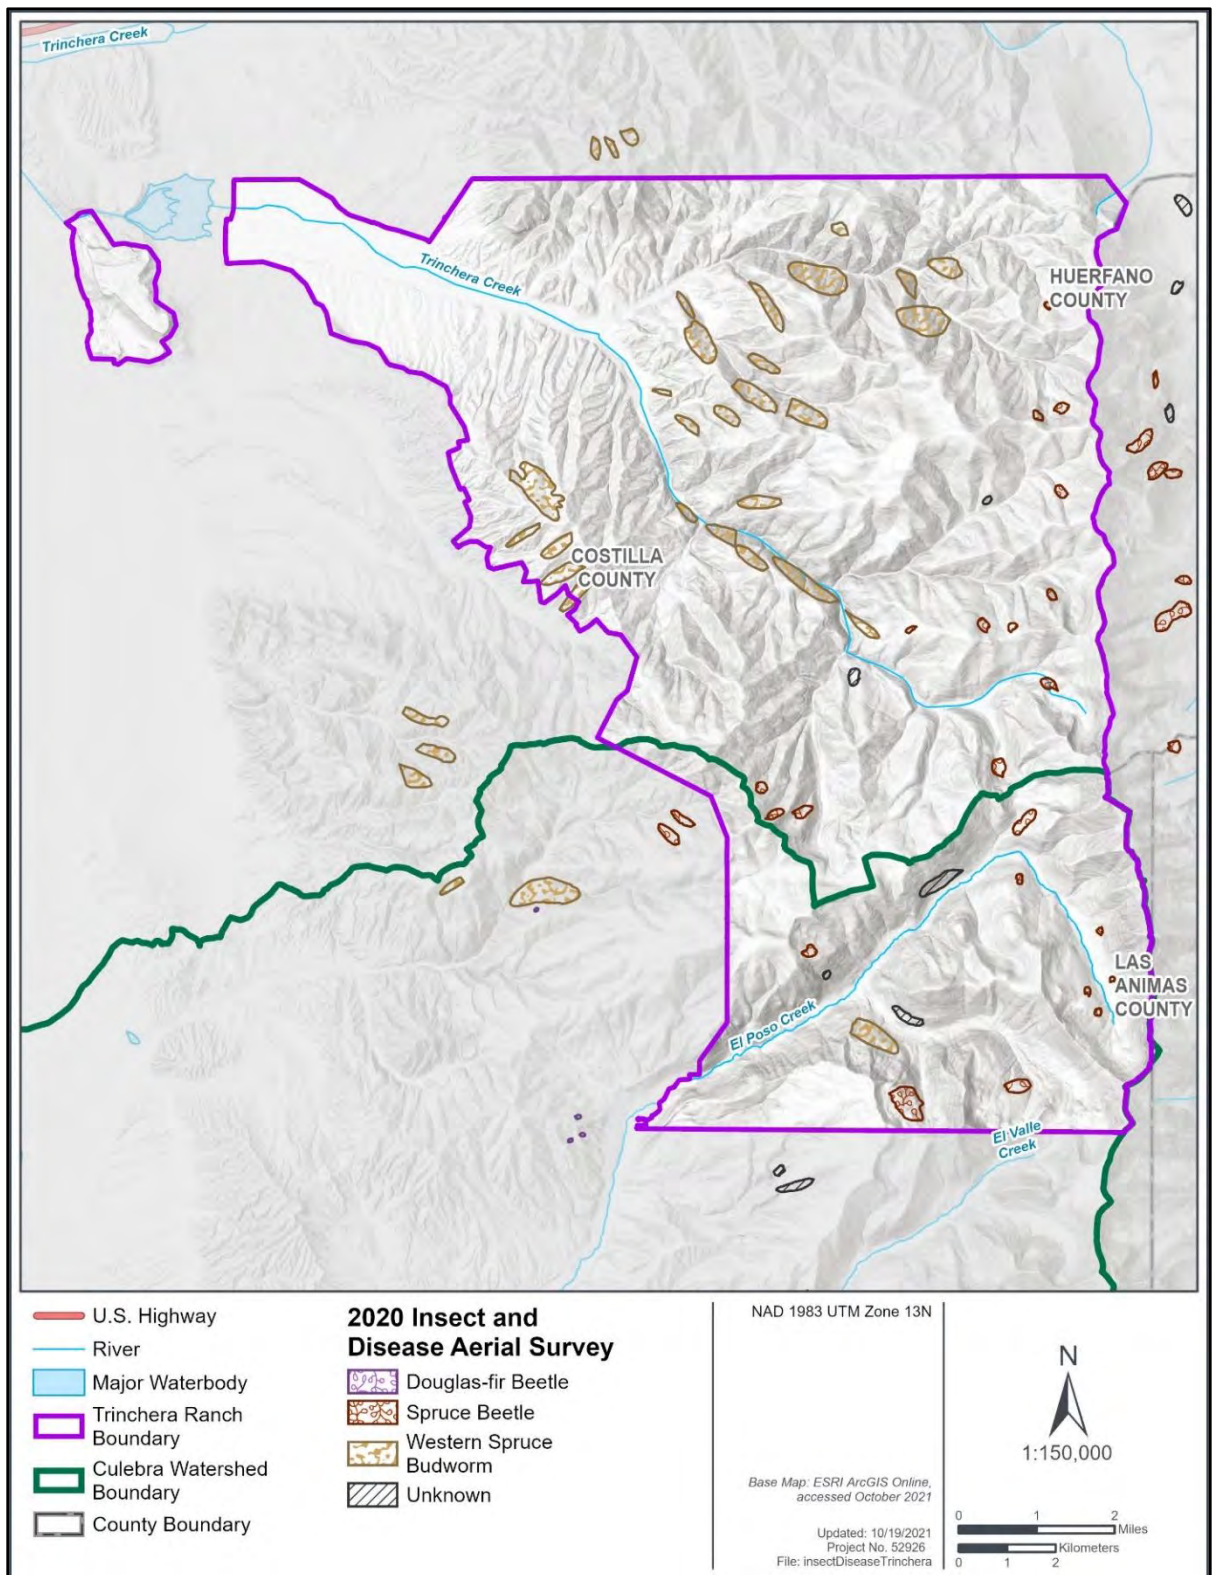
Agriculture National Insect and Disease Risk and Hazard Mapping Program (CSFS 2021b; USFS 2021a). During the 2020 detection flight over Trinchera Ranch, the CSFS detected three main defoliators: the spruce beetle, western spruce budworm, and unknown aspen defoliator.

Table 10-3 Insect and Disease Type and Approximate Acreage within Trinchera Ranch provides approximate acreage that is affected in the Trinchera Ranch boundary, while Figure 10-17 presents the areas where tree damage was observed during the 2020 aerial detection flight.

Insect and Disease Type	Approximate Acres within Ranch Boundary	Approximate Percentage within Ranch Boundary	Damage Type	Severity
Spruce beetle	164.2	1	Mortality	Light to Moderate 4%–30%
Western spruce budworm	88.9	<1	Defoliation	Very Severe >50%
Aspen defoliation (unknown)	75.0	<1	Defoliation	Very Severe >50%
Total	328.1	2

Figure 10-17 Insect and disease observations within Trinchera Ranch.

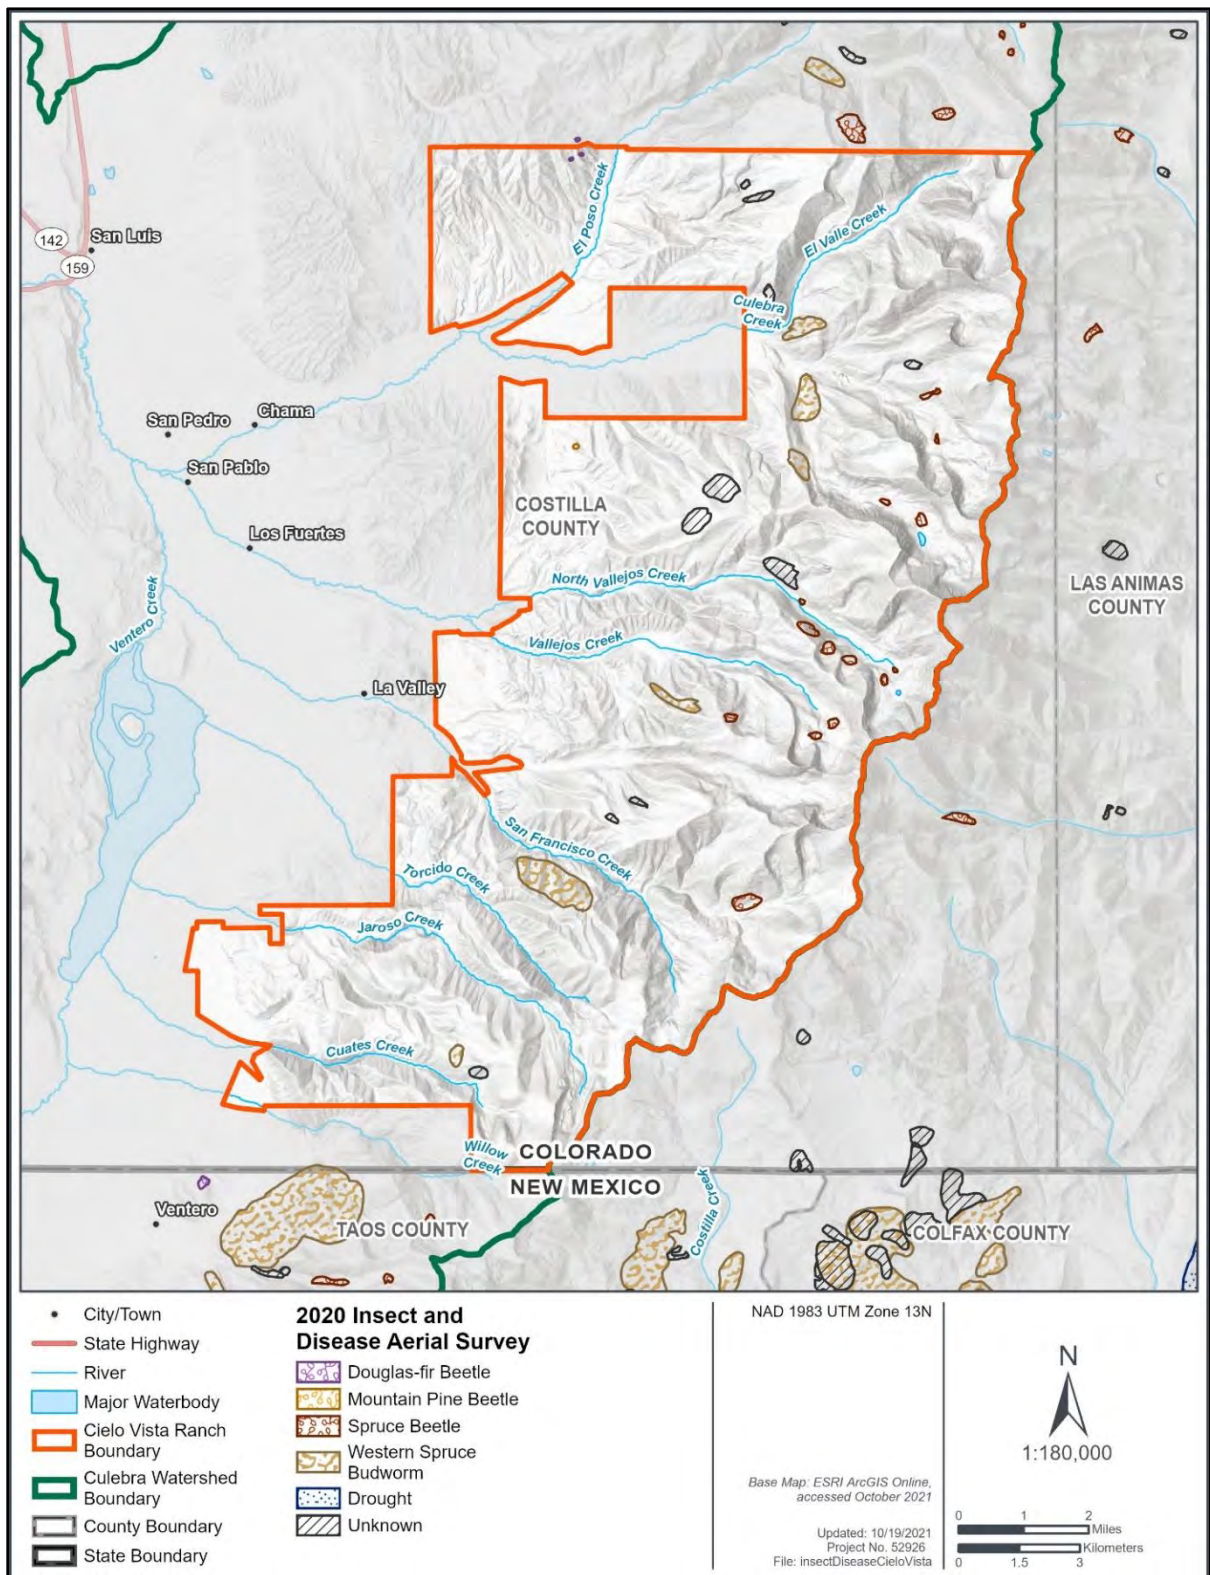
Table 10-5 provides approximate acreage that is affected in the Cielo Vista Ranch boundary, while Figure 10-21 presents the areas where tree damage was observed during the 2020 aerial detection flight.

Insect and Disease Type	Approximate Acres within Ranch Boundary	Approximate Percentage within Ranch Boundary	Damage Type	Severity
Spruce beetle	188.6	<1	Mortality	Light to Moderate 4%–30%
Western spruce budworm	719.4	1	Defoliation >75%	Severe 30%–50%
Douglas fir beetle	2.6	<1	Mortality	Light 4%–10%
Mountain pine beetle	3.1	<1	Mortality	Light 4%–10%
Aspen defoliation (unknown)	379.4	<1	Defoliation >75%	Light to Very Severe 4%–>50%
Total	1,293.2	2

Figure 10-21 Insect and disease observations within Cielo Vista Ranch.

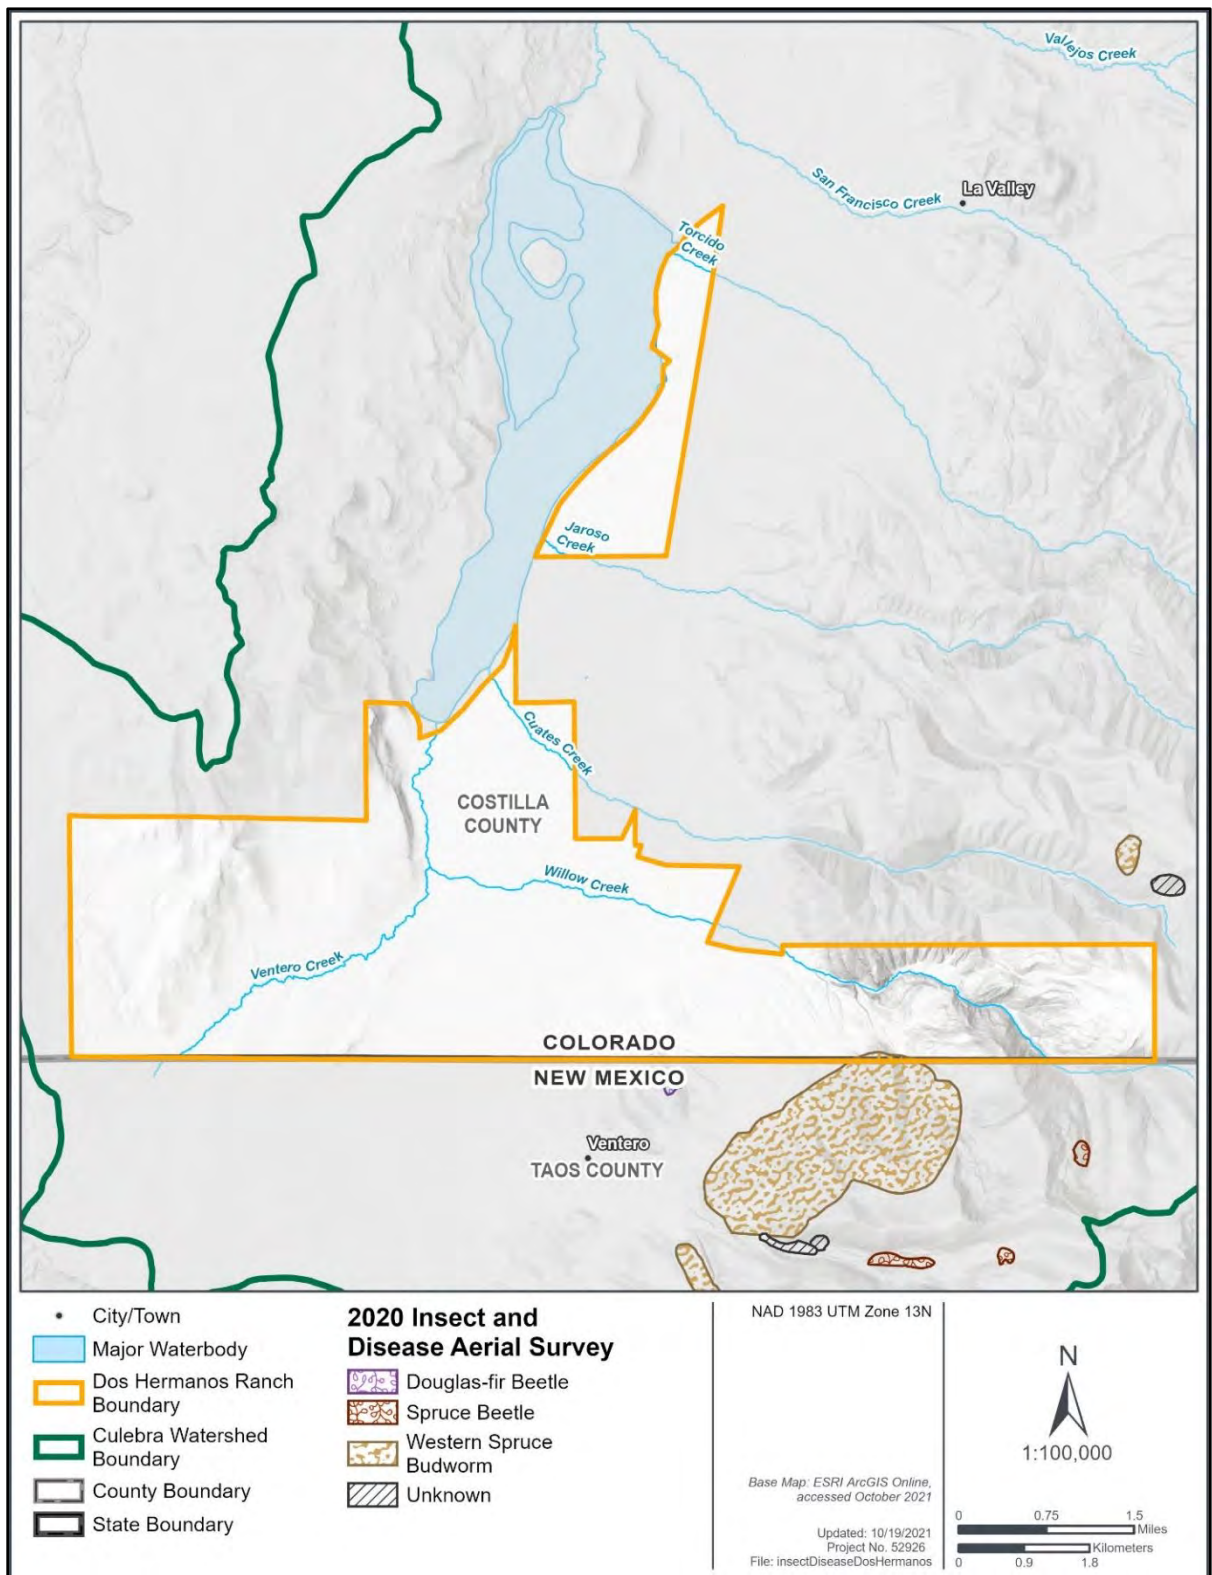
Table 10-7 provides approximate acreage that is affected in the Dos Hermanos Ranch boundary, while Figure 10-23 presents the areas where tree damage was observed during the 2020 aerial detection flight.

Insect and Disease Type	Approximate Acres within Ranch Boundary	Approximate Percentage within Ranch Boundary	Damage Type	Severity
Western spruce budworm	17.6	1	Defoliation >75%	Very Severe >50%
Total	17.6	1

Figure 10-23 Insect and disease observations within Dos Hermanos Ranch.

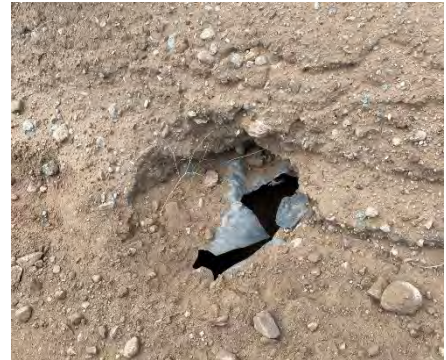
During the evaluation of roadways and road/stream crossings, numerous issues with gravel road maintenance were observed. Issues included removal of the culvert cover by road grading activities and road surface gravels graded to road edges causing concentrated flows resulting in gully formation.

Figure 16-2 Damaged culvert in Rito Seco Road.

Developing a training program for county employees and an employee retention process to maintain institutional knowledge will improve roadway safety and reduce sediment transport to streams. Coupling this with a monitoring program for road/stream crossings, including culverts and bridges, will help identify and address these issues before they become more significant and more costly to fix.

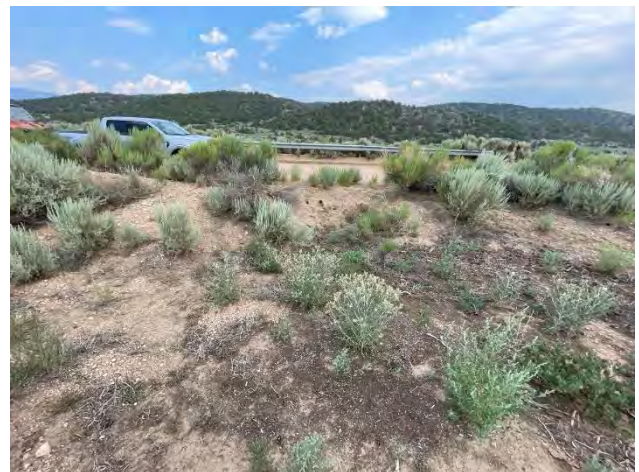
Figure 16-3 No culvert found in drainage, guardrail along roadway downstream due to gully formation (headcut).

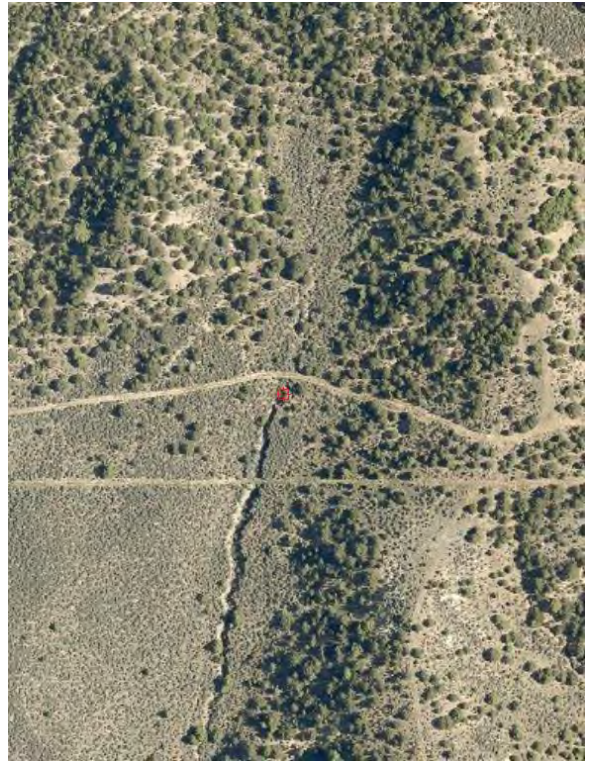
Many private roads with direct impacts on watershed health were identified within the Culebra Basin. These impacts include destruction of vegetation, changes in slope, and concentration of flows. Many of these headwater streams should be vegetated swales with no defined channel. This landscape damage has converted these swales into concentrated flow paths with actively eroding channels.

Figure 16-4 Road concentrating flows resulting in headcutting below road 37.141870, -105.318386, Eagleview aerial imagery dated May 13, 2019

Projects involving private roads will require public-private partnerships. Working with landowners to restore areas that have been damaged and prevent future damage will reduce downstream impacts. Restoration includes stabilizing and replanting existing channels and blocking access from public roads to drainages by installing gates, fencing, and other administrative and physical controls. Working with landowners who request assistance to prevent trespass travel and prevent new unplanned roadways is recommended.

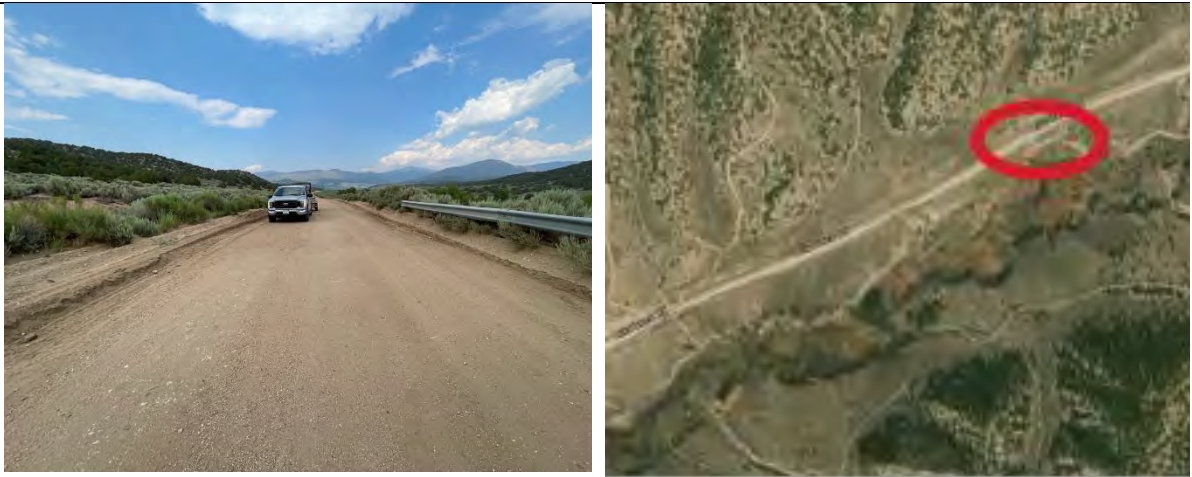
Rito Seco Road is a primary ingress/egress route to portions of the Sangre de Cristo Ranches Subdivision. This road has areas where guardrails have been installed to prevent vehicles from dropping off the shear banks of Rito Seco and tributaries. The assessment identified damaged culverts and culverts without adequate downstream scour protection.

Figure 16-5 Guard rail on Rito Seco Road, location of the photo shown on the right.

Concerns	Strategies
<ul style="list-style-type: none"> Increased long-term maintenance cost due to poorly installed crossings. Increased sediment loading due to concentrated flows from the roadway. Ingress/egress compromised along the primary access route for portions of Sangre de Cristo Ranches. 	<ul style="list-style-type: none"> Improvements to arroyo/road crossings, including proper culvert sizing, cover, and scour protection. Improvements to grading to reduce concentrated flow points. Potential hillslope stabilization along Rito Seco terrace banks and gullies that are near roadway. Stabilize shear banks near roadways through grading or installation of retaining structures.

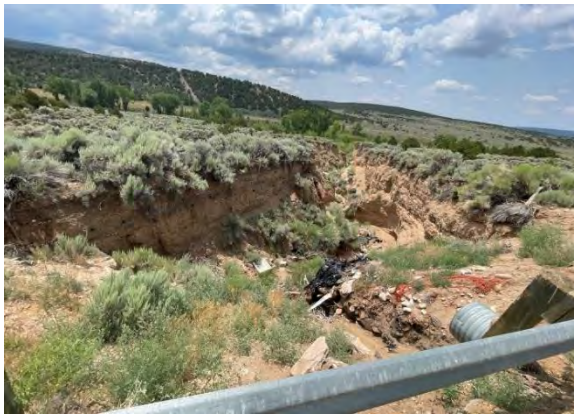
County Road K.5 is impacted by three gullies resulting in guardrail installation along the road to address user safety. In locations, gullies have formed where run-off from County Road K.5 is concentrated. This road is critical for emergency crew access and serves as a vital evacuation route in an emergency, such as a fire. Stabilization of gullies and prevention of new gully formation is needed to improve community safety. It may be possible to use lower cost stabilization techniques such as brush matting or hay-bale structures within the ephemeral drainages. These structures are used to promote the vegetation growth and sediment deposition necessary for stabilizing the gullies. For these measures to be successful, erosion control below replaced/constructed culverts or future bridges is necessary.

Figure 16-6 Vallejos tributary gully erosion and trash dumping along County Road K.5. Note culvert in lower left of photo extending well above the channel invert.

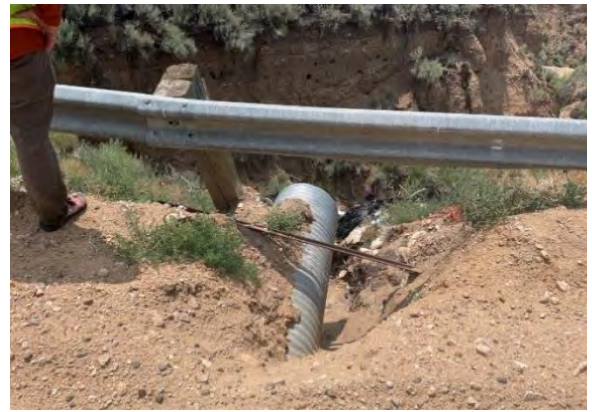
Figure 16-7 Roadway safety hazard due to embankment failure and insufficient culvert cover along County Road K.5.

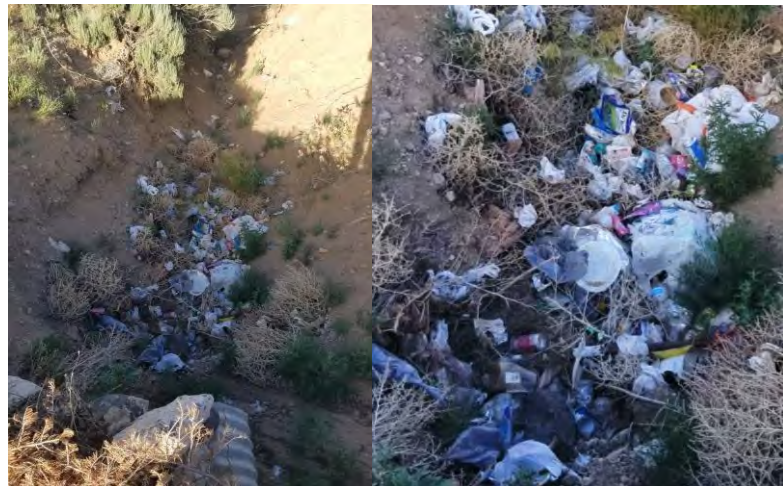
Waste disposal is an issue that every community must deal with. During our conversations with residents, it was noted that trash disposal was inaccessible to some community residents. The lack of access to trash disposal results in illegal dumping within many of the arroyos and throughout the county. Solid waste management is a costly but necessary service that is needed for maintaining a safe and healthy community.

Figure 16-8 Example of trash dumping in arroyo. Trash includes numerous plastic bottles, aluminum cans, paper plates, and packaging.

A first step to addressing this issue is to understand the types and volumes of waste generated regionally to develop a solid waste management program that meets the community's needs. Additional landfills are often not the most effective or sustainable long-term solution to waste management. A complete solid waste assessment should include an evaluation of the volume and types of trash produced, estimates of costs, and potential buyers for recycled and/or composted materials. A complete evaluation would include multiple alternatives, including developing a new regional solid waste facility, expanded regional transfer services, and alternative waste stream solutions.

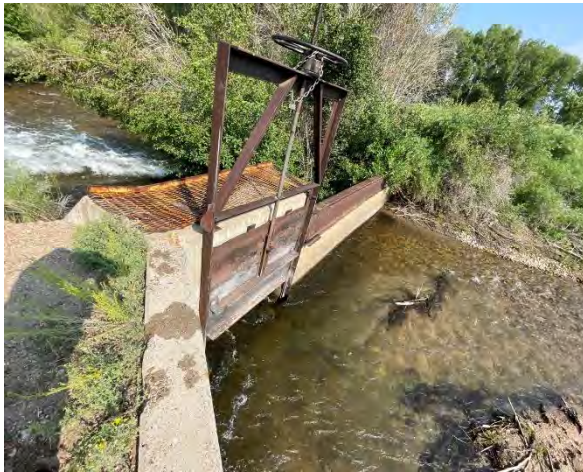
Figure 16-10 Slide gate regulating flows in Culebra Creek at Sanchez Canal Diversion Dam.

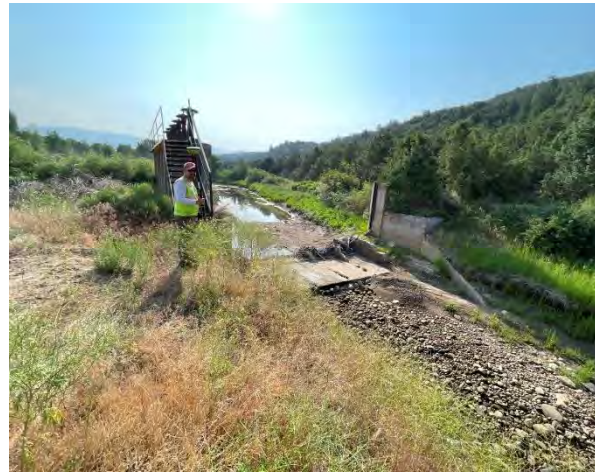
Figure 16-11 Flood gate diversion dam.

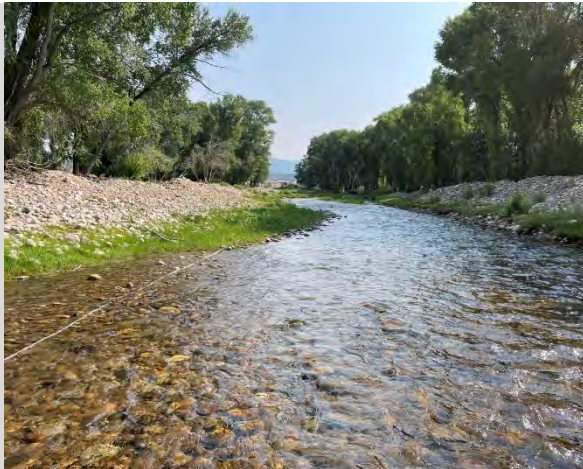
Figure 16-12 Culebra Creek above Sanchez Canal headgate. Note significant cottonwood cover along banks.

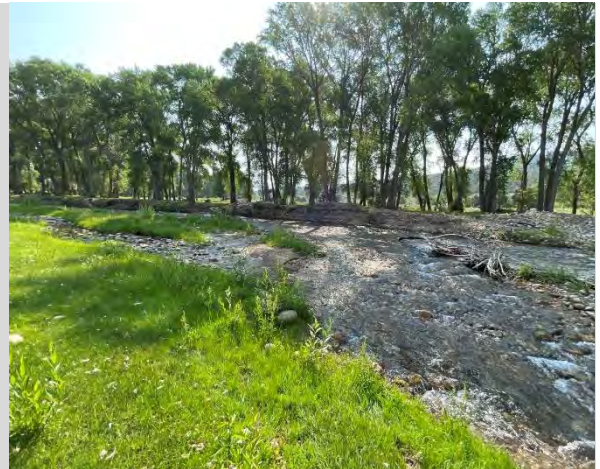
Figure 16-13 Bank erosion and overwide reach reducing flow depths, approximately 800 feet upstream of diversion dam, looking upstream. This is just below the Pando Ditch Diversion.

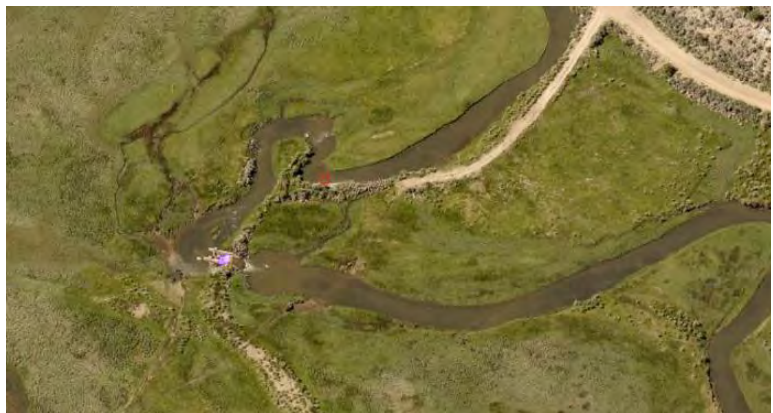
restore floodplain function and reduce flooding risk around the structure. The stream pattern within this reach is impacted by historical channelization. Restoration of the reach could address tight radiuses and decrease fine sediment inputs into the stream, making the channel more stable. Improvements to this reach could also improve wetland function and increase basin resilience to nutrient inputs.

Figure 16-15 San Luis People's Ditch old diversion dam.

Removing the downstream old diversion dam would

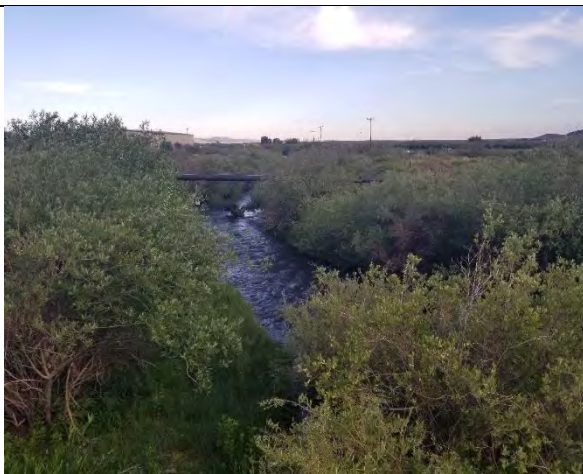
Figure 16-16 Dense riparian vegetation downstream of Hwy 159 near San Luis WWTP where cattle are excluded.

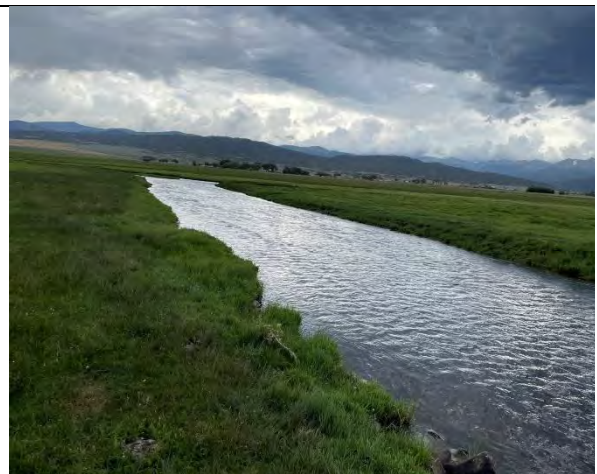
Figure 16-17 Culebra Creek near San Luis gaging station absent woody riparian vegetation.

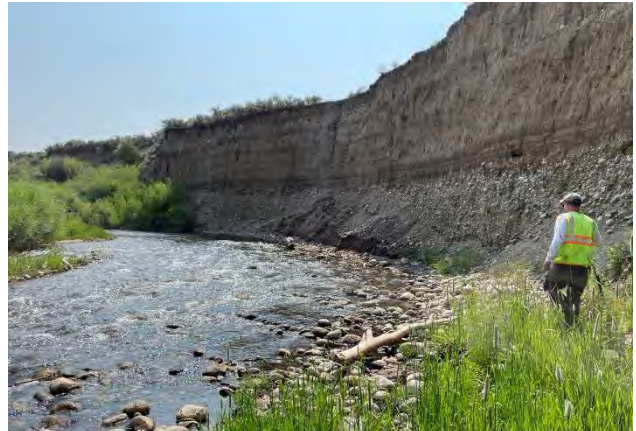
Upstream of the Sanchez Canal Culebra Diversion Structure, Culebra Creek migrates south into steep embankments. This migration is resulting in significant bank erosion (Figure 16-21). The reach begins approximately a half-mile upstream of the Sanchez Canal diversion structure and extends approximately three-quarters of a mile upstream. Moving the channel away from the high terrace through this reach would reduce sediment inputs into Culebra Creek and reduce sediment deposition at Sanchez Canal and other downstream diversion structures.

Figure 16-21 Culebra Creek bank erosion left edge of water approximately 1 mile upstream of Sanchez Canal headgate.

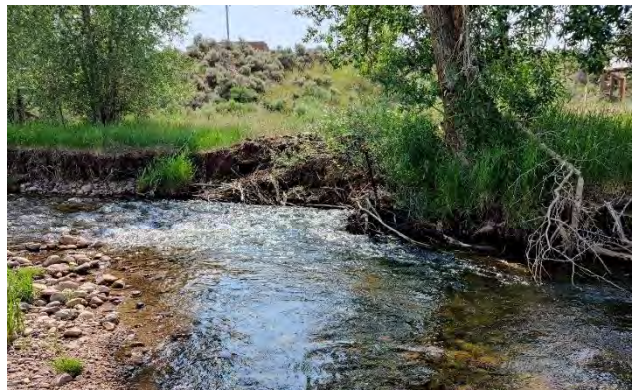
Figure 16-20 Bank erosion along left edge of water, Culebra Creek.

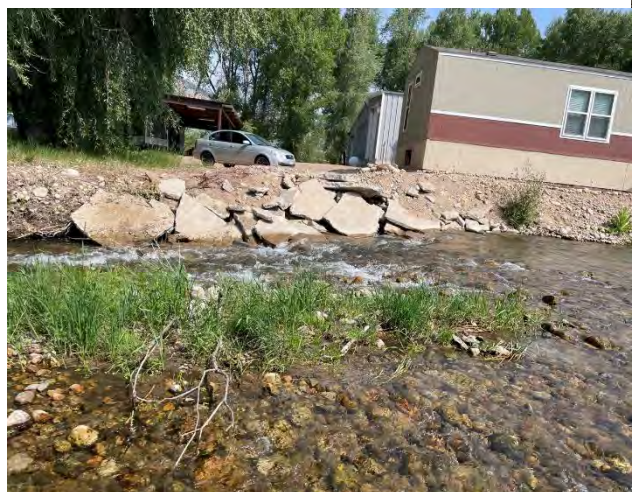
Additional concerns were noted within this reach, including flood hazards and water diversion maintenance operations. Noted flood hazards included a residence along the right edge of the water (Figure 16-22). Work in this reach could be utilized to improve community safety. A small push-up dam moves water through a pond along the left edge of the water in

Figure 16-22 Residence in floodplain.

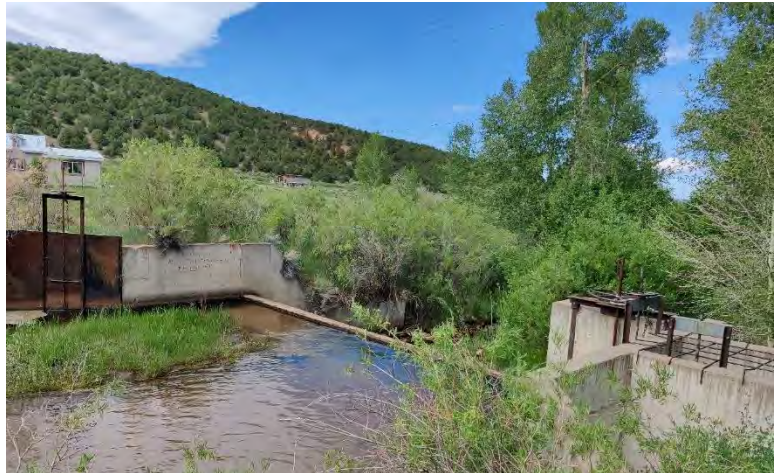
Figure 16-23 San Francisco Ditch diversion dam. Single screw gate on left edge of water provides sediment passage when ditch is not in priority.

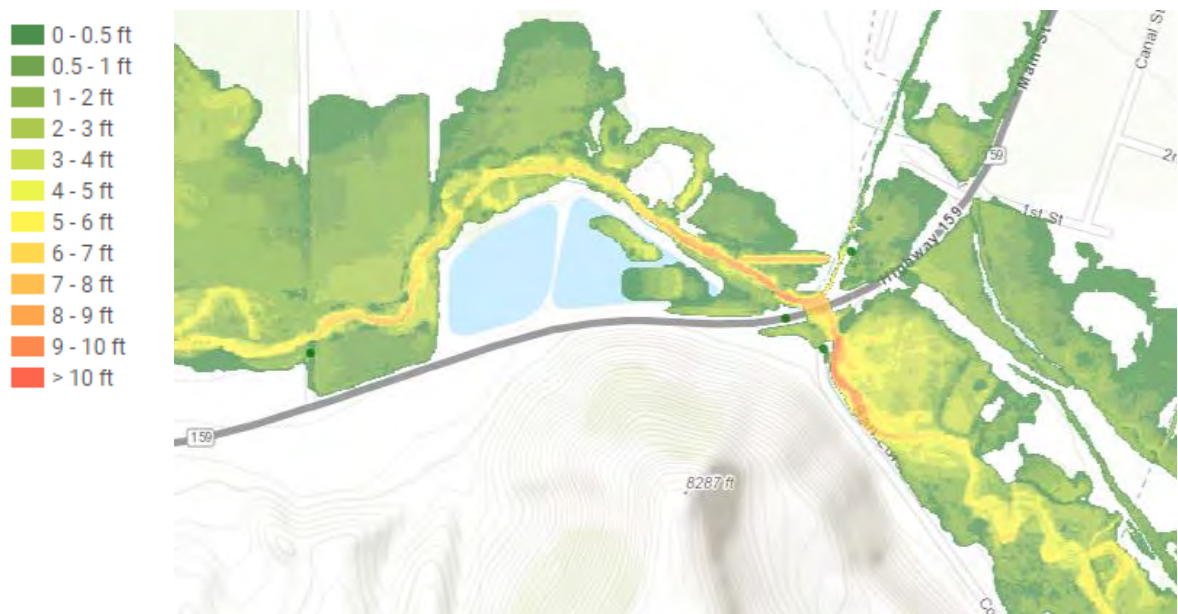
Figure 16-24 San Luis Wastewater Treatment Plant Preliminary 1% Depth Grid from Colorado Hazard Mapping and Risk Portal accessed October 29, 2021. (Also figure 7-186).

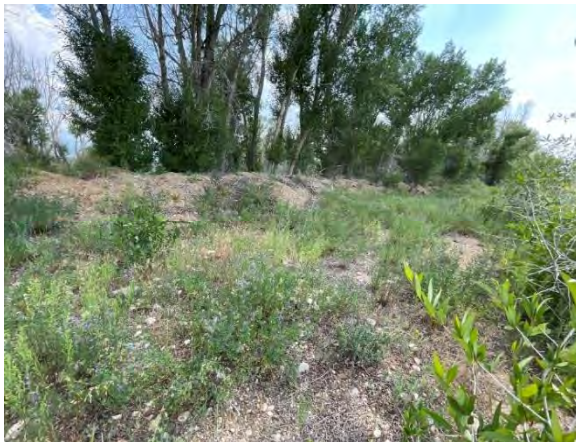
Figure 16-26 Berms along Culebra Creek upstream of County Road 21.

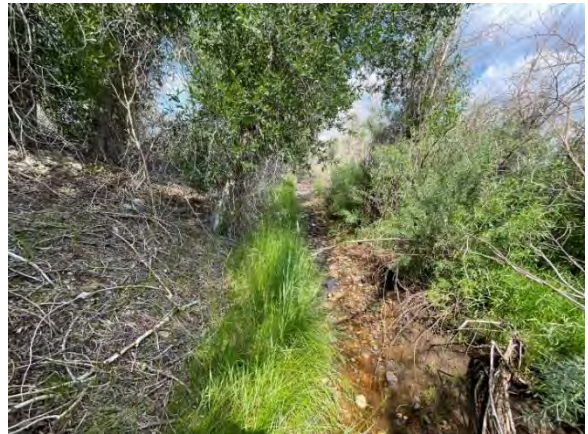
Figure 16-27 Culebra Creek inside berms upstream of County Road 21.

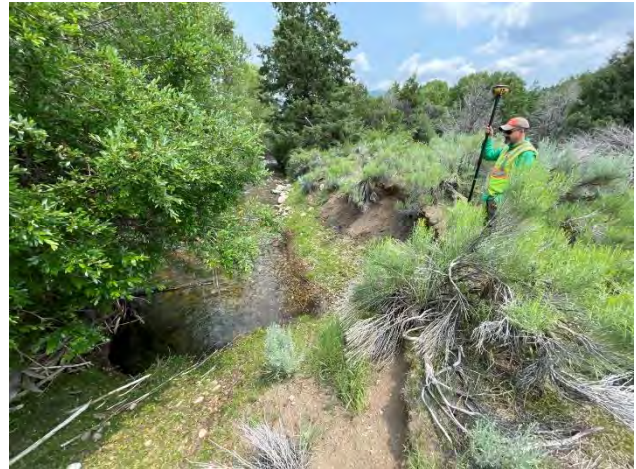
Figure 16-28 Bank erosion El Poso Creek.

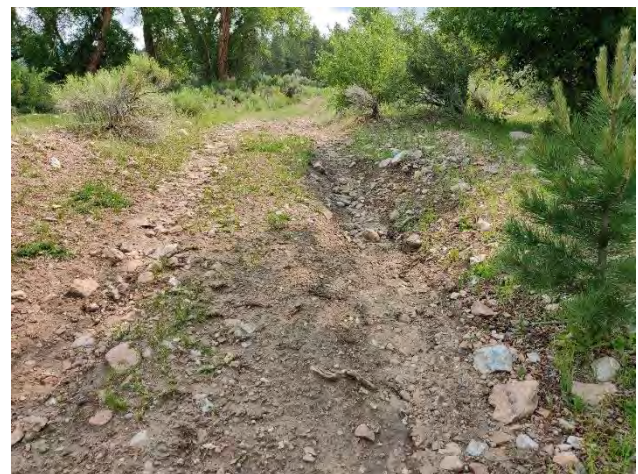
Figure 16-29 Ruts in road from water running down road instead of in channel.

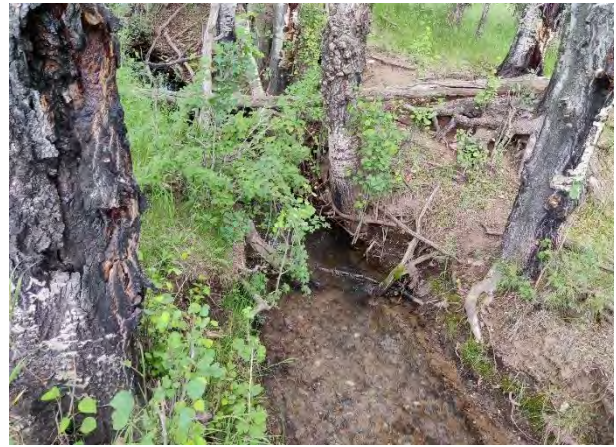
Figure 16-30 Incised ditch at upstream end of Jaroso meadow.

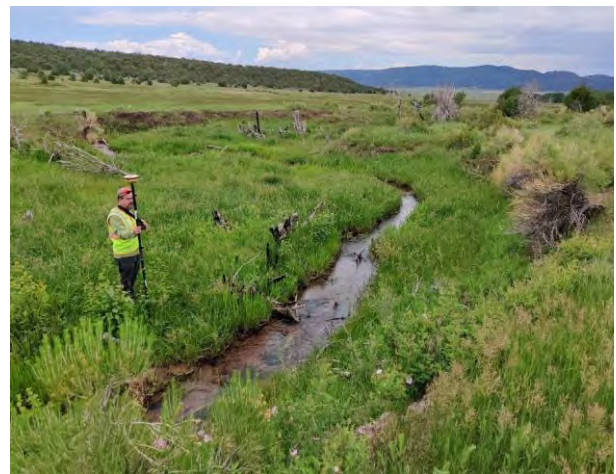
Figure 16-31 Jaroso meadow, note channel has formed small floodplain within the original floodplain after incision.

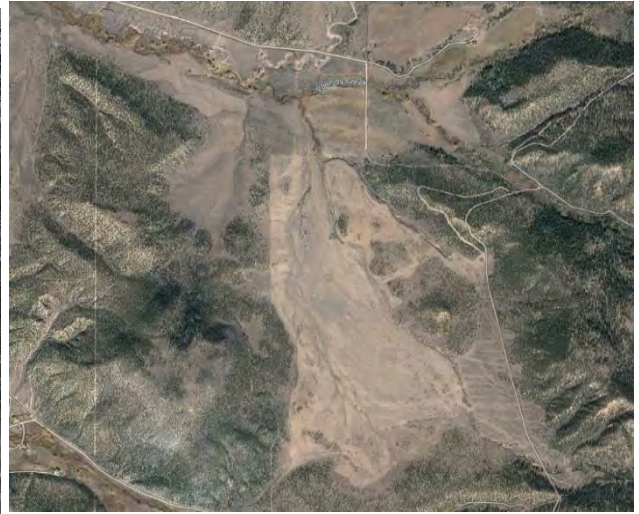
The area south of the confluence of North Vallejos Creek and Vallejos Creek is severely degraded. This degradation is likely attributed to excessive grazing, and this area would benefit from active restoration including revegetation and gully stabilization. The soil erosion model indicated high erosion rates despite the low slope due to the lack of vegetative cover.

Figure 16-32 Damage upland vegetation south of the confluence of North Vallejos Creek and Vallejos Creek.
