**Colorado Trout Unlimited and Boulder Flycasters
Lower South Boulder Creek
Stream Management Plan Phase II - Final Report
September 30, 2022**

Colorado Trout Unlimited and Boulder Flycasters
Lower South Boulder Creek Stream Management Plan Phase II
Final Report

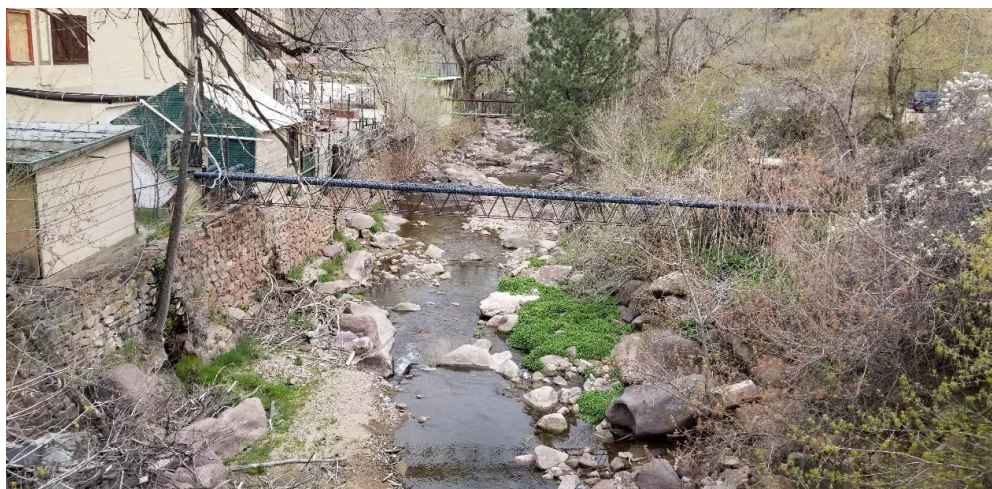
Reach 2.1 Eldorado Springs beginning at Farmers Reservoir and Irrigation Company ("FRICO") / Community Diversion and Ditch Structure to 3575 Eldorado Springs Road

Flow		2.8 functioning
Riparian	Left	1.0 poorly functioning
	Right	1.0 poorly functioning
Landscape	Left	1.5 partly functioning
	Right	2.0 partly functioning
Geomorphology		1.8 partly functioning
Aquatic Habitat		1.0 poorly functioning
Recreation		(No public access)

Preliminary Project Priority and Time Frame: Low (no time frame)

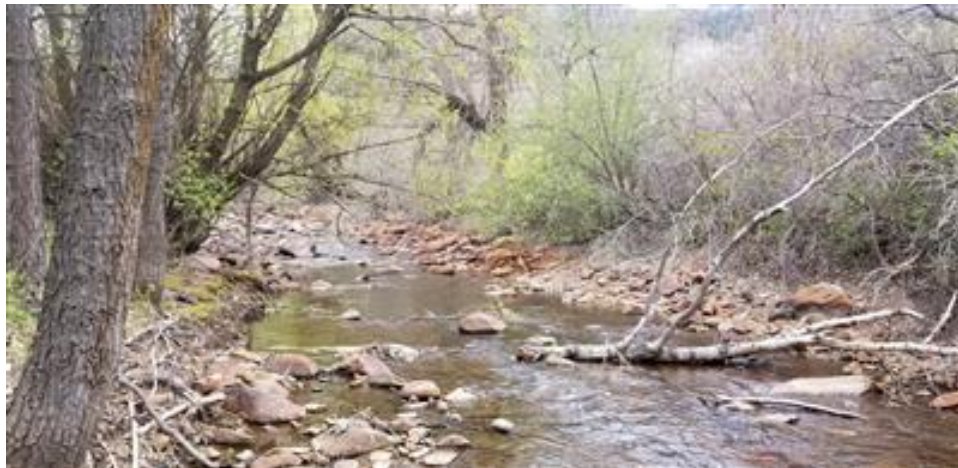
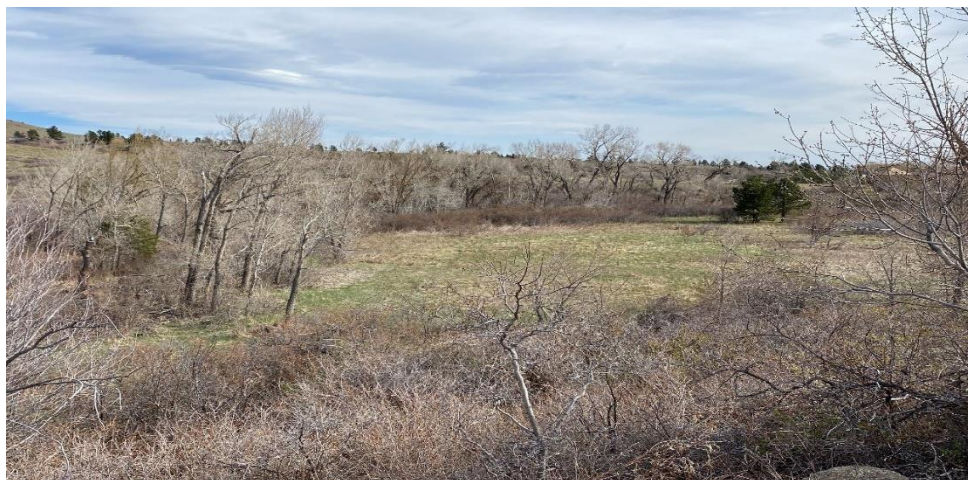
Detailed Observations: Although much of Reach 2.2 is privately owned, development is minimal, and this reach represents a very natural channel. Floodplain connectivity is good, and an adequate margin of thriving and regenerating riparian vegetation provides resistance to bank erosion. Upland connectivity within the reach is mostly unimpeded. Emergent wetlands are on an upland terrace on the south side. Water chemistry is likely compromised from upstream stressors. The Davidson diversion and ditch is a barrier to aquatic connectivity / fish passage at low flows. For potential improvements, plant installation could be relatively low-cost, but the benefits would not be as measurable without more expensive grading to optimize floodplain connectivity.

Recommended Project: None within the project planning (3 years) horizon of this assessment, although plant installation could be relatively low-cost, the benefits would not be as measurable without more expensive grading to optimize floodplain connectivity, possibly in conjunction with aquatic connectivity / fish passage efforts at the Davidson diversion and ditch structure (future engineering / construction project).

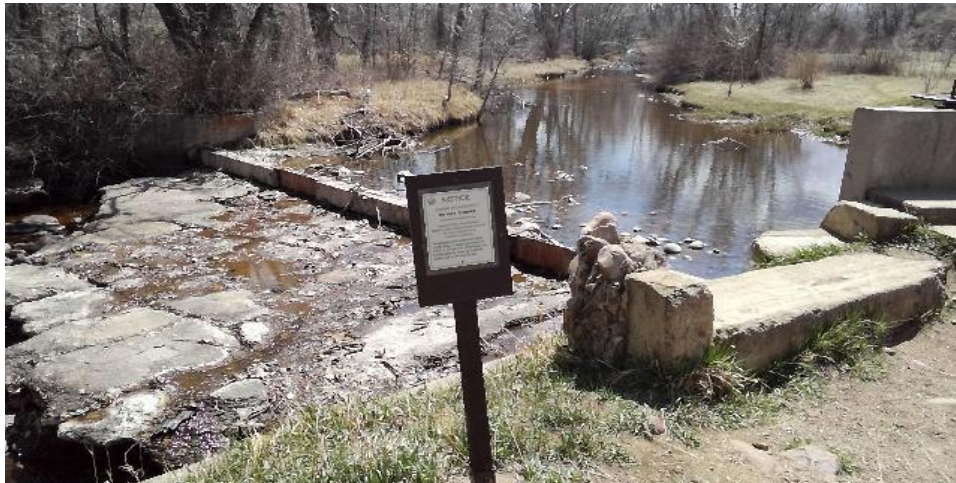
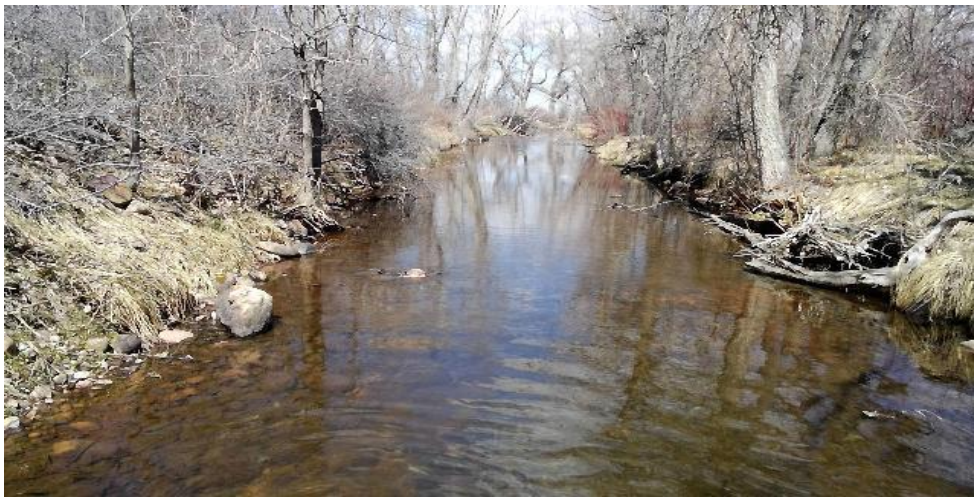
Flow		1.2 partly functioning
Riparian	Left	1.3 partly functioning
	Right	2.3 functioning
Landscape	Left	2.0 partly functioning
	Right	2.5 functioning
Geomorphology		1.5 partly functioning
Aquatic Habitat		1.0 poorly functioning
Recreation		No impact

Detailed Observations: This reach has been channelized. It is highly entrenched and very straight. It does have a narrow riparian buffer of mostly mature cottonwoods. Little bank erosion due to trees stabilizing channel banks. The Reach is isolated due to aquatic connectivity / fish passage barriers up-stream and downstream. Cattle do not have access to this reach. It is accessible to the public, but most people stay on the trail. The Green Belt Meadows housing sub-division is just to the west and abuts the OSMP lands. Impacts from rogue trails are more prevalent in the downstream reach. New Dry Creek Carrier diversion often sweeps the creek but there is usually an upstream flow. An additional source of water from the Viele Channel enters South Boulder Creek from the west during non-winter months. This reach (and the downstream reaches to the confluence with Boulder Creek) often has no-to-very-low flows from upstream water (less than 1 cfs) during the winter months. There is some runoff / return flow from storms and snow melt during the winter months.

Project Narrative: The floodplain is 5' to 7' above channel. This high entrenchment makes it difficult for any improvements to be successful. Establishing woody vegetation that high above groundwater would be difficult without several years of irrigation, and in-channel structures would have to be hardened to withstand shear stresses during very high flows. Raising the channel invert would help but may not be possible due to houses on west side of floodplain. Some grading to create floodplain benches may be possible. This would help reduce shear stress and allow for large wood installation and aquatic habitat enhancement. Work on this reach should occur concurrently with the project described for downstream Reach 3.1.2.

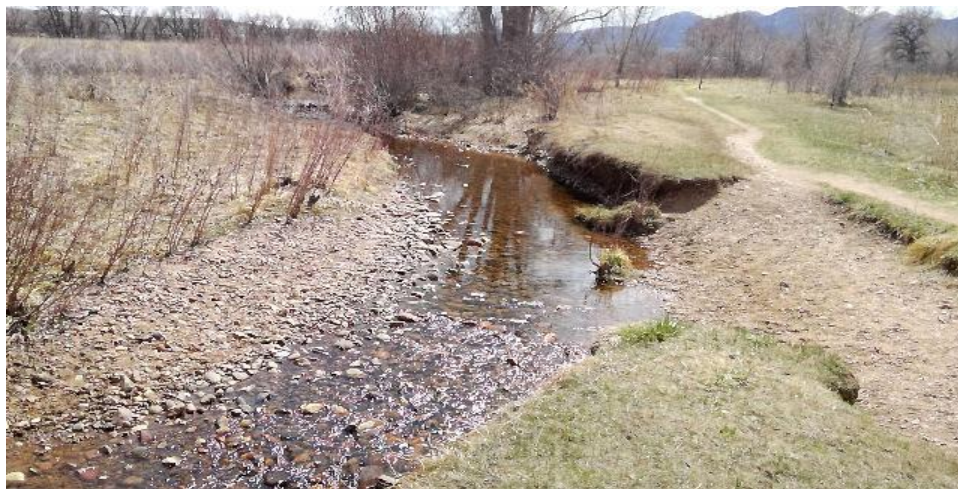
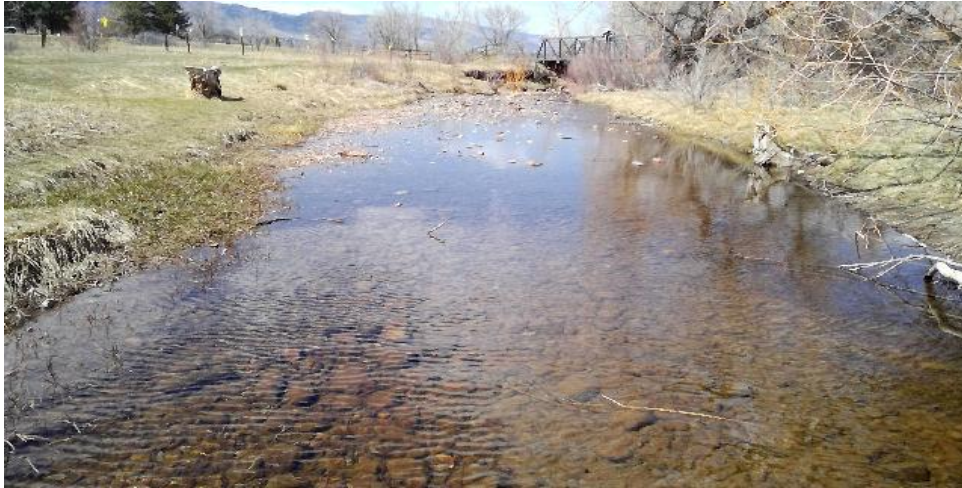
Flow		1.0 poorly functioning
Riparian	Left	2.0 partly functioning
	Right	1.7 partly functioning
Landscape	Left	2.5 functioning
	Right	3.0 functioning
Geomorphology		1.8 partly functioning
Aquatic Habitat		2.0 partly functioning
Recreation		High impact

Detailed Observations: Creek is moderately entrenched with moderate to severe bank erosion in places due to visitor / dog access and lack of woody vegetation. Reach has few trees and allows unfettered public access to creek, causing bank erosion and over-wide channel. Most trees are mature cottonwoods with little opportunity for seedling establishment. There are small patches of willow on low benches. Howard diversion at the upstream end blocks aquatic connectivity / fish passage. While moderately entrenched, this reach has the lowest entrenchment of all the reaches on OSMP property. The creek was most likely channelized at some point in time, but due to the lack of woody bank stabilization it has created some small meander bends with moderate pool habitat. The upstream New Dry Creek Carrier diversion often sweeps the creek but there is usually an upstream flow. An additional source of water from the Viele Channel (a constructed flood control channel) enters South Boulder Creek from the west during non-winter months. This reach (and the downstream reaches to the confluence with Boulder Creek) often has no-to-very-low flows from upstream water (less than 1 cfs) during the winter months. There is some runoff / return flow from storms and snow melt during the winter months.

Recommended Project: Modify OSMP recreational trails to allow managed access to creek, plantings up to 200' along creek, buried woody stabilization structures

Project Narrative: Riparian vegetation, bank erosion, water quality, floodplain access, and aquatic habitat could be improved by installing fences to keep the public out of the creek and the riparian buffer. Public access to the creek could be provided at a few select locations to allow visitors to enjoy a creek-side experience. Long rooted nursery stock should be utilized, or regular nursery stock installed in extra deep planting pits to ensure roots reach groundwater. Plantings may require supplemental watering for the first few years. Some eroding banks should be graded / stabilized to ensure vegetation establishment, which may include the installation of toe wood to provide bank stabilization, aquatic habitat, and large wood to the system. Large wood structures in the creek could also be designed to allow the creek more frequent access to the floodplain. These engineered log structures mimic woody debris jams – essentially raising the channel invert, creating deeper pools, and adding large wood into the system. Project could also consider moving the existing concrete trail farther away from the

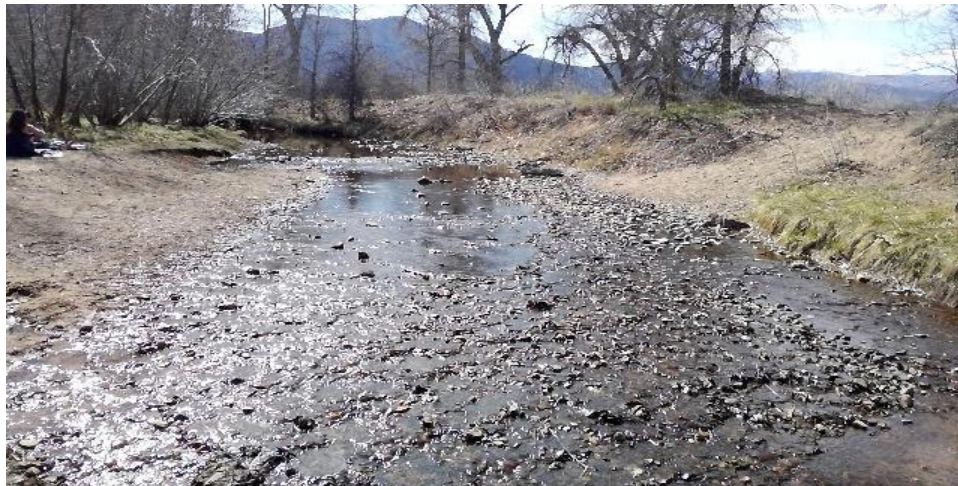
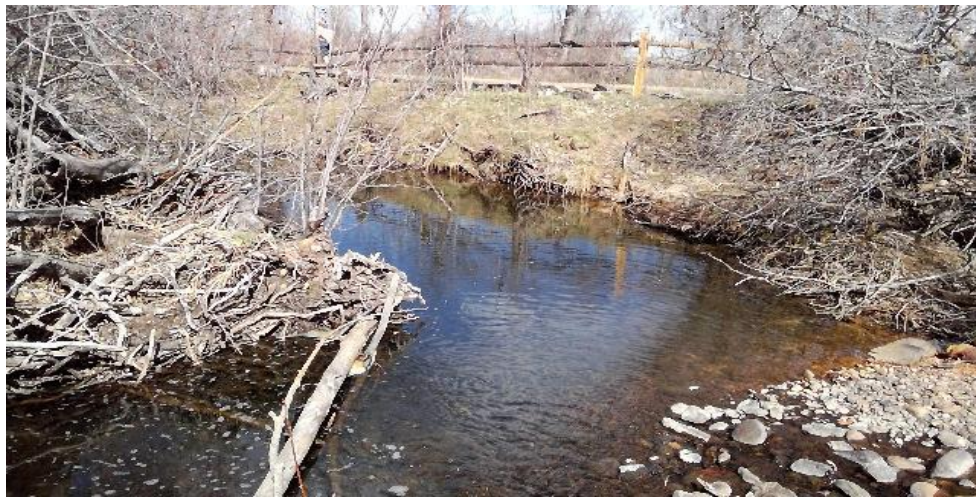
Flow		1.0 poorly functioning
Riparian	Left	2.3 functioning
	Right	2.3 functioning
Landscape	Left	3.0 functioning
	Right	3.0 functioning
Geomorphology		1.8 partly functioning
Aquatic Habitat		1.5 partly functioning
Recreation		moderate impact

Detailed Observations: Creek is moderately entrenched and mostly straight except for a couple of meanders at the upstream end. Most of the reach has a woody riparian buffer and mature cottonwoods keep the banks from eroding. Existing fencing controls public access. A few areas with no trees and breaks in the fencing allow public access, resulting in moderate to severe bank erosion. Most trees are mature cottonwoods with little opportunity for seedling establishment. East Boulder diversion is a barrier to aquatic connectivity / fish passage at downstream end. The next upstream blockage to aquatic connectivity / fish passage is Howard Ditch. The creek was most likely channelized at some point in time. While moderately entrenched, raising the creek bed would greatly reduce the entrenchment and the stresses associated with it.

Project Narrative: Stabilize eroding banks through grading and wood toe protection. Create floodplain benches to reduce shear stress. Plant native woody species in restoration areas and other areas with minimal woody vegetation. Install fencing to eliminate public access to restoration areas to allow vegetation to establish (8 – 10 years). Install wood and rock structures to raise channel invert and reduce entrenchment. Create stabilized public access points.

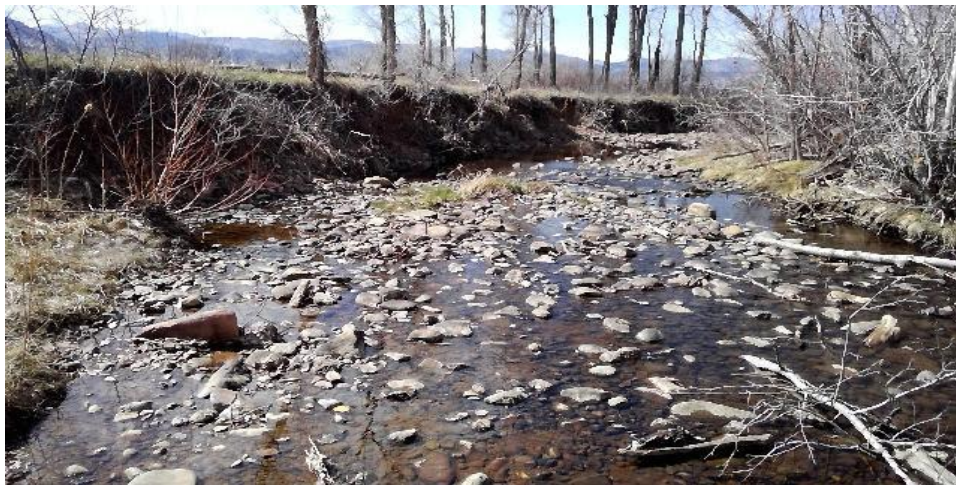
Summary: Recreational impacts are moderate, riparian habitat is in good condition relative to adjacent reaches, but aquatic habitat is very poor. No cattle access to creek.

Overall Condition: Partly Functioning

Flow		0.8 poorly functioning
Riparian	Left	2.3 partly functioning
	Right	2.3 partly functioning
Landscape	Left	2.5 functioning
	Right	2.5 functioning
Geomorphology		1.5 poorly functioning
Aquatic Habitat		0.5 poorly functioning
Recreation		Moderate impact

Recommended Project: Plant native vegetation to expand and diversify riparian buffer. Stabilize eroding banks and create floodplain benches.

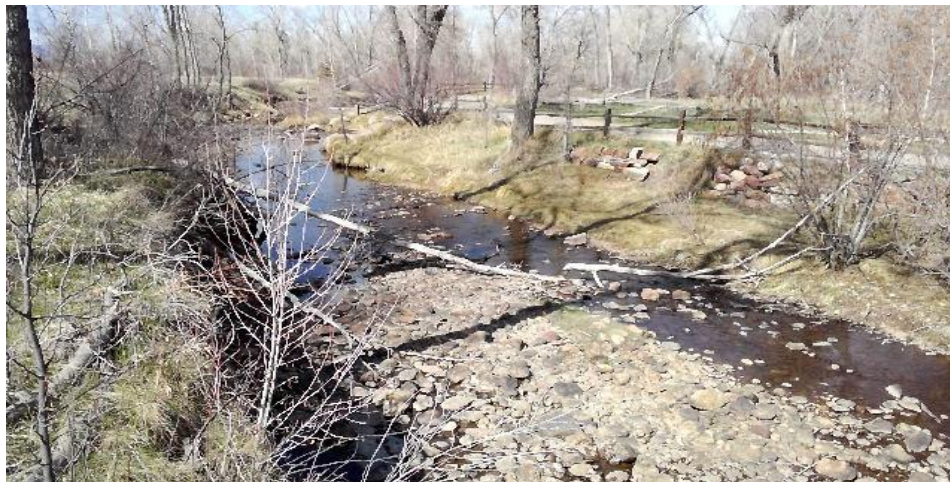
Detailed Observations: Creek is moderately to severely entrenched with some natural meandering. Good riffle/pool sequences but most pools are shallow. Most of the reach has a woody riparian buffer and mature cottonwoods keep banks from eroding. A few areas with no trees have allowed moderate to severe bank erosion. Most trees are mature cottonwoods with little opportunity for seedling establishment. Existing fencing controls public access. A few areas with no trees and breaks in the fencing allow public access, resulting in moderate to severe bank erosion. East Boulder diversion is a barrier to aquatic connectivity / fish passage at upstream end, and a drop at Baseline Road culvert create an isolated reach. While moderately entrenched, raising the creek bed would greatly reduce the entrenchment and the stresses associated with it. This reach scores very low for aquatic habitat due to being isolated and lacking habitat features. Implementation of the East Boulder Ditch project (to include aquatic connectivity / fish passage) will improve connectivity. The upstream New Dry Creek Carrier diversion often sweeps creek but there is usually an upstream flow. An additional source of water from the Viele Channel (a constructed flood control channel) enters South Boulder Creek from the west during non-winter months. This reach (and the downstream reaches to the confluence with Boulder Creek) often has no-to-very-low flows from upstream water (less than 1 cfs) during the winter months. There is some runoff / return flow from storms and snow melt during the winter months.

Project Narrative: Stabilize eroding banks through grading and wood toe protection. Create floodplain benches to reduce shear stress. Plant native woody species in restoration areas and other areas with minimal woody vegetation. Install fencing to eliminate public access to restoration areas to allow vegetation to establish (8 – 10 years). Install wood and rock structures to raise channel invert and reduce entrenchment. Create stabilized public access points.

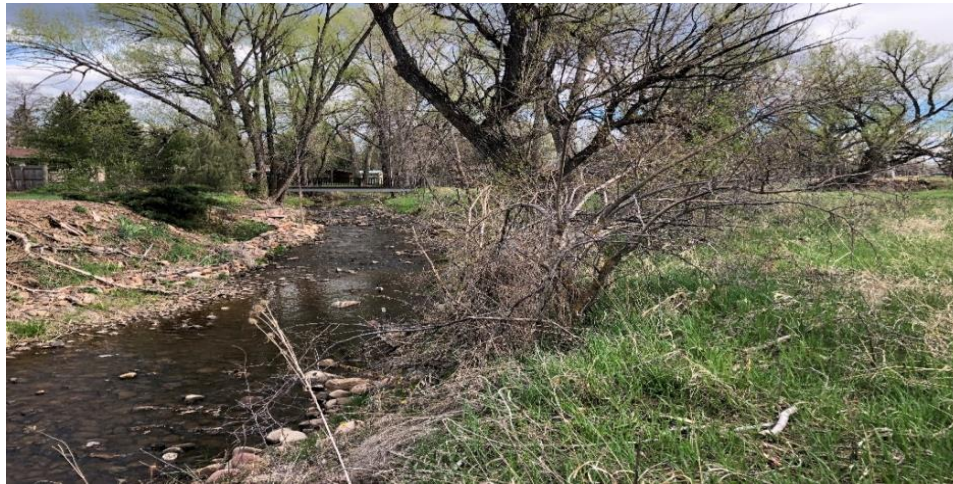
Overall Condition: Partly Functioning

Flow		0.8 poorly functioning
Riparian	Left	2.0 partly functioning
	Right	1.0 poorly functioning
Landscape	Left	2.5 functioning
	Right	1.0 poorly functioning
Geomorphology		1.8 partly functioning
Aquatic Habitat		1.0 poorly functioning
Recreation		No impact

Recommended Project: Hunter-Hinde structure assessment and structure rehabilitation (including improved fish passage); public outreach on creek stewardship, including stream bank landscaping. See Educational Outreach Project description.

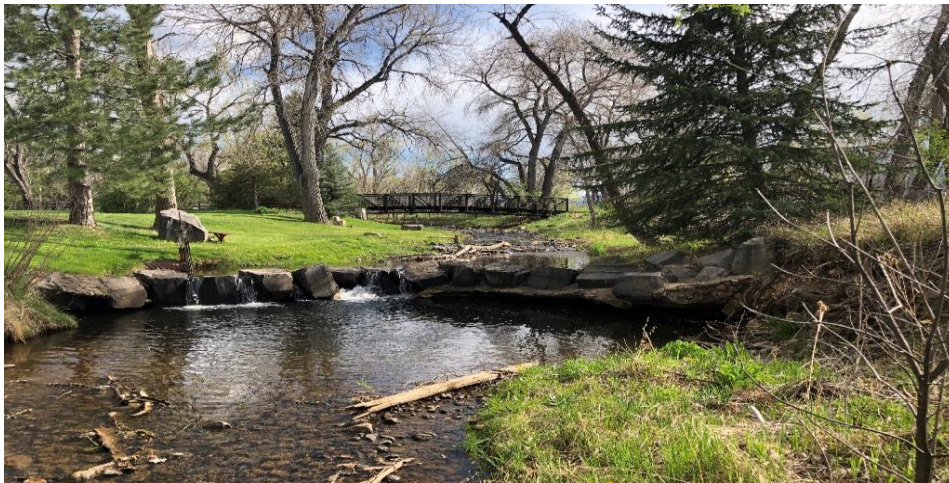
Road, there is a short section where private property is on both sides of the creek. Overall, the creek is more channelized with relatively limited restoration opportunities due to private land. Some properties have rock-armored banks. Most of them maintain mowed lawn all the way to the creek edge.). In-stream structures, many simply stacked rock to create drops and pools, but also some relatively permanent, restrict channel connectivity and creek function. A paved path runs along half of this sub-reach on the OSMP land to the west and does not appear to limit creek function, nor provide public access. The private Hunter-Hinde structure is in the middle of the sub-reach; it does not function when water is low, appears to be undercut, and inhibits aquatic connectivity / fish passage. Upstream New Dry Creek Carrier and East Boulder diversions often sweep the creek but there is usually an upstream flow. An additional source of water from the Viele Channel enters South Boulder Creek from the west during non-winter months. This reach (and the downstream reaches to the confluence with Boulder Creek) often has no-to-very-low flows from upstream water (less than 1 cfs) during the winter months. There is some runoff / return flow from storms and snow melt during the winter months.

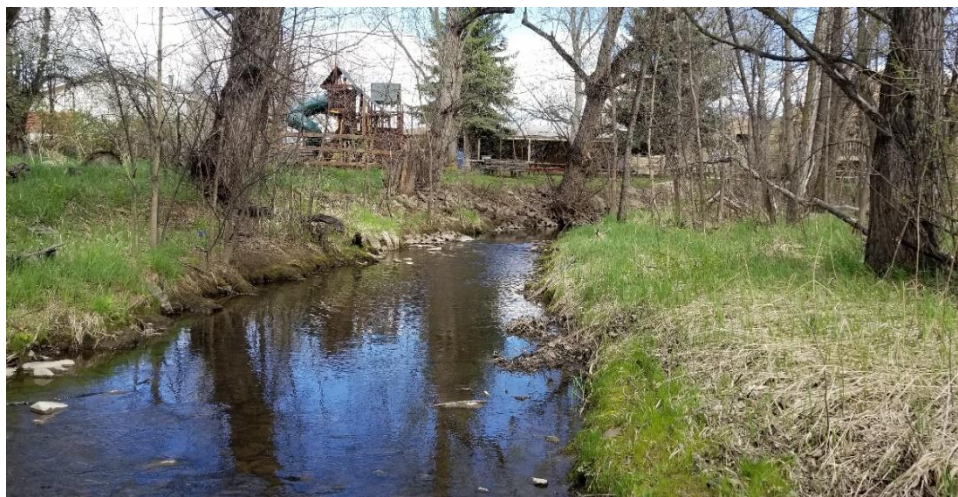
Reach 3.4 Wellman Canal Outlet to Leggett/Jones-Donnelly Canal Control Structure

Summary: Creek continues through residential area, now with private properties on both sides for the entire reach. Like Reach 3.3, overall corridor structure is simplified with poor riparian area and lack of aquatic features.

Overall Condition: Partly Functioning

Flow		1.3 partly functioning
Riparian	Left	1.0 poorly functioning
	Right	1.3 partly functioning
Landscape	Left	0.5 poorly functioning
	Right	0.5 poorly functioning
Geomorphology		1.5 partly functioning
Aquatic Habitat		1.0 poorly functioning
Recreation		No impact

Recommended Project: Public outreach on creek stewardship, including stream bank landscaping. See Educational Outreach project description.

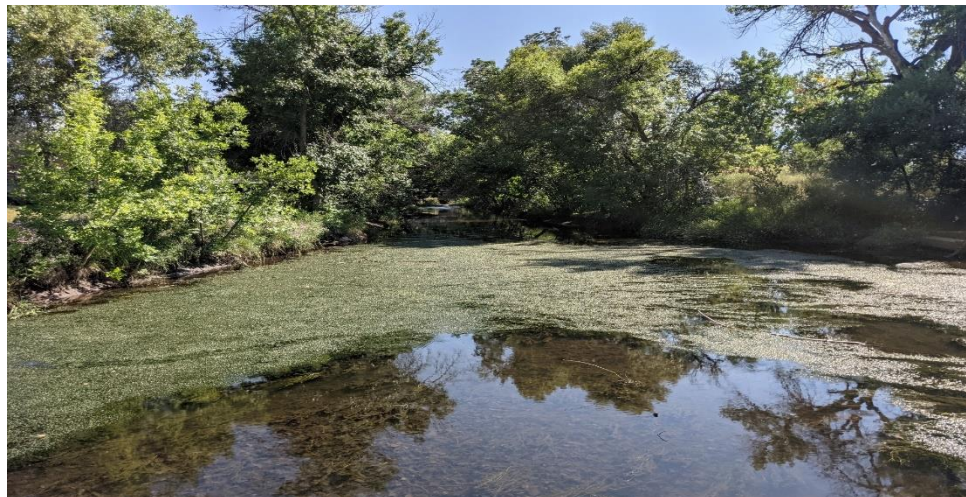
Detailed Observations: Downstream of the Wellman Canal, the creek flows through a residential neighborhood with private properties on both sides. Overall, the creek is channelized with areas of steep banks and relatively limited opportunities due to private land. Some properties have rock-armored banks, and many of them maintain mowed lawn to the creek edge.). In-stream structures, many simply stacked rock to create drops and pools, but also some relatively permanent, restrict channel connectivity and creek function. Channel bed appears relatively homogenous. Compared to Reach 3.3, the channel is more sinuous.

Reach 3.4 includes a short section between Arapahoe Road and the Leggett Inlet Canal Complex diversion structure. Due to the control structure, this part of the creek is typically a stagnant pond that can become covered with algae and other aquatic plant growth. These conditions further degrade water quality and would be expected to contribute to higher temperature, lower dissolved oxygen, and higher nutrients and bacteria. The channel is confined by a levee/trail on the left (west) side and automobile dealership on the right (east) side. Upstream New Dry Creek Carrier and East Boulder diversions often sweep the creek but there is usually an upstream flow. An additional source of water from the Viele Channel enters South Boulder Creek from the west during non-winter months. This reach (and the downstream reaches to the confluence with Boulder Creek) often has no-to-very-low flows from upstream water (less than 1 cfs) during the winter months. There is some runoff / return flow from storms and snow melt during the winter months.

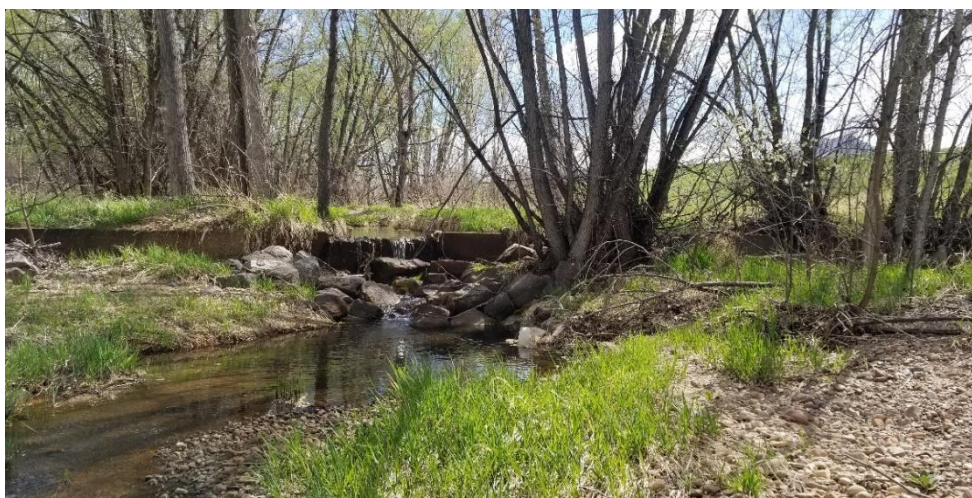
Reach 3.5 Leggett Inlet Canal Control Structure to KOA Lake Inlet Structure

Summary: Downstream of the Leggett Inlet Canal Control Structure, the creek passes through highly degraded sections, including a flood conveyance project managed by Mile High Flood District (MHFD), with a high level of commercial and light industrial activity adjacent to the corridor.

Overall Condition: Poorly Functioning

Flow		1.0 poorly functioning
Riparian	Left	2.3 functioning
	Right	1.7 partly functioning
Landscape	Left	1.0 poorly functioning
	Right	1.0 poorly functioning
Geomorphology		1.0 poorly functioning
Aquatic Habitat		0.5 poorly functioning
Recreation		No impact

Recommended Project: Keep track of future development and potential improvement opportunities. One concept is to create a bypass channel to take KOA Lake offline of the stream channel.

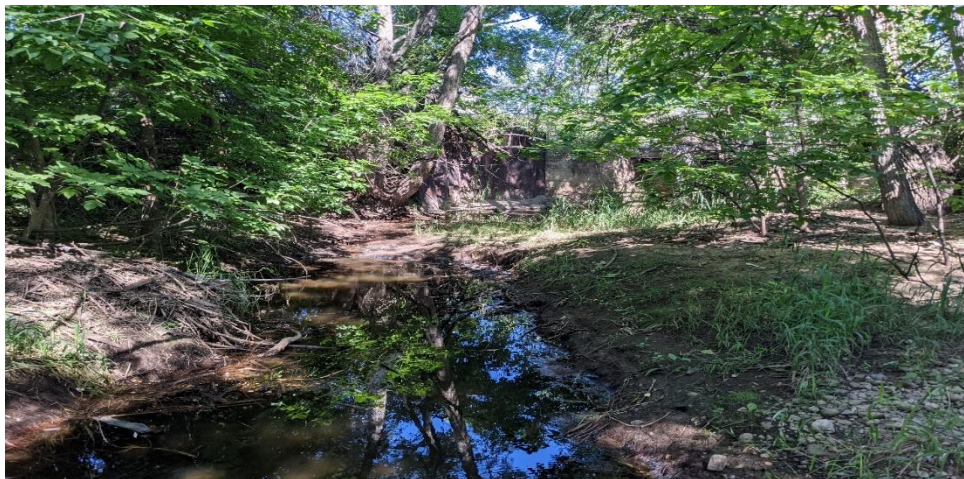
Detailed Observations: In this lower stretch, the creek is highly degraded, braided in some areas, and hemmed in by commercial / industrial development. The upstream quarter of the reach, between the control structure and a railroad bridge, is often subject to illegal camping that inhibits establishment and growth of riparian vegetation and is a source of pollution, including waste such as syringes, human excrement, abandoned camp equipment, etc. A levee / trail on the left (west) side and backyard parking area of the neighboring automobile dealership to the right (east) confines the creek corridor.

Downstream of the railroad bridge, the remainder of the reach to KOA Lake is an MHFD flood conveyance channel. Levees on each side form an artificial valley with concrete weirs evenly spaced along the reach length and that extend across the entire floodplain. Woody vegetation appears to be limited as part of maintenance of flood capacity.

This reach is downstream of all major diversions. In addition to the Leggett control structure, upstream New Dry Creek Carrier and East Boulder diversions often sweep the creek but there is usually an upstream flow. An additional source of water from the Viele Channel enters South Boulder Creek from the west during non-winter months. This reach (and the downstream reaches to the confluence with Boulder Creek) often has no-to-very-low flows from upstream water (less than 1 cfs) during the winter months. There is some runoff / return flow from storms and snow melt during the winter months. The channel is smaller and aquatic habitat is limited.
