# San Luis Valley Aquatic Habitat Assessment

*Compendium of Reports  
for Purchase Order  
POGG1-2020-3208*

# San Luis Valley Aquatic Habitat Assessment: Compendium of Reports

This report was prepared by Matthew A. Reddy, Regional Biologist, Ducks Unlimited, Inc. & Cary Aloia and Jenny Nehring with Wetland Dynamics, LLC on June 30th, 2022.

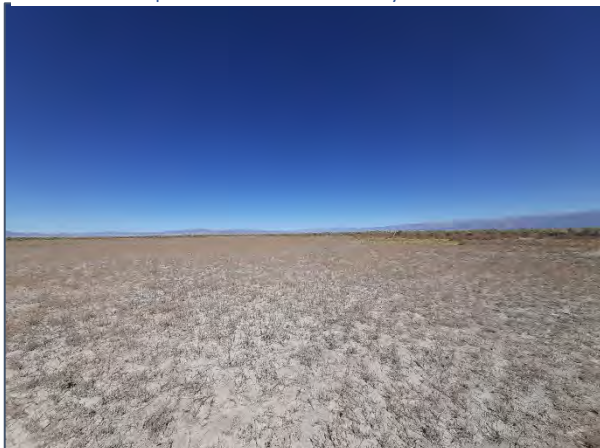
A remnant spike rush community at Mishak Lakes.

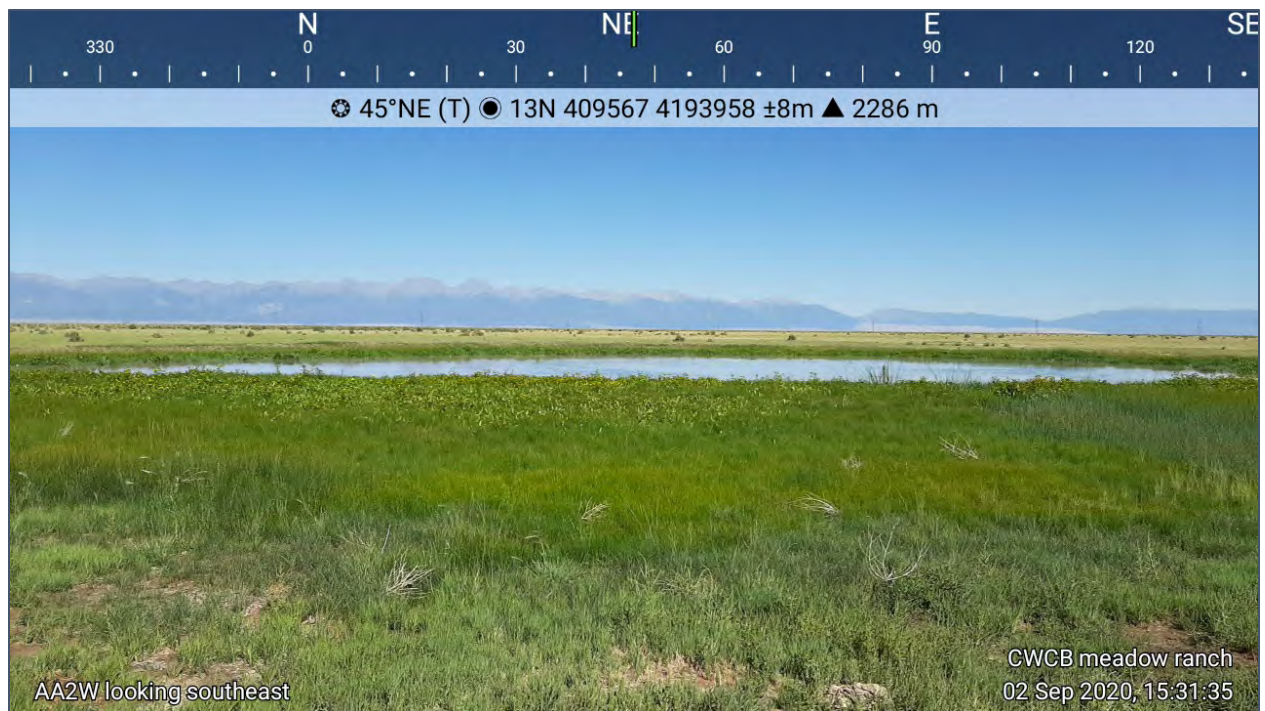
During site visits, locations predicted to be wet by the Assessment were either wet or showed indications of being wet with the exception of two locations. One location was on the Meadow Ranch which had been wet in the past but was not at the time of the field visit due changes in grazing and water management the prior year (an AA was originally placed in this location but was not completed due to intensive grazing and lack of irrigation that had resulted in the removal of almost all vegetation from the site and completely altered the habitat). The second property that did not have indications of on-the-ground wetness was the drainage on the Cloud Crest SLB property which the model showed had wet conditions within greasewood immediately adjacent to the channel (Figure 18, Appendix II). Both exceptions could be explained due to changes in management or slight offsets perhaps due to reflectance of snow in the model.
