Spring Creek Fire Remediation Project
CWCB Grant Contract CTGG1 PDAA 202100002486

FINAL REPORT

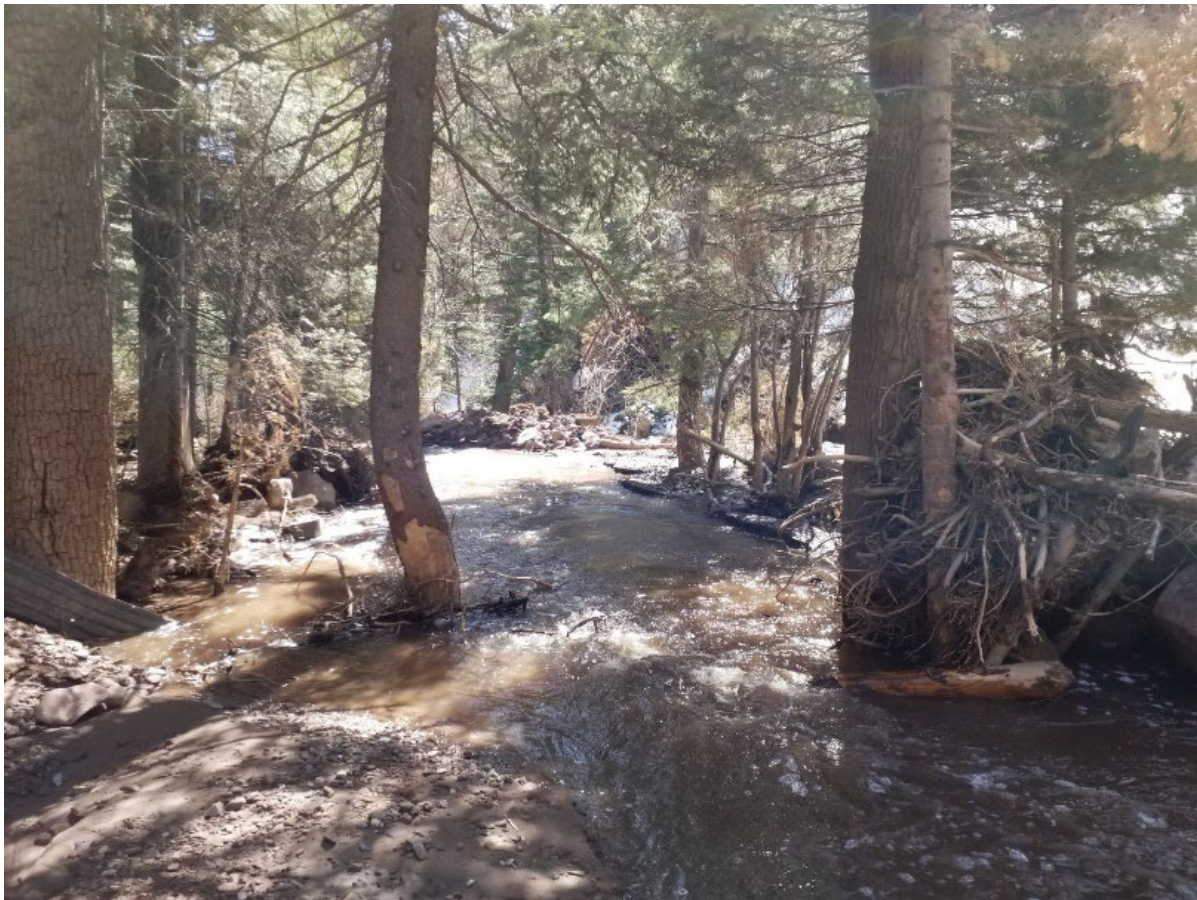
The stakeholder meetings established that the first phase task, considered a top priority, was to get the flows of Indian Creek and Price Creek, tributaries to the Cucharas River, reestablished in the historical stream channels instead of on County Road 421. Significant Spring runoff was causing further head cutting and adding significant sediment to the stream system.

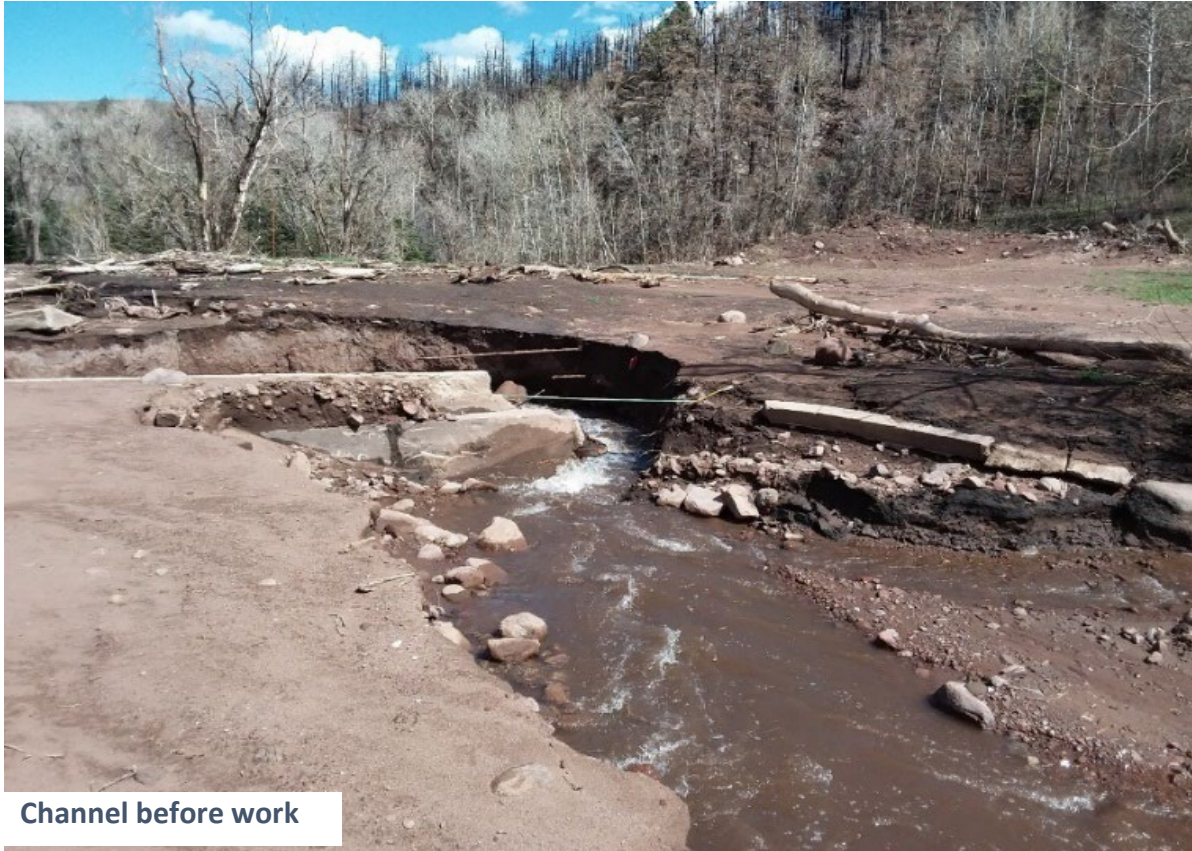
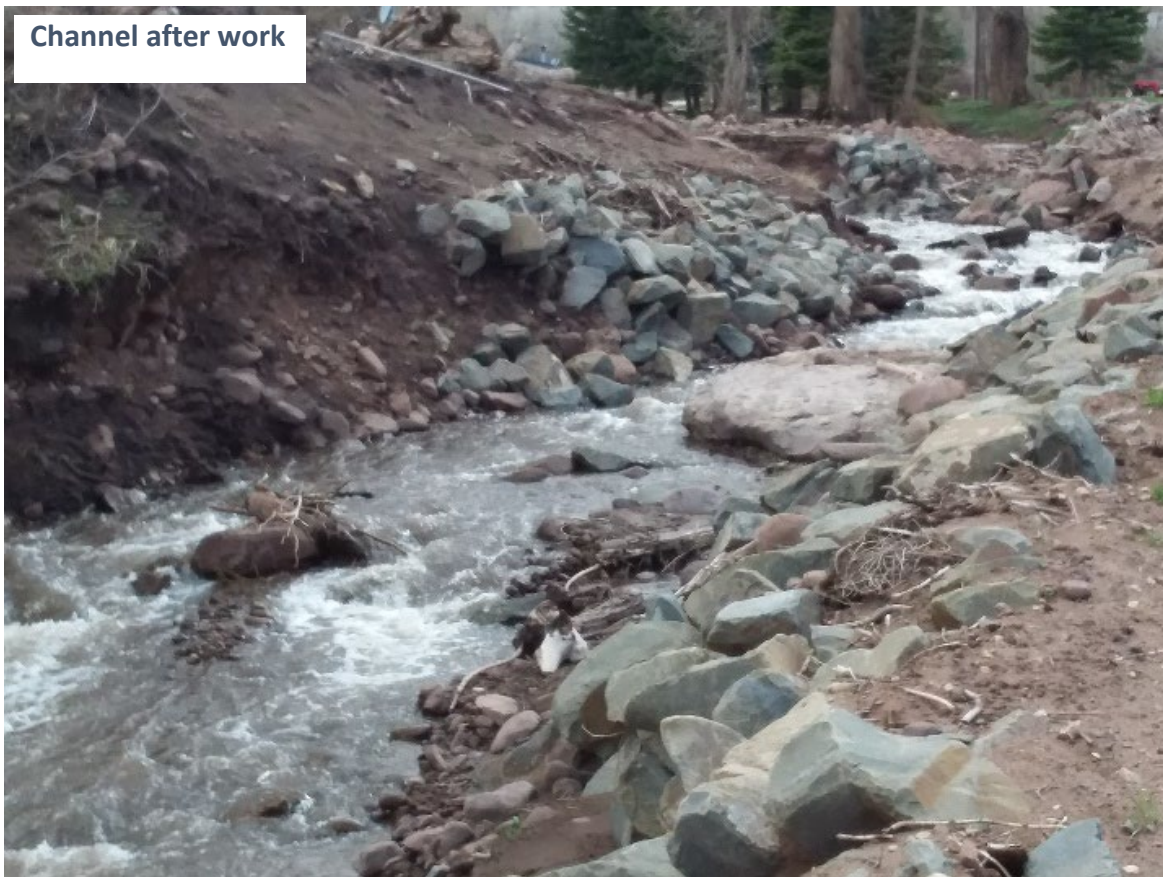
The channel was recreated to keep the water flowing to the side rather than on the roadway.

The Sulphur Springs property, particularly the swimming pool, was overwhelmed by rock and sediment runoff and sustained damage. It was decided to utilize the swimming pool as a detention basin.

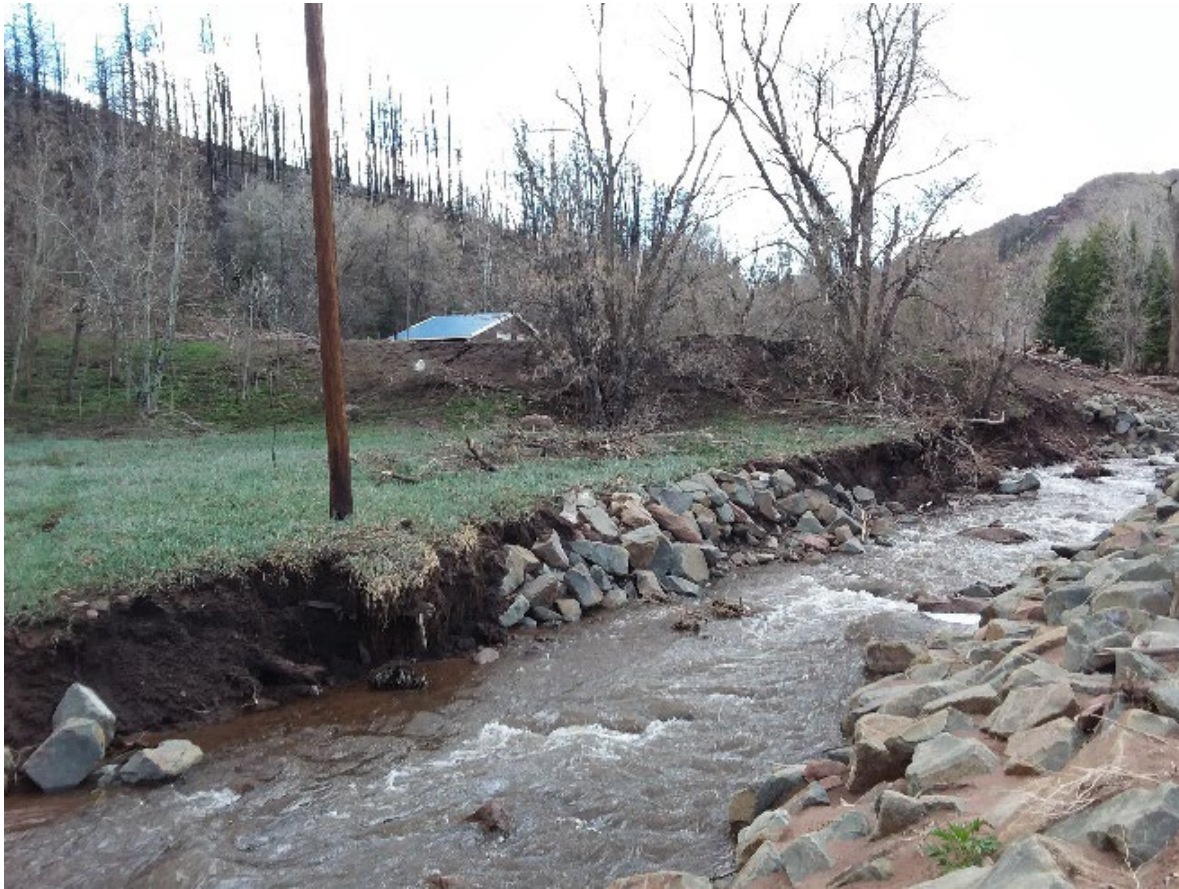
Spring runoff was high. Huerfano County Emergency Management and ARWC worked with an NCCC team to clear slash from Indian Creek, piling and burning it as work proceeded. In cooperation with the La Veta Fire Protection District, with burn piles closely monitored. The side of the creek away from the road was cleared, offering flowing water a path of least resistance instead of claiming the roadbed.

Although the damage was extensive, the project task was workable, and Indian Creek was moved back into its channel.
