COLORADO DIVISION OF RECLAMATION, MINING AND SAFETY
MINERALS PROGRAM INSPECTION REPORT
PHONE: (303) 866-3567

MINE NAME: Bachelor Mines (Syracuse Portal)	MINE/PROSPECTING ID#: M-1980-170	MINERAL: Silver	COUNTY: Ouray
INSPECTION TYPE: Monitoring	INSPECTOR(S): Wallace H. Erickson	INSP. DATE: September 20, 2013	INSP. TIME: 14:00
OPERATOR: Bachelor Silver Mines Company	OPERATOR REPRESENTATIVE: None present	TYPE OF OPERATION: 110(2) - Hard Rock Limited Impact	
REASON FOR INSPECTION: Normal I&E Program	BOND CALCULATION TYPE: Partial Bond	BOND AMOUNT: \$7,693.00	
DATE OF COMPLAINT: NA	POST INSP. CONTACTS: None	JOINT INSP. AGENCY: None	
WEATHER: Cloudy	INSPECTOR'S SIGNATURE:

Bachelor Mines
(Syracuse Portal)
M-1980-170
September 20, 2013

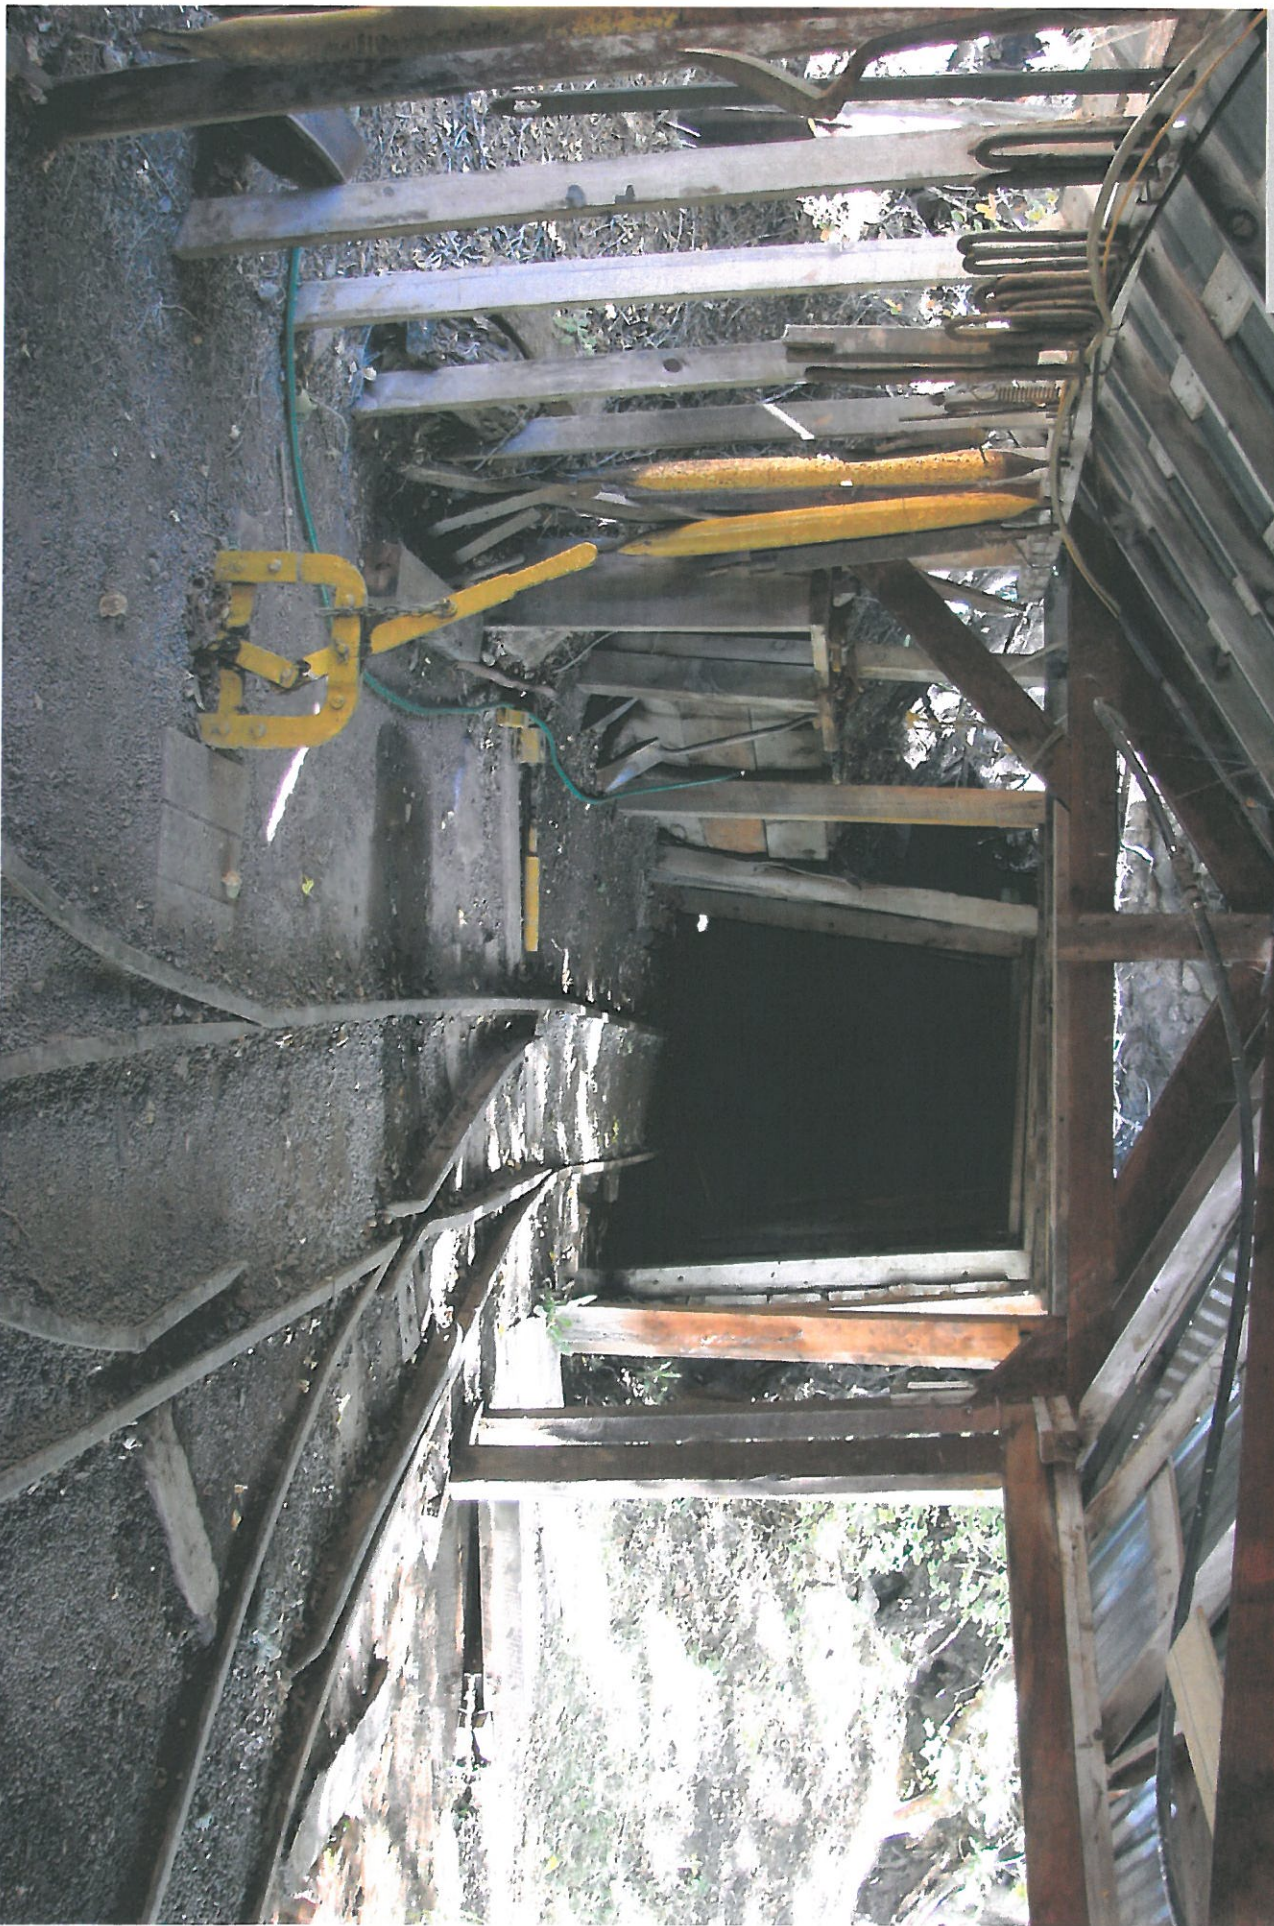
As shown in the photos, current conditions appear similar to the descriptions of the pre-permit disturbance provided in the original application documents. The portal discharge was estimated at 250-300 gallons per minute and was routed to the south end of the permit area as indicated in the application documents. Mine drainage appeared clear; no evidence of iron staining or metals precipitation was observed. Aquatic plants were thriving throughout all portions of the discharge ditch. Mine drainage ultimately reports to Lake Lenore Estates and does not discharge directly to a live stream channel.
