COLORADO DIVISION OF RECLAMATION, MINING AND SAFETY COAL PROGRAM INSPECTION REPORT

Permit Number: C-1981-017 Mine Name: Coal Basin Mines Operator: Mid-Continent Resources Operator Address:	County: Pitkin Operation Type: Underground Permit Status: Revoked Ownership: Federal
	Operator Representative Present: None
Operator Representative Signature: (Field Issuance Only)

Inspection Start Date: July 23, 2013 Inspection Start Time: 09:00 Inspection End Date: July 23, 2013 Inspection End Time: 16:00	Inspection Type: Coal Complete Inspection Inspection Reason: Normal I&E Program Weather: Clear	
Joint Inspection Agency: None	Joint Inspection Contacts:	
Post Inspection Agency: None	Post Inspection Contacts:	
Inspector(s): Brock F. Bowles	Inspector's Signature:

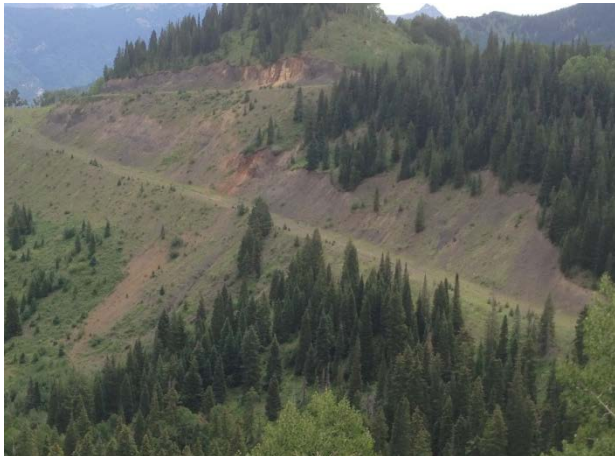
Photo 2 – Alluvial Fan in Road B

The USFS has constructed an alluvial fan in Road B, west of the lamphouse, to mitigate a slide area. A rock lined water channel was constructed with willows stems in the bottom. A several acre fan area west of the channel was constructed to catch excess water and sediment. All areas of the alluvial fan had 3 inches of biochar applied and was then ripped and seeded. Tree seedlings were planted and some large logs were laid across the fan area as energy dissipaters. The entire area was enclosed by an electric fence (photo 2).
