Reference: Cripple Creek & Victor Gold Mining Company,
Cresson Project Squaw Gulch (VLF), Hwy 67 Realignment

Subject: Weekly Construction Quality Assurance ("CQA") Report:
AMEC: Squaw Gulch (VLF), Hwy 67 Realignment - Weeks ending 12/14/13 and
12/21/13

CRIPPLE CREEK & VICTOR GOLD MINING Co.
Squaw Gulch (VLF), HWY 67 Realignment Field Monitoring Summary Weekly Report

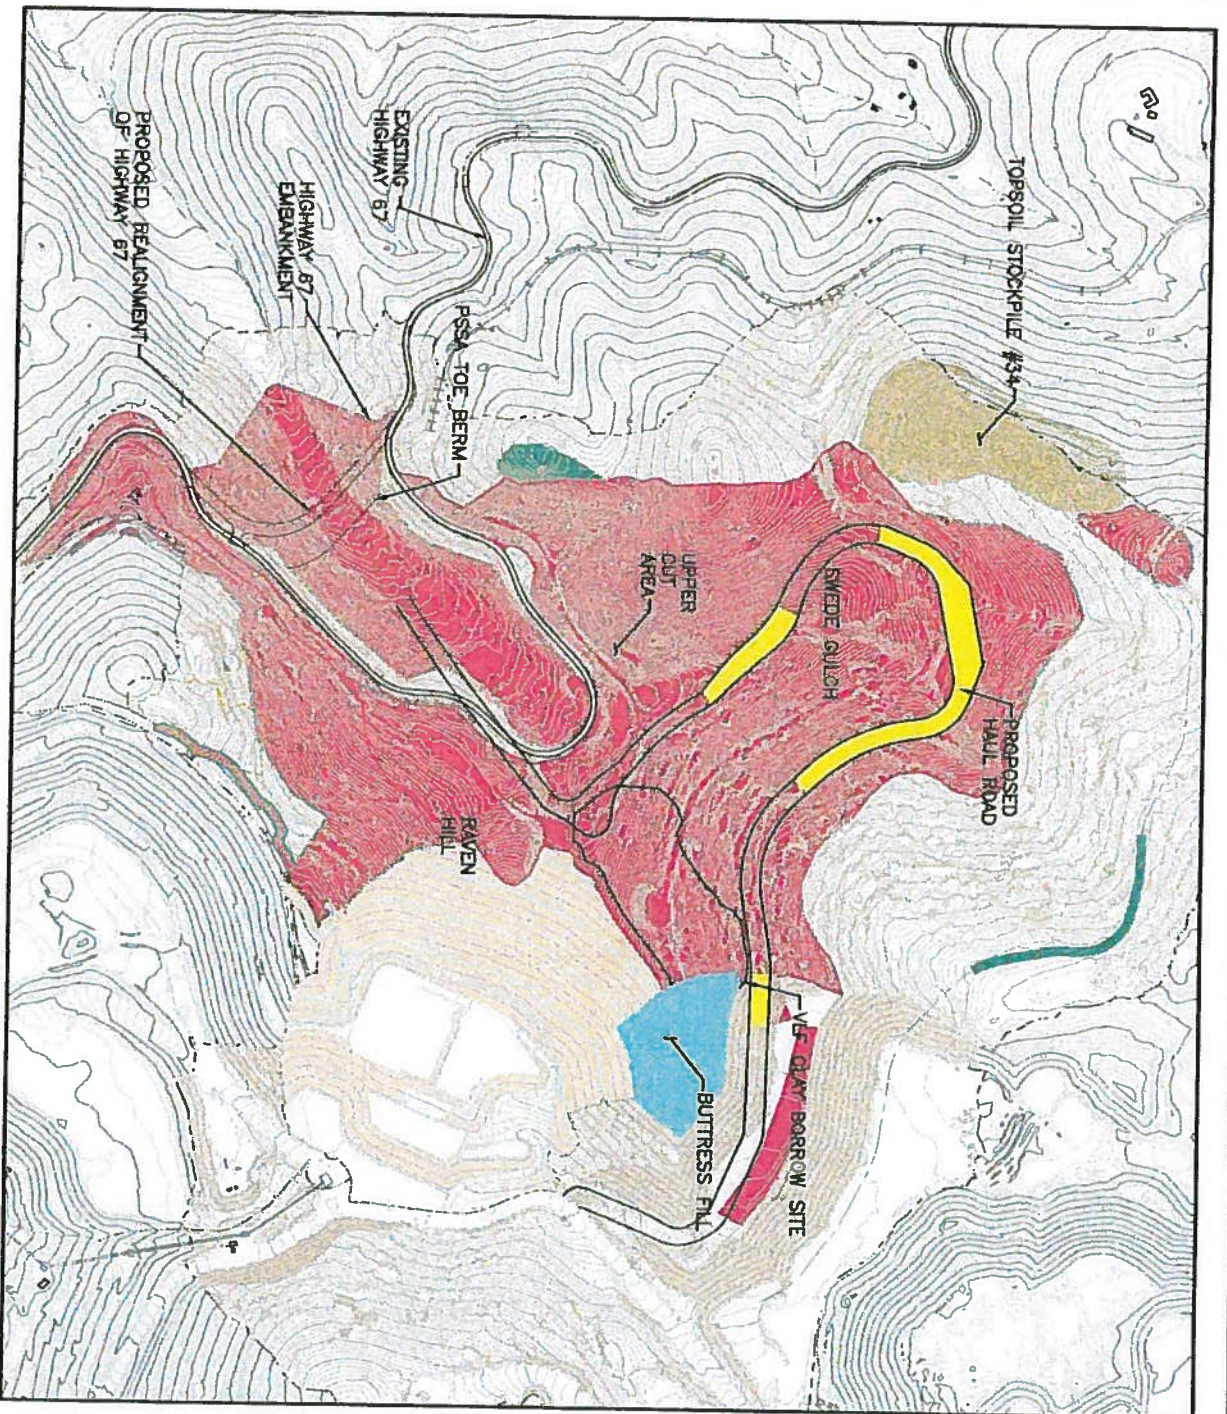
GRIFFIN STREET & VICTOR	
SOLID MINING COMPANY	
MILE 2 SQUAW GULCH	
CLEARING, GRUBBING AND FILL AREAS	
DESIGNED BY	TWO
DRAWN BY	ONE
CHECKED BY	ONE
APPROVED BY	ONE
DATE	12/14/13
SCALE	1" = 100'
1	A
