Reference: Cripple Creek & Victor Gold Mining Company,
Cresson Project Squaw Gulch (VLF), Hwy 67 Realignment

Subject: Weekly Construction Quality Assurance ("CQA") Report:
AMEC: Squaw Gulch (VLF), Hwy 67 Realignment - Week ending 01/04/14.

CRIPPLE CREEK & VICTOR GOLD MINING Co.
Squaw Gulch (VLF), HWY 67 Realignment Field Monitoring Summary Weekly Report

Reporting Period: 12.29.13 thru 1.4.14

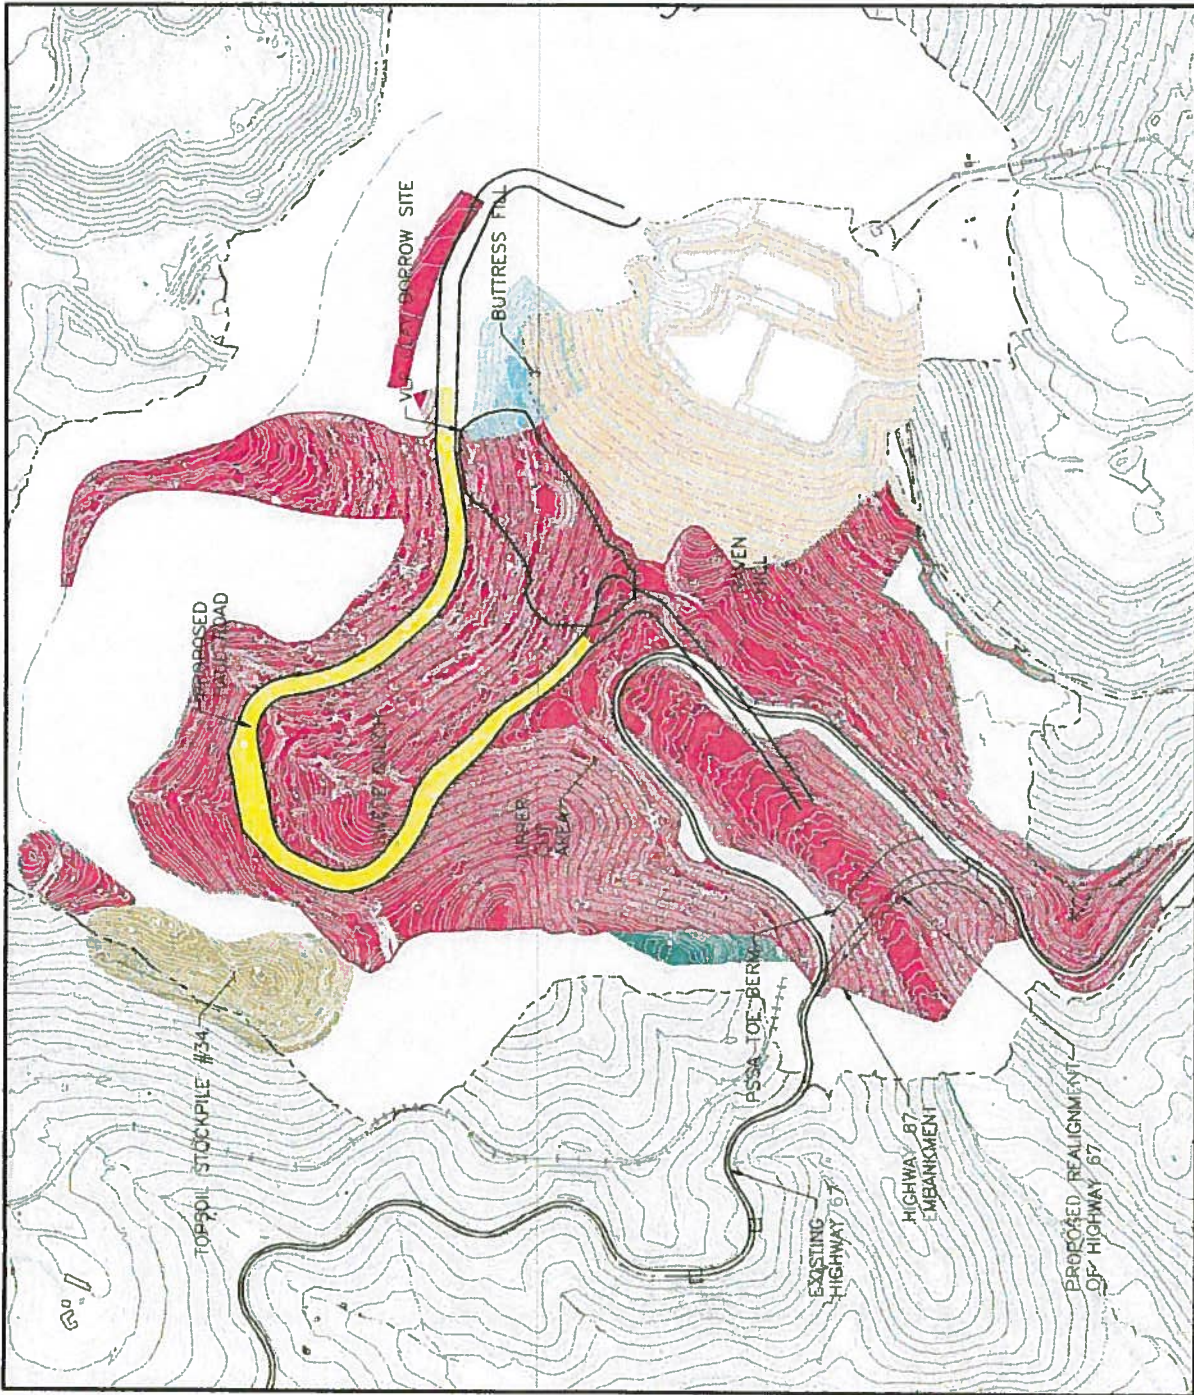
CRIPPLE CREEK & VICTOR GOLD MINING COMPANY			
MILE 2 SQUAW GULCH			
CLEARING, GRUBBING AND FILL AREAS			
DESIGNED BY	THE	CHECKED BY	DATE
DRAWN BY	UP	APPROVED BY	DATE
1		A
