Nyholt Mann Pit M-1982-147

MODIFIED 30-DAY LEAK TEST RESULTS

MANN LAKES, LAKE #2

ADAMS COUNTY, COLORADO

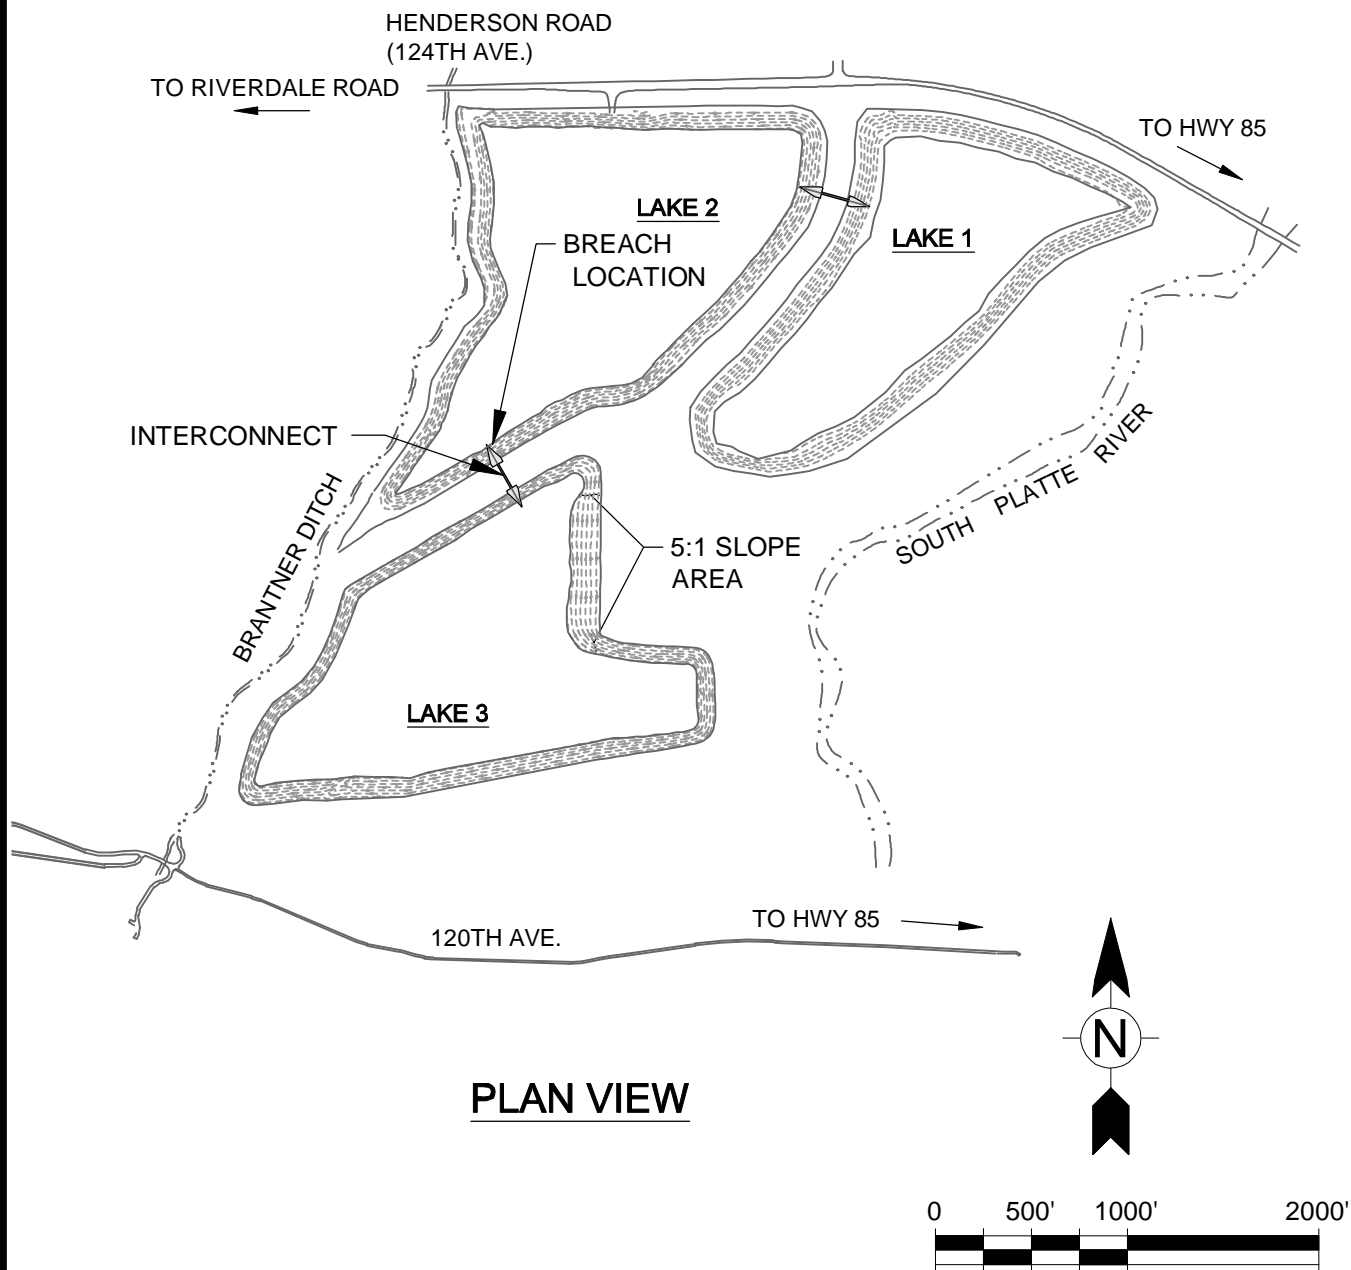
FIG 1

Mann Lakes is located west of the South Platte River and east of the Brantner Ditch in Adams County, Colorado. The site is southeast of the intersection of Riverdale Road and Henderson Road, south of the Adams County Fairgrounds. The site is more particularly described as being located in Section 34, Township 1 South, Range 67 West of the 6th Principal Meridian in Adams County as shown on Figure 1.

Mann Lakes is lined with compacted clay embankment seal zone (Zone 1a) adjacent to and protected by gravelly clay zone (Zone 1b). A typical liner section is provided on Figure 2. A plan view of the lined pit is provided on Figure 1. The slope liner typically slopes 3:1 horizontal to vertical (H:V) into the pit.

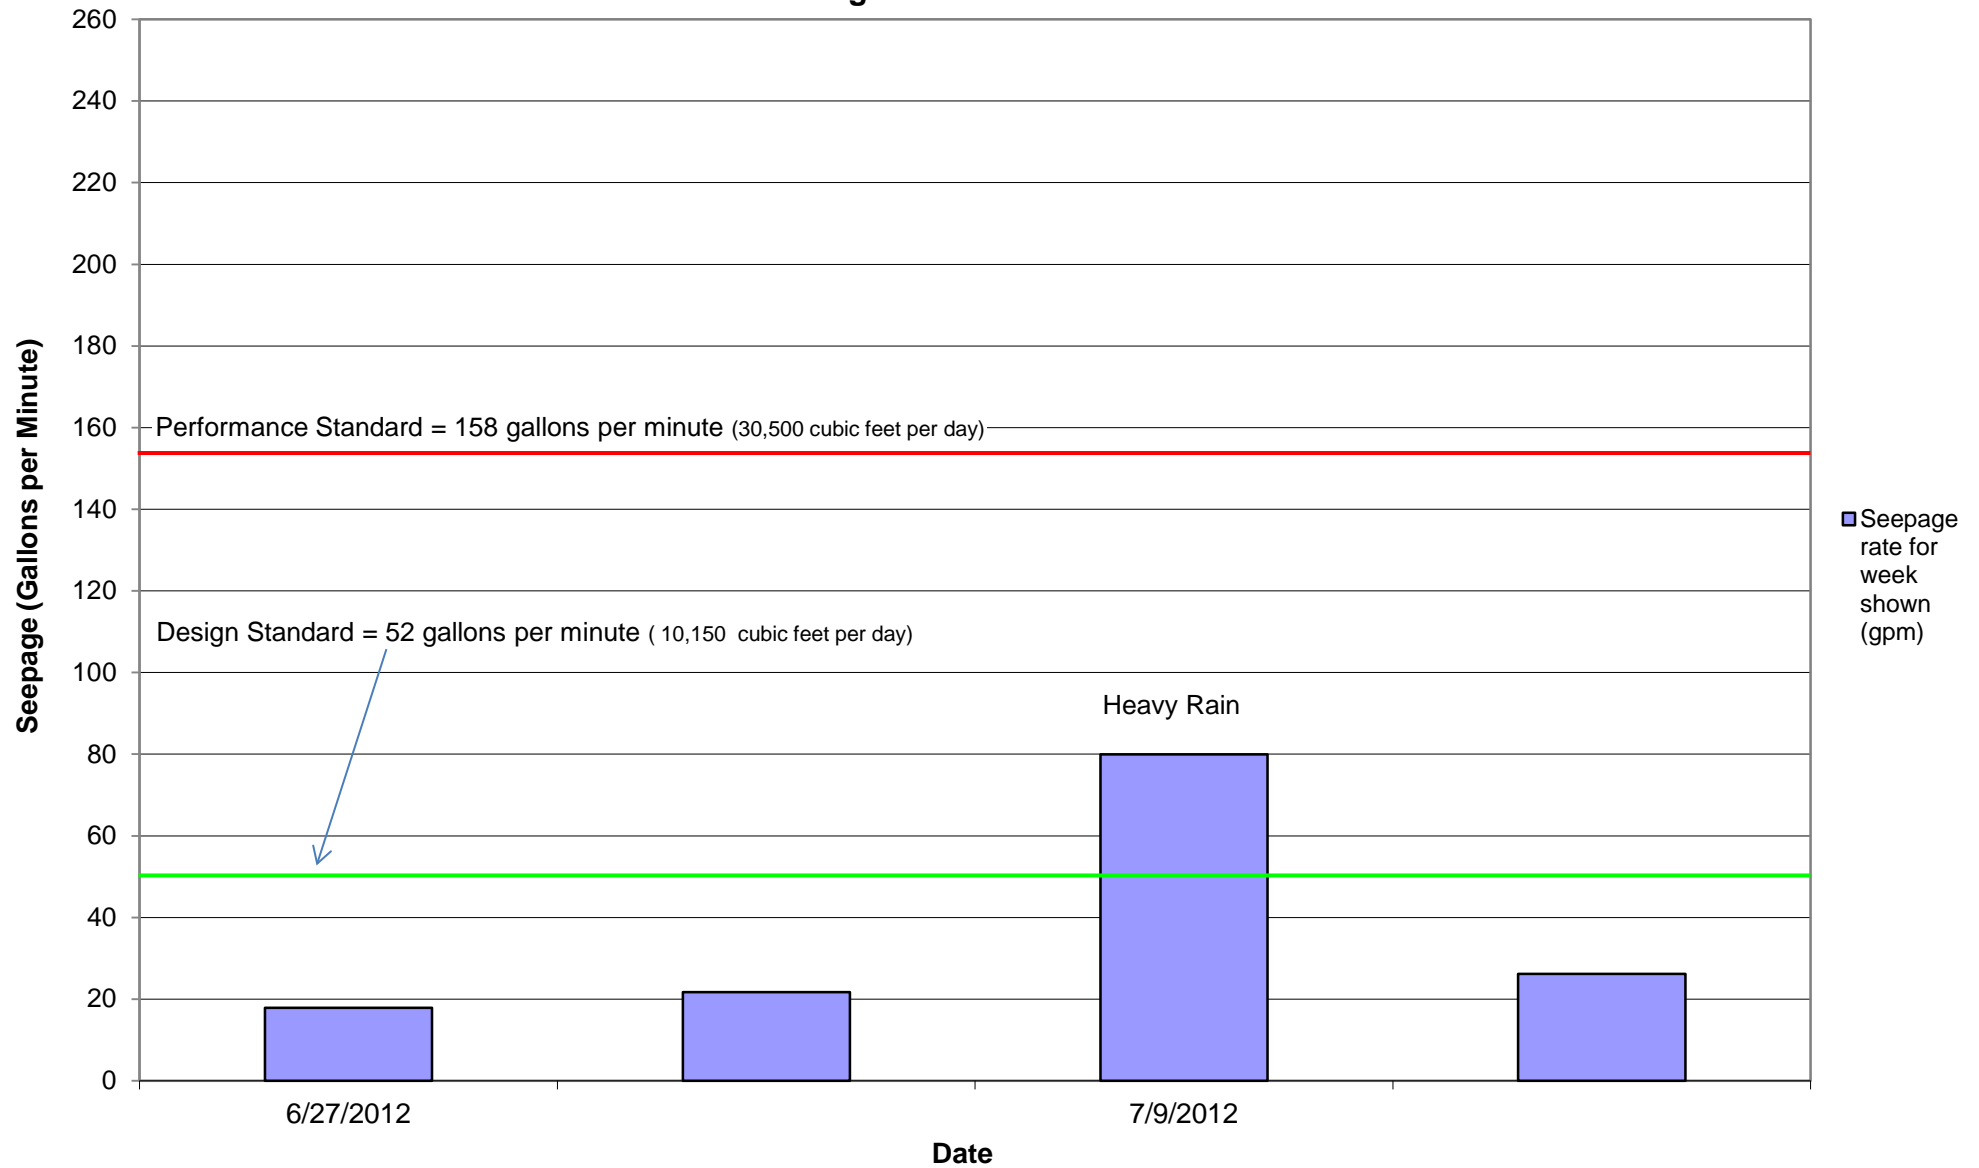
Total Calculated Seepage - Mann Lakes, Lake #2
Figure 6

Calculated seepage into the pits typically ranged from approximately 3,438 to 15,386 cubic feet per day (17.9 to 79.9 gpm) for Lake #2. The high value is skewed due to heavy rainfall. Table one lists the total calculated seepage for each measurement and Figure 6 graphically illustrates the total calculated seepage compared to the maximum allowable seepage for the design and performance standards. Appendix B contains the weather data and the calculations for each pond. Electronic versions in spread sheet format are provided in the pocket.

Date	Pond # 1	Pond # 2	Trench	Total Seepage (gal/min)	Allowable Seepage (performance, gal/min)	Difference (Measured Seepage - Allowable)
6/17/2012						
6/27/2012	0.000	17.758	0.102	17.86	52	-34.14
7/3/2012	17.444	3.227	1.025	21.70	52	-30.30
7/9/2012	51.426	28.404	0.098	79.93	52	27.93
7/17/2012	19.232	6.174	0.801	26.21	52	-25.79
