**COLORADO DIVISION OF RECLAMATION, MINING AND SAFETY**  
**MINERALS PROGRAM INSPECTION REPORT**  
**PHONE: (303) 866-3567**

| <b>MINE NAME:</b><br>Pueblo East Pit | <b>MINE/PROSPECTING ID#:</b><br>M-1986-015 | <b>MINERAL:</b><br>Sand and gravel | <b>COUNTY:</b><br>Pueblo |

**Re: Summary of Soils Investigation 5-13-14: Cooper Property/M-1986-015**

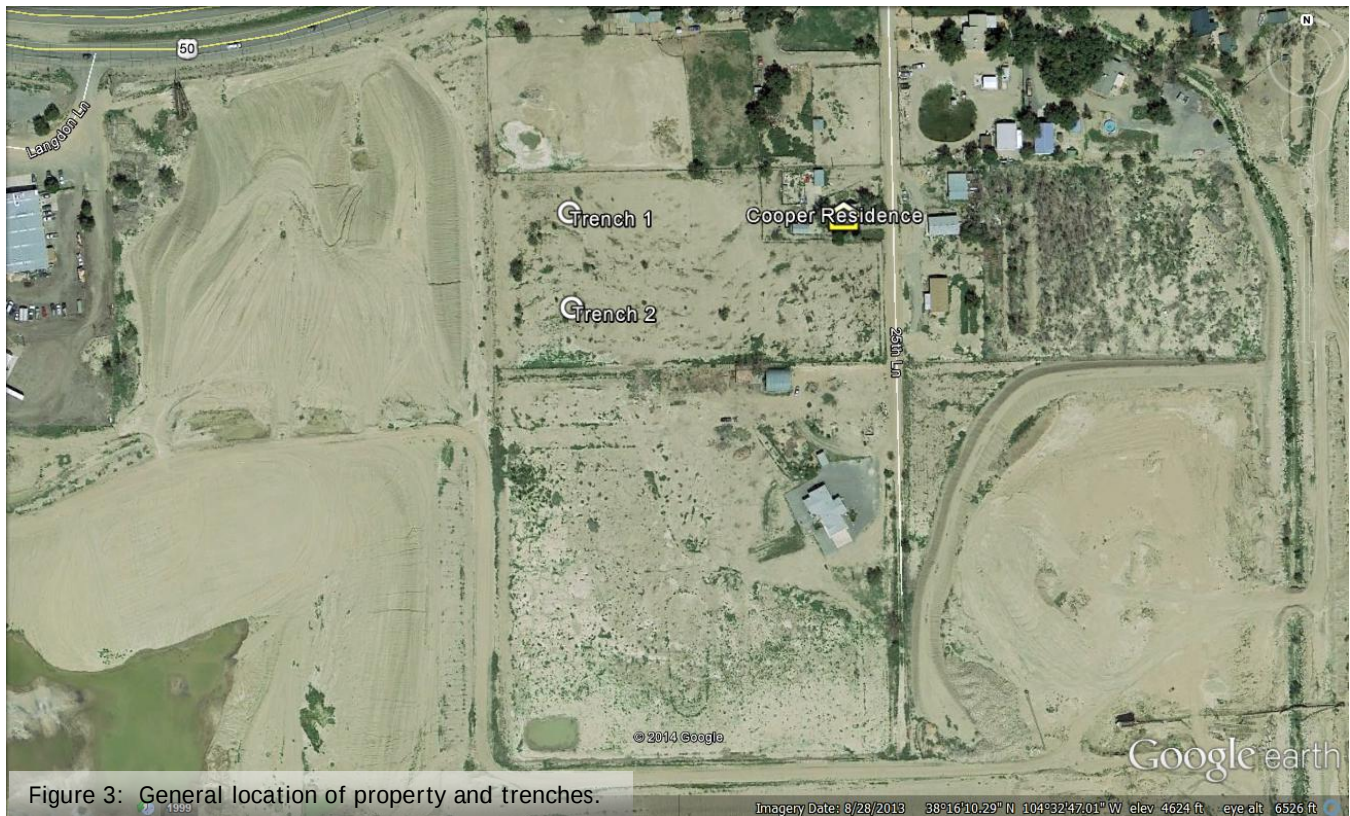
Two trenches were excavated during the investigation. Trench 1 was located in the northwestern quarter of Ms. Cooper's property where a deep fissure was noted during the November 2013 investigation. The opening was approximately 6 inches in diameter and 7 feet deep along a trend of small east-west openings. Trench 1 was opened north-south across the opening to a total depth of approximately 10.5 feet bgs.

Trench 2 was located in the southwest quarter of Ms. Cooper's property over the middle sinkhole-like depression along an east-west trend of depressions. The opening was approximately 3-4 feet in diameter, and 18 inches deep. Trench 2 was opened north-south across the hole to a depth of approximately 8 feet bgs.
