**COLORADO DIVISION OF RECLAMATION, MINING AND SAFETY**  
**MINERALS PROGRAM INSPECTION REPORT**  
**PHONE: (303) 866-3567**

<b>MINE NAME:</b> Road Runner Rest	<b>MINE/PROSPECTING ID#:</b> M-1979-195	<b>MINERAL:</b> Sand and gravel	<b>COUNTY:</b> Adams
<b>INSPECTION TYPE:</b> Monitoring	<b>INSPECTOR(S):</b> Tyler V. O'Donnell	<b>INSP. DATE:</b> May 14, 2014	<b>INSP. TIME:</b> 13:00
<b>OPERATOR:</b> Denver Water Department	<b>OPERATOR REPRESENTATIVE:</b> Greg Gulley	<b>TYPE OF OPERATION:</b> 112c - Construction Regular Operation

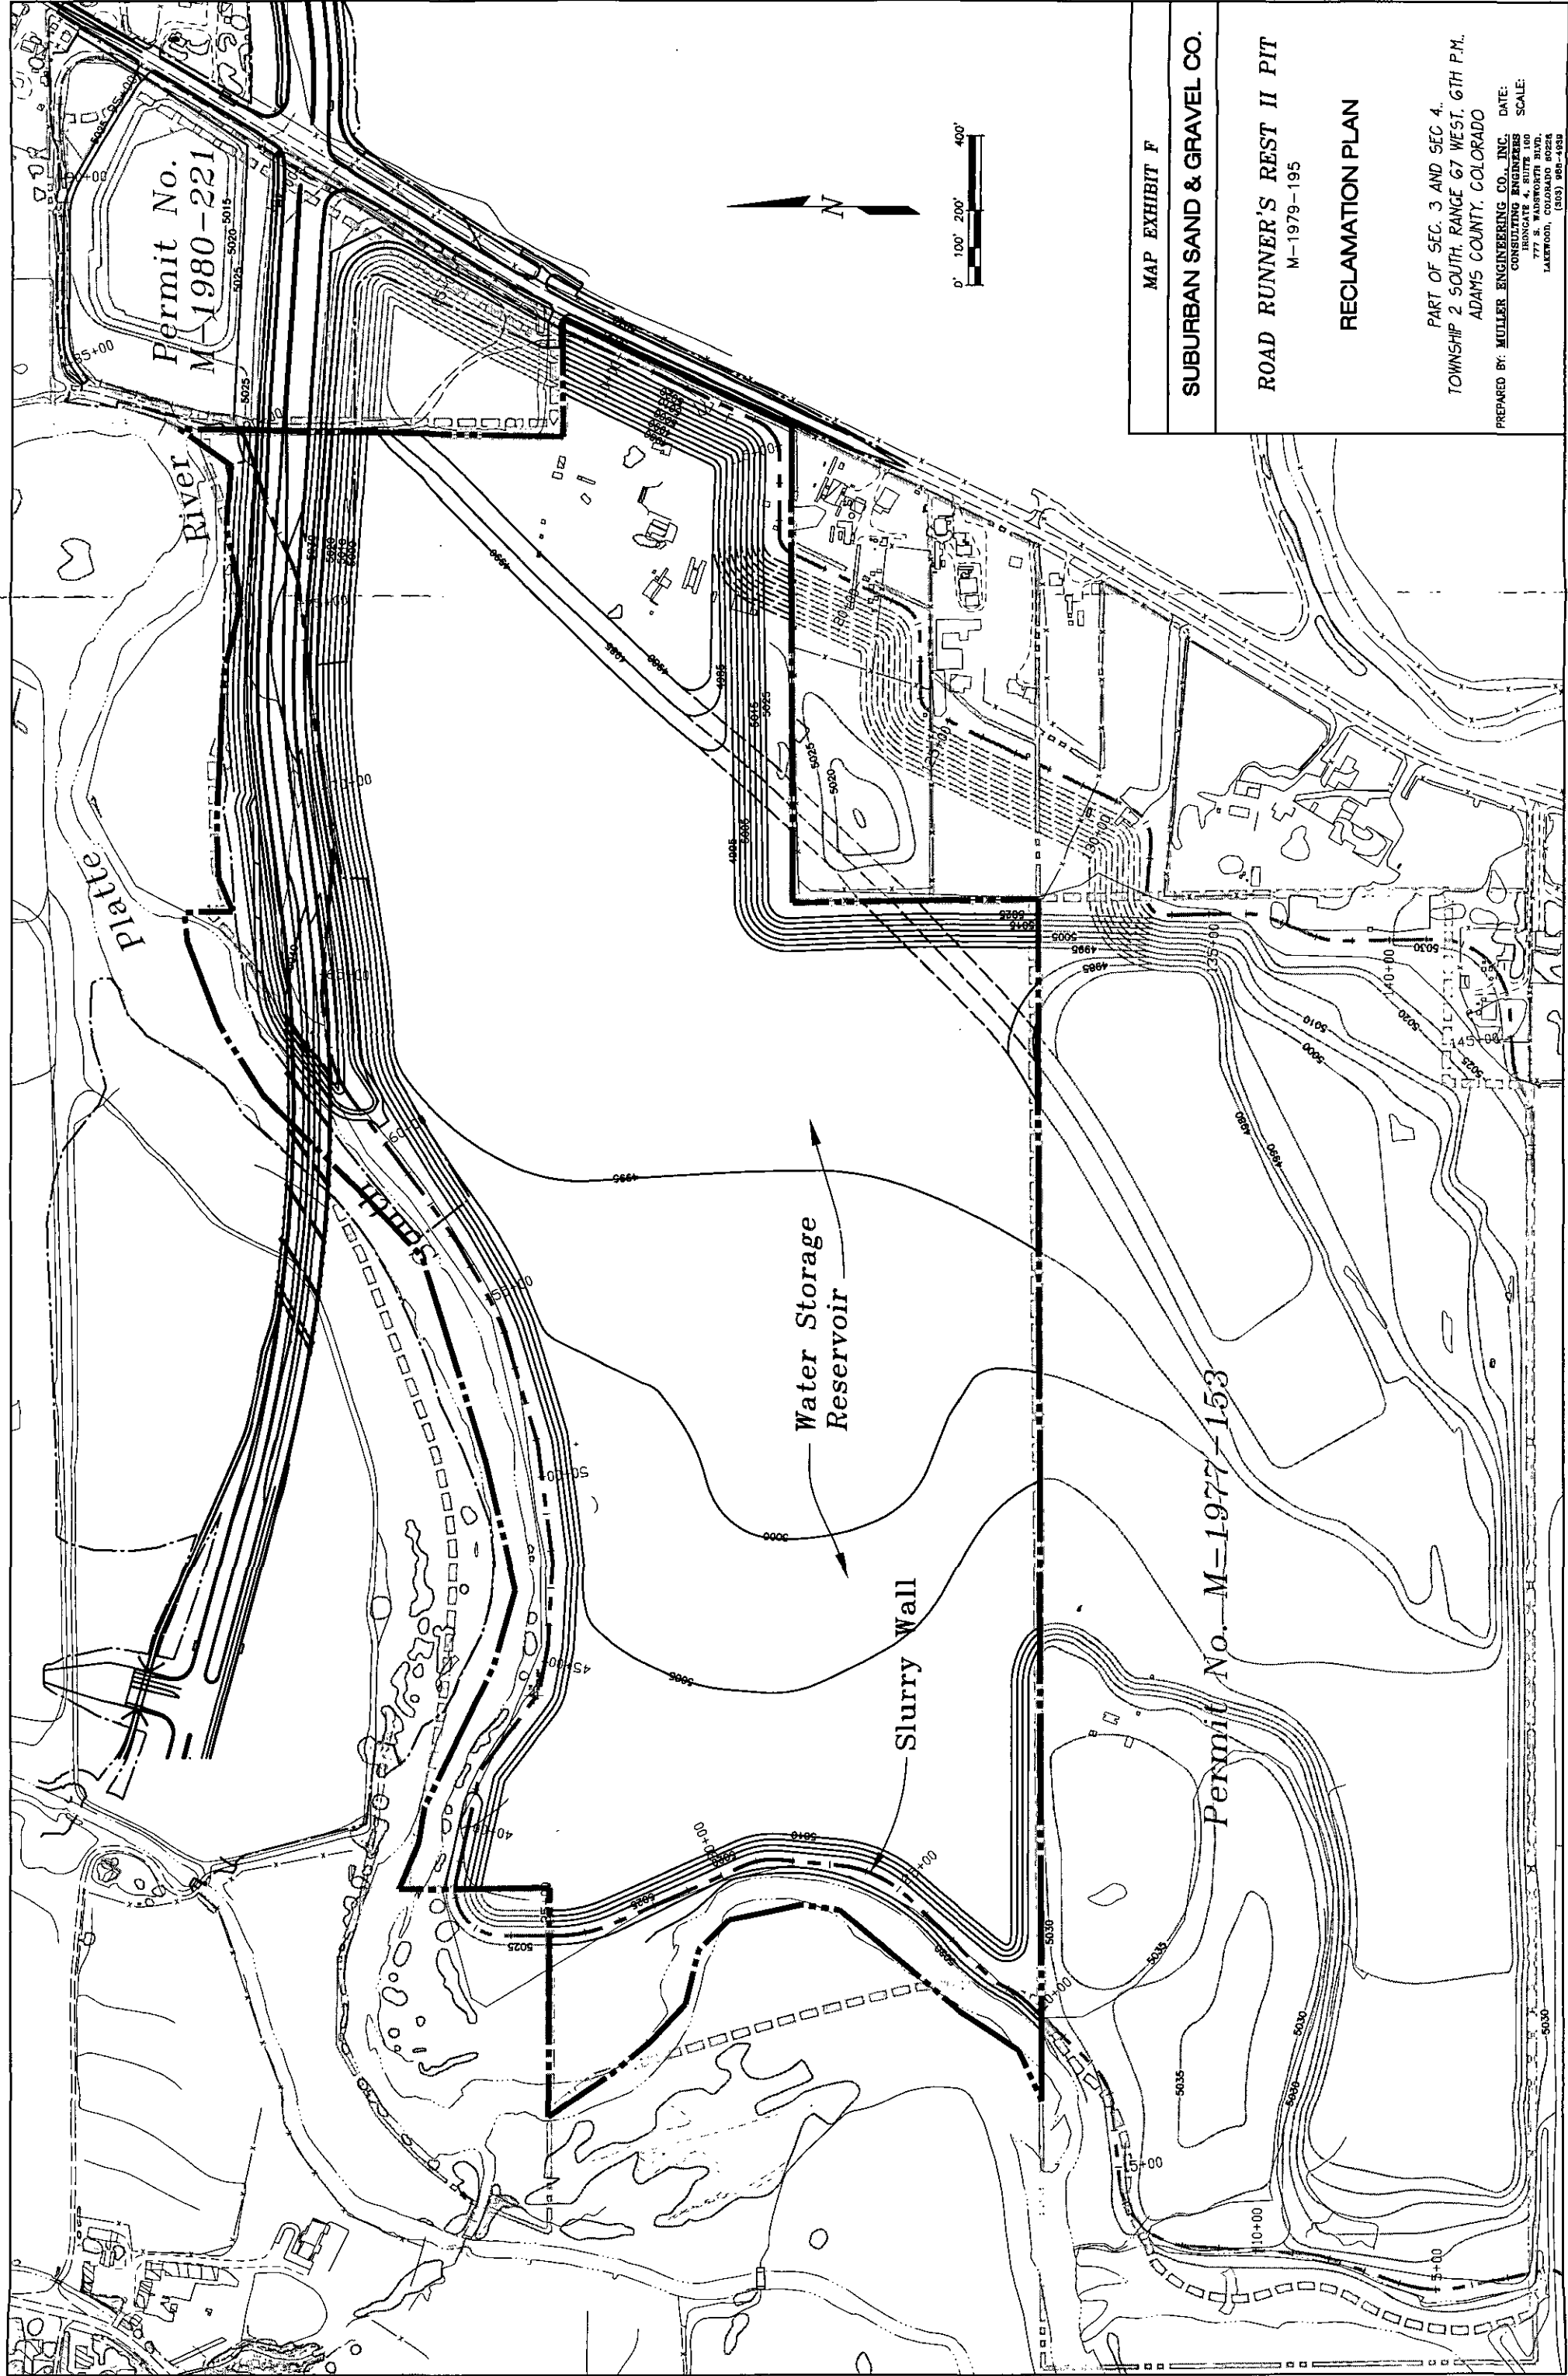
MAP EXHIBIT F	
SUBURBAN SAND & GRAVEL CO.	
ROAD RUNNER'S REST II PIT	
M-1979-195	
RECLAMATION PLAN	
PART OF SEC. 3 AND SEC. 4, TOWNSHIP 2 SOUTH, RANGE 67 WEST, 6TH P.M., ADAMS COUNTY, COLORADO	
PREPARED BY: MULLER ENGINEERING CO., INC.	DATE:
CONSULTING ENGINEERS	SCALE:
777 N. WADSWORTH BLVD.	
LAKESIDE, CO. 80026	(303) 968-4459
