M-1998-080

RESPONSE TO DRMS BOND
ESTIMATE

SUBJECT: M1998-080 H&H Quarry #2

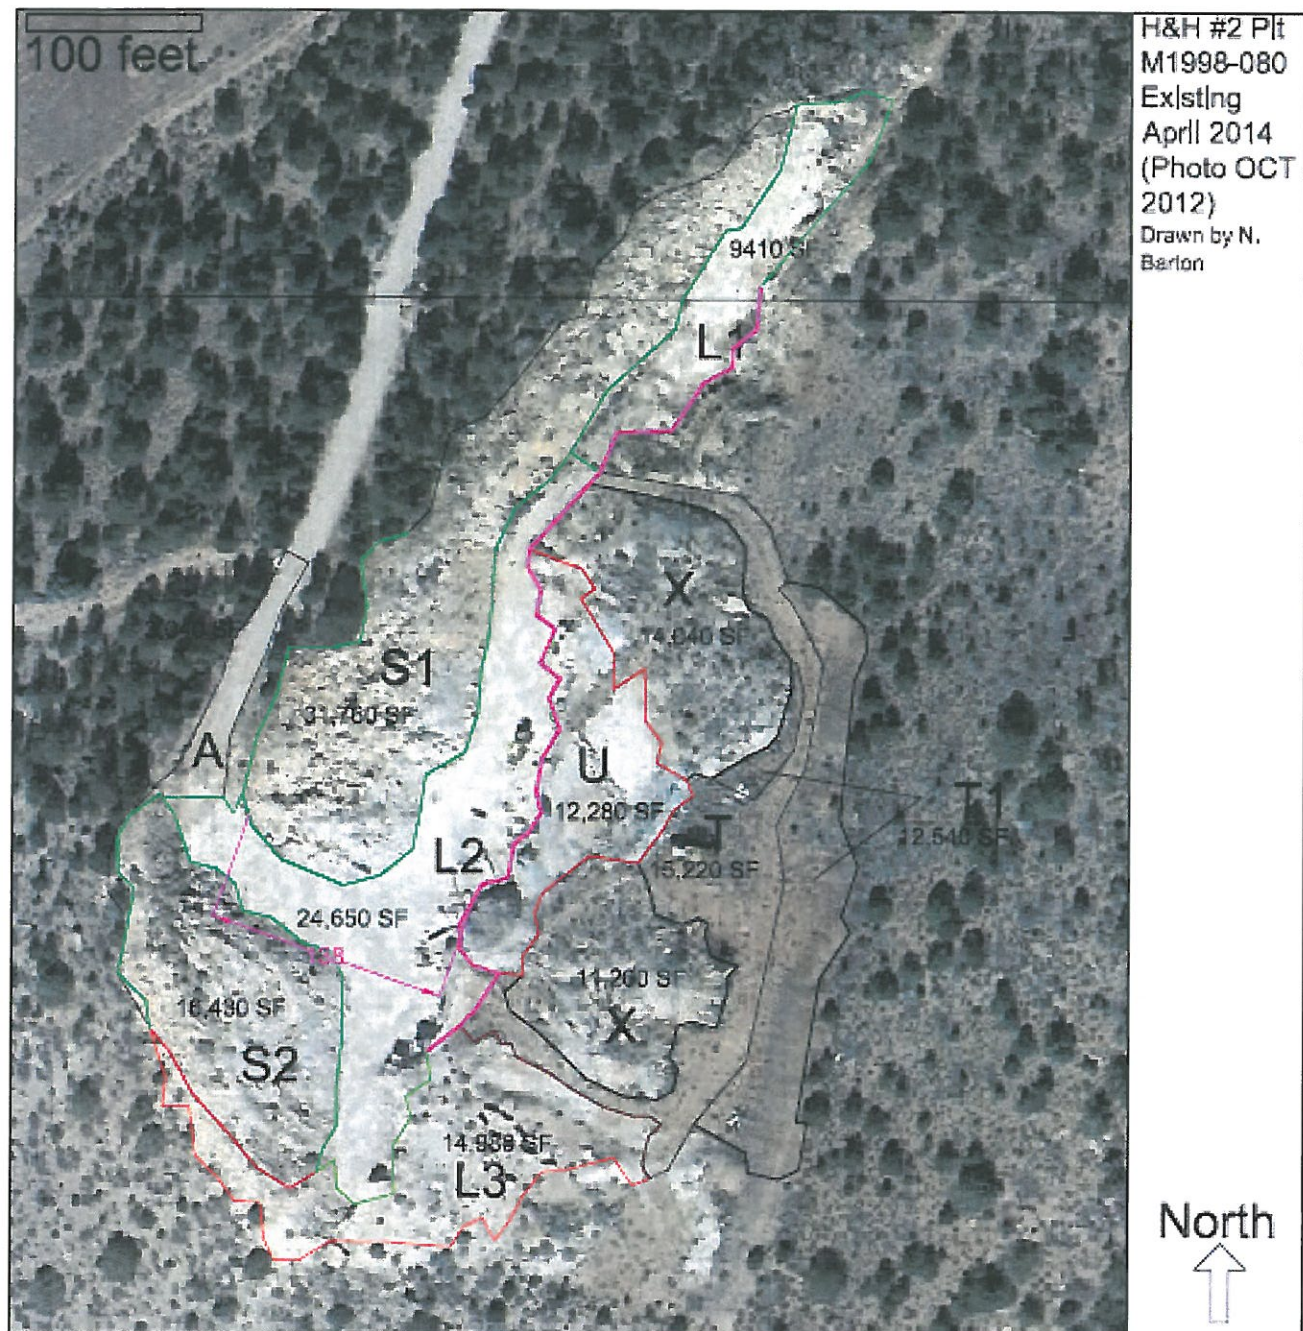
The site is divided into three areas: the lower level on which material is stockpiled and processed, a bench face/work area, and the upper level on which some equipment is parked and soil stockpiles and traffic areas are maintained.

Map 1. From aerial photo OCT 2012, showing affected areas (labeled, see Table 1) as of April 2014.

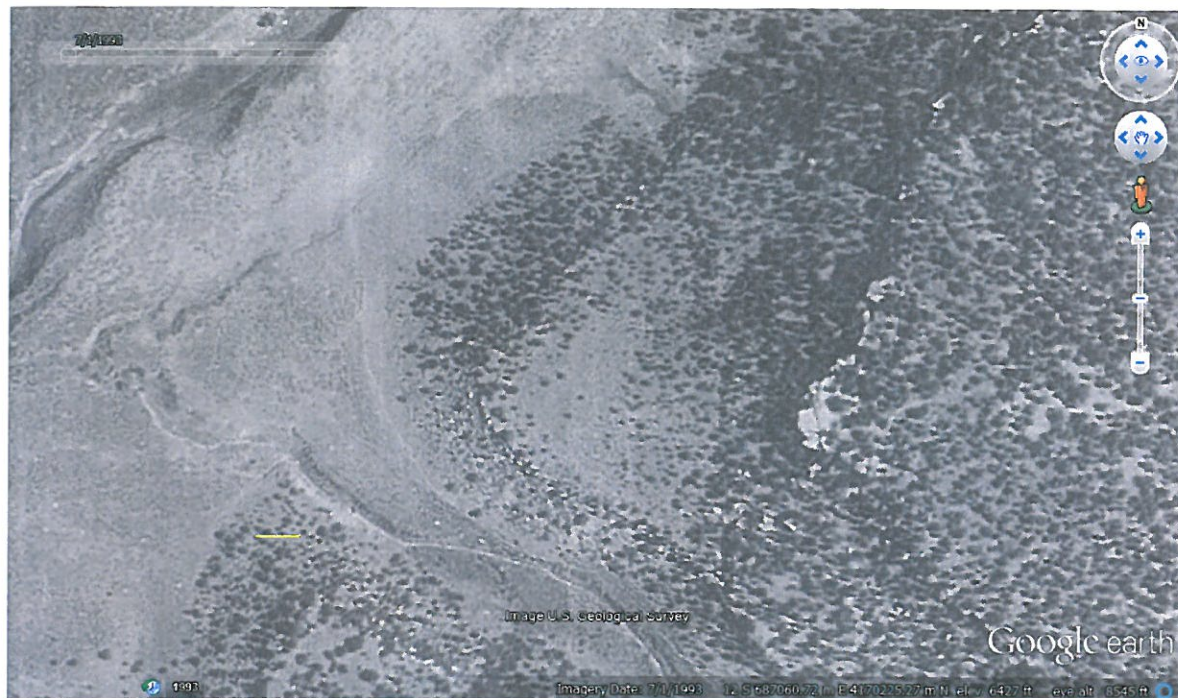
As can be seen in 1993 satellite/aerial photography, much of the site was already in rock outcrop, and soil existing on the site was very limited. Although the soil descriptions for the typical Romberg-CrossCan-Rock Outcrop indicate that 20% of the surface is rock outcrop and 35% is the deep Romberg, pre-mining photos indicate that this particular area has at least 35% rock outcrop, and significantly less Romberg (perhaps as little as 15%). In addition, the entire 60-inch profile of the Romberg is "very stony," and the CrossCan soil (only 18 inches to bedrock) is "very bouldery" to "very gravelly." (That is the soil that was salvaged and is located in stockpiles on the upper level.)

Map 3. July 1993 (pre-mining) Scale shown by yellow line in lower left (100-feet).

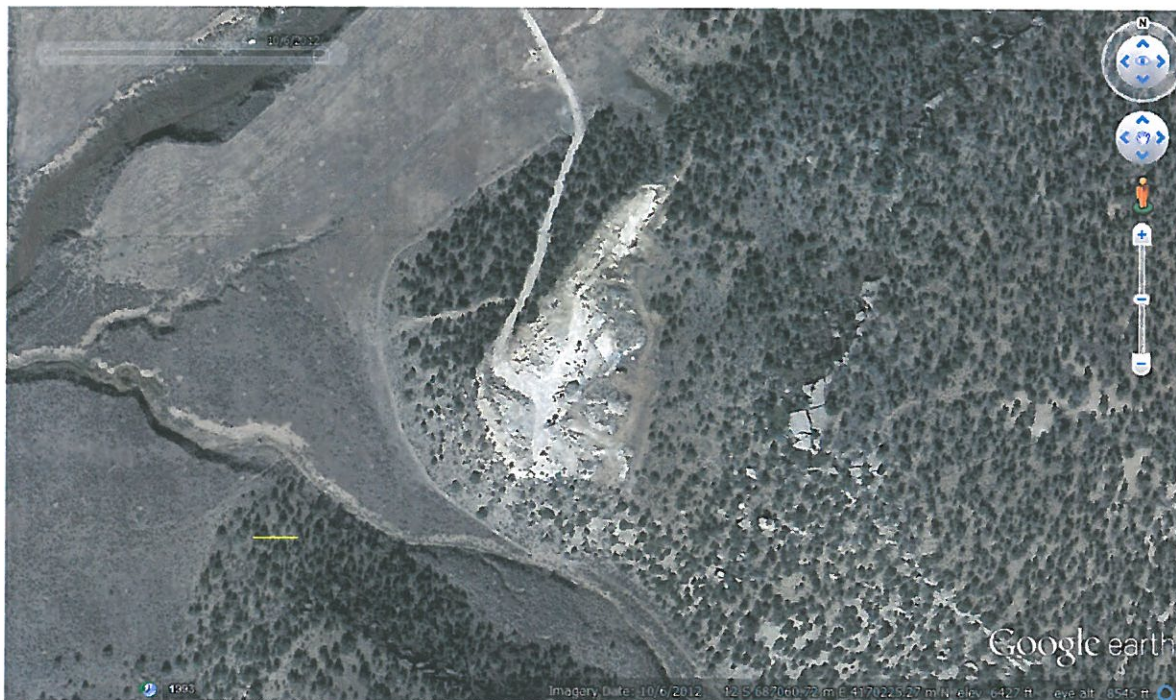
Map 4. October 2012 (no significant change since) Scale shown by yellow line in lower left (100-feet).
