COLORADO DIVISION OF RECLAMATION, MINING AND SAFETY MINERALS PROGRAM INSPECTION REPORT

MINE NAME:	MINE/PROSPECTING ID#:	MINERAL:	COUNTY:
San Luis Project	M-1988-112	Au, Ag	Costilla
INSPECTION TYPE:	INSPECTOR(S):	INSP. DATE:	INSP. TIME:
Multi Person Inspection	Wallace H. Erickson, G. Russell Means	July 24, 2014	13:00
OPERATOR:	OPERATOR REPRESENTATIVE:	TYPE OF OPERATION:	
Battle Mountain Resources, Inc.	Julio Madrid, Steve Carino	112d-3 - Designated Mining Operation	
REASON FOR INSPECTION:	BOND CALCULATION TYPE:	BOND AMOUNT:	
Normal I&E Program	Partial Bond	\$7,400,000.00	
DATE OF COMPLAINT:	POST INSP. CONTACTS:	JOINT INSP. AGEN	CY:
NA	None	None	
WEATHER:	INSPECTOR'S SIGNATURE:	SIGNATURE DATE:	
Cloudy	Wallace H. Sil	October 17, 2014

PERMIT #: M-1988-112 INSPECTOR'S INITIALS: WHE INSPECTION DATE: July 24, 2014

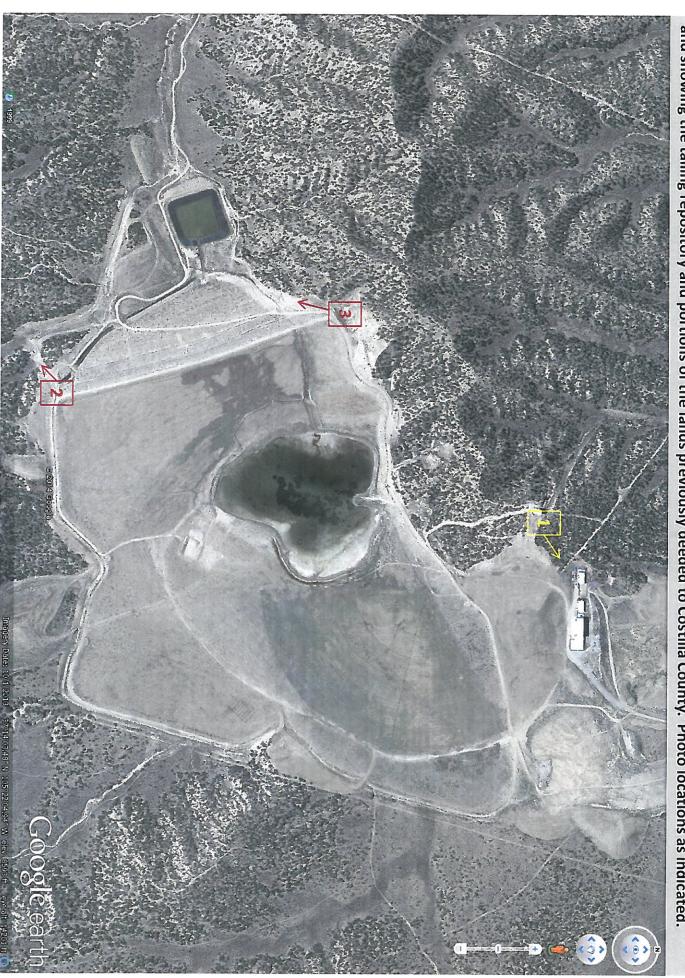
and showing the tailing repository and portions of the lands previously deeded to Costilla County. Photo locations as indicated. San Luis Project, M-1988-112, Google Earth image date October 1, 2013, view from approximately 5,600 feet above ground surface
