COLORADO DIVISION OF RECLAMATION, MINING AND SAFETY
MINERALS PROGRAM INSPECTION REPORT
PHONE: (303) 866-3567

MINE NAME: Luke the Duke Gravel Pit	MINE/PROSPECTING ID#: M-2013-036	MINERAL: Gravel	COUNTY: La Plata
INSPECTION TYPE: Monitoring	INSPECTOR(S): Wallace H. Erickson	INSP. DATE: October 9, 2014	INSP. TIME: 14:00
OPERATOR: LUKE THE DUKE, LLC	OPERATOR REPRESENTATIVE: John Avery	TYPE OF OPERATION: 110c - Construction Limited Impact	
REASON FOR INSPECTION: Normal I&E Program	BOND CALCULATION TYPE: Partial Bond	BOND AMOUNT: \$14,631.48	
DATE OF COMPLAINT: NA	POST INSP. CONTACTS: None	JOINT INSP. AGENCY: None	
WEATHER: Raining	INSPECTOR'S SIGNATURE:

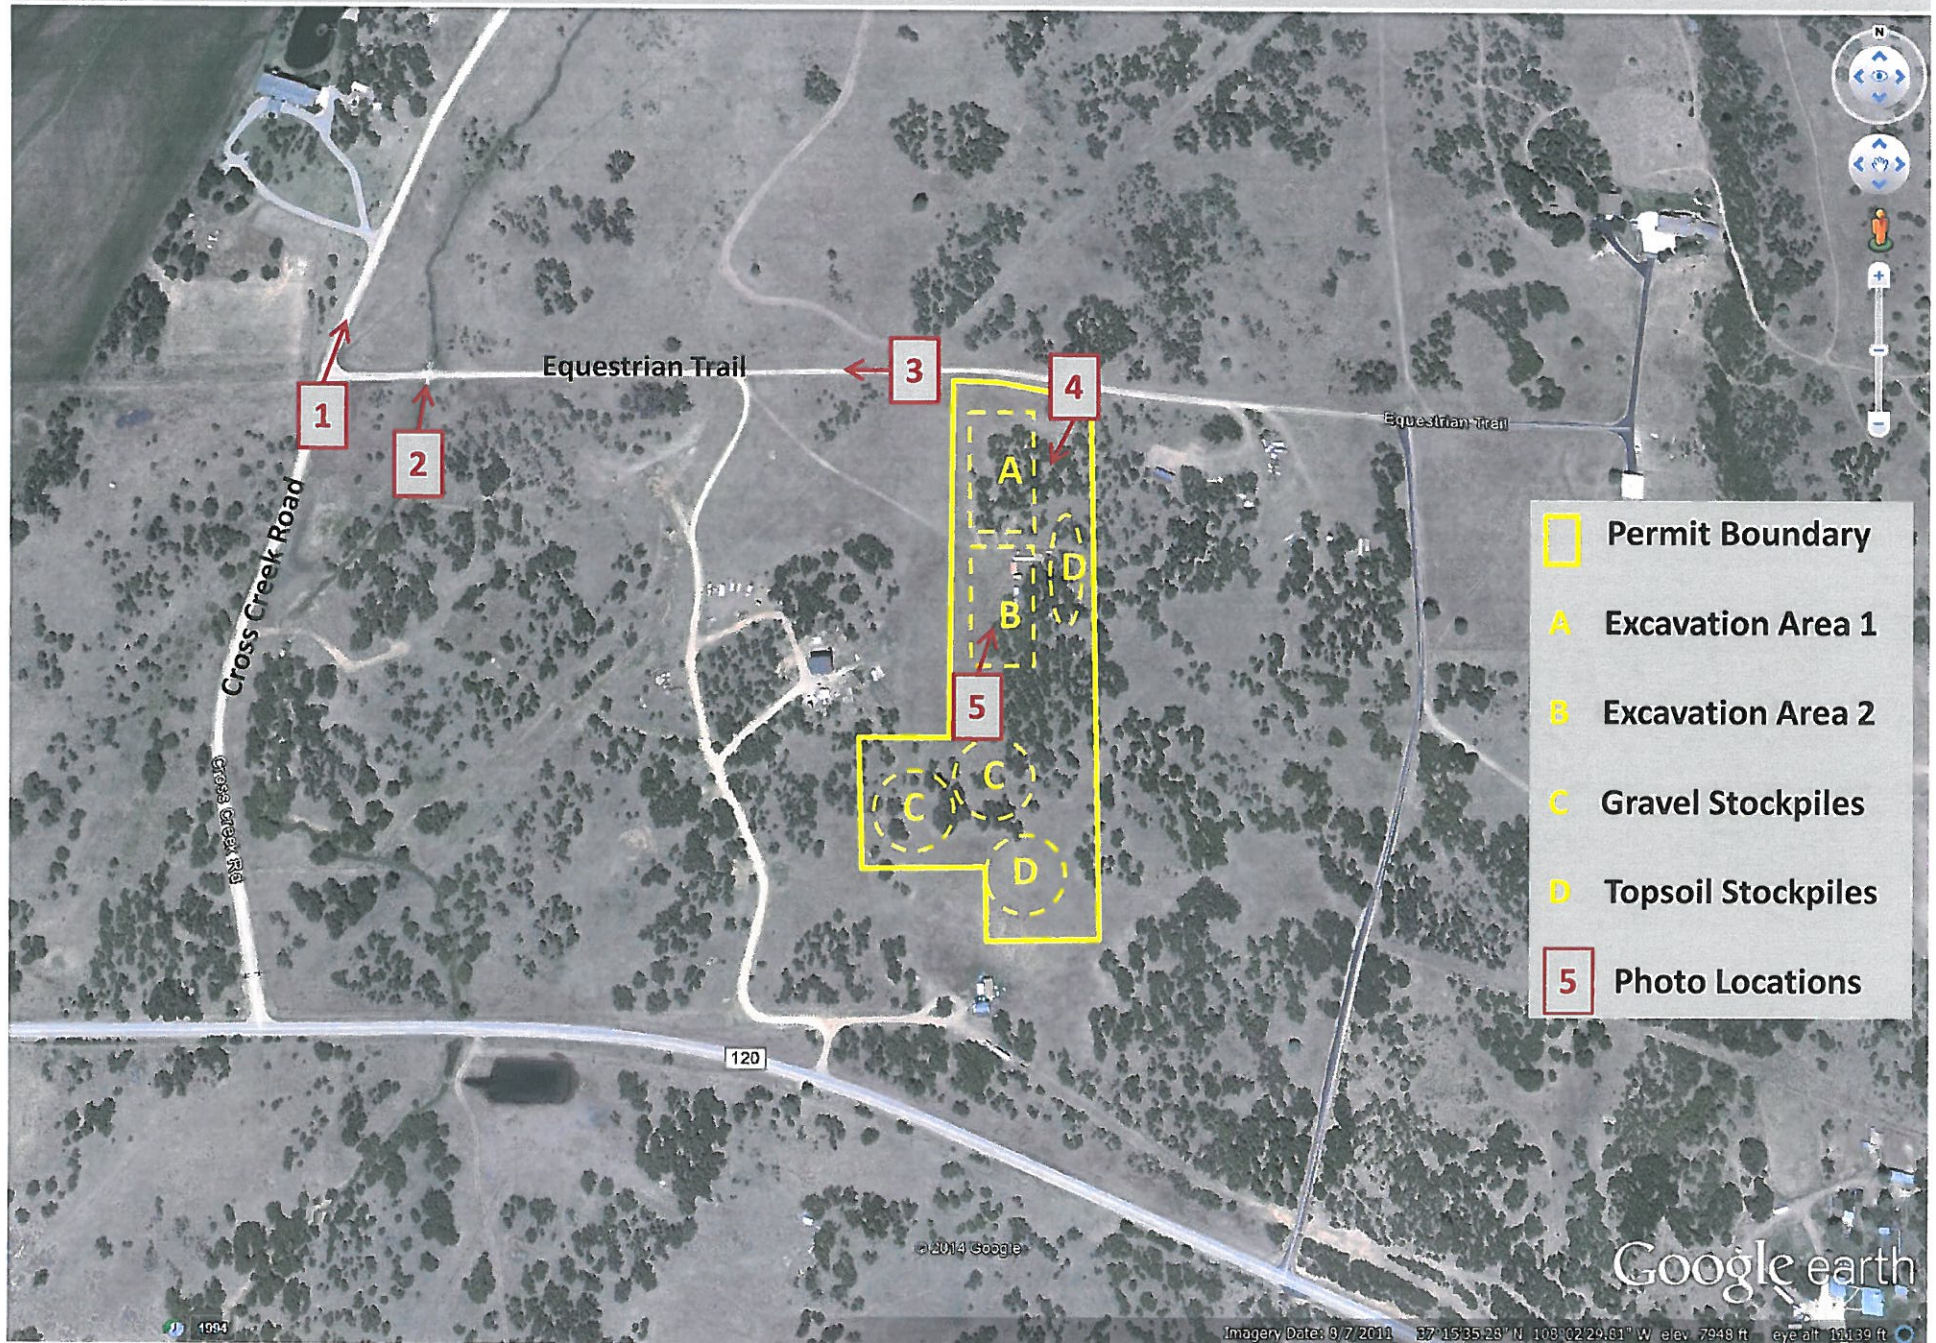
Google Earth, imagery date August 7, 2011, showing the approximate location of the 7.66 acre permit boundary, major features of the affected lands, and the locations of photographs taken during the October 9, 2014 inspection of Luke the Duke, Permit No. M-2013-036.
