# Appendix Q

# **Closure Drain Installation Summary**

Project No.: 74201125N

# Subject: Squaw Gulch VLF Closure Drain Installation Summary Revised with Detailed Logging Data and Horizontal Component Installation Details (REV 2)

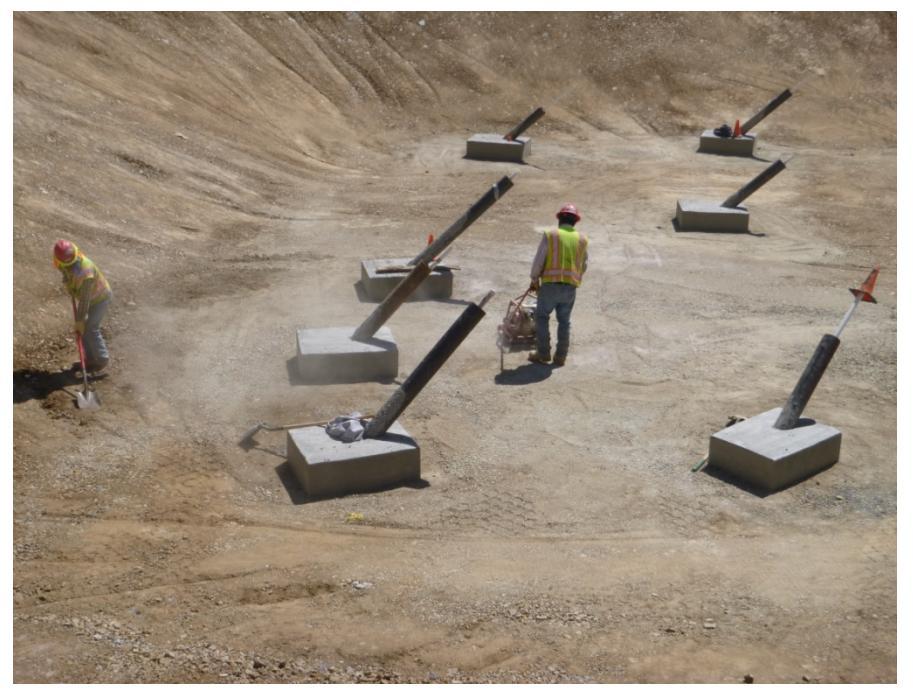
Photo 1 Closure Drain Pads

Completion for the closure drains began on June 3, 2014. Concrete pads with rebar were poured around each collar per the design. A summary of test results is included in Appendix Q.1 with the individual concrete cylinder test reports presented in this Appendix Q.2.

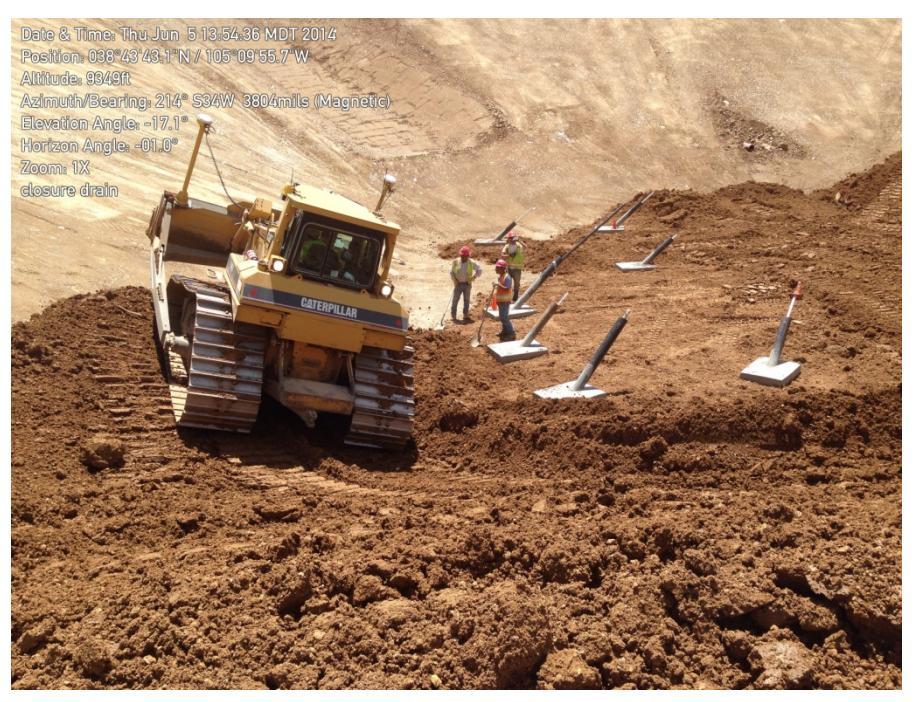
Photo 2 Soil Liner Fill Material Placement around Closure Drains

Soil Liner Fill material was placed in the PSSA floor around the closure drains, nuclear density tests N37 through N40 presented on Table 11 of under the Tables tab portion of the Record of Construction Report. The material was compacted with a plate tamper and a smooth drum roller. The steel casing was cut flush with the concrete pads.

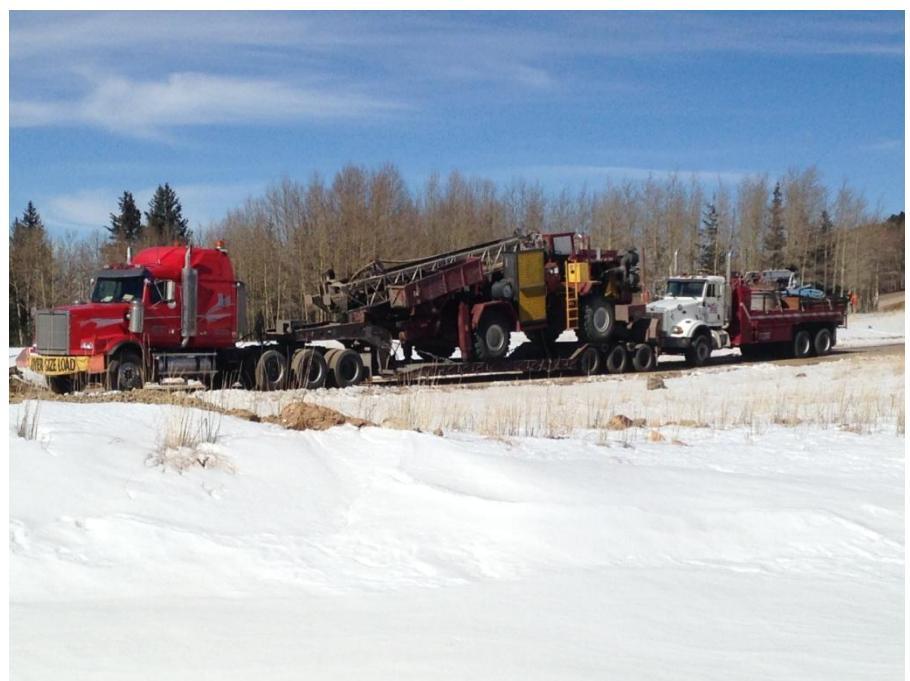
AK's RC rig and pipe truck at mine entrance.

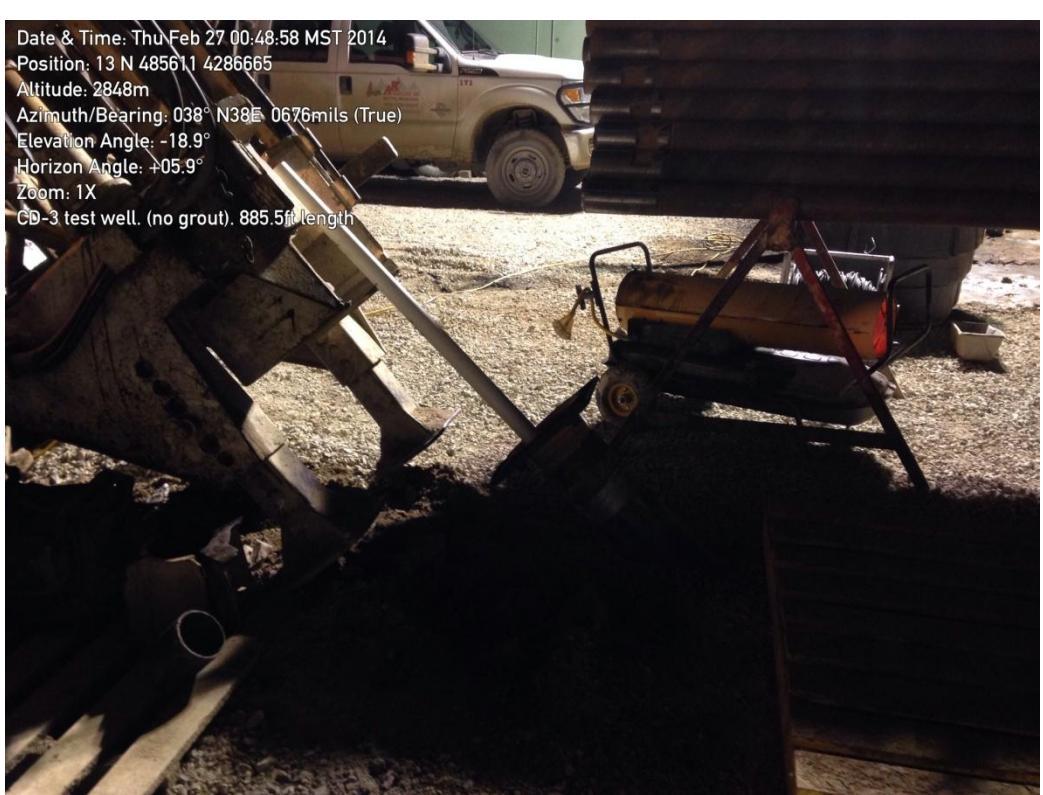
Photo 5. Drain is installed to 885.5 ft depth

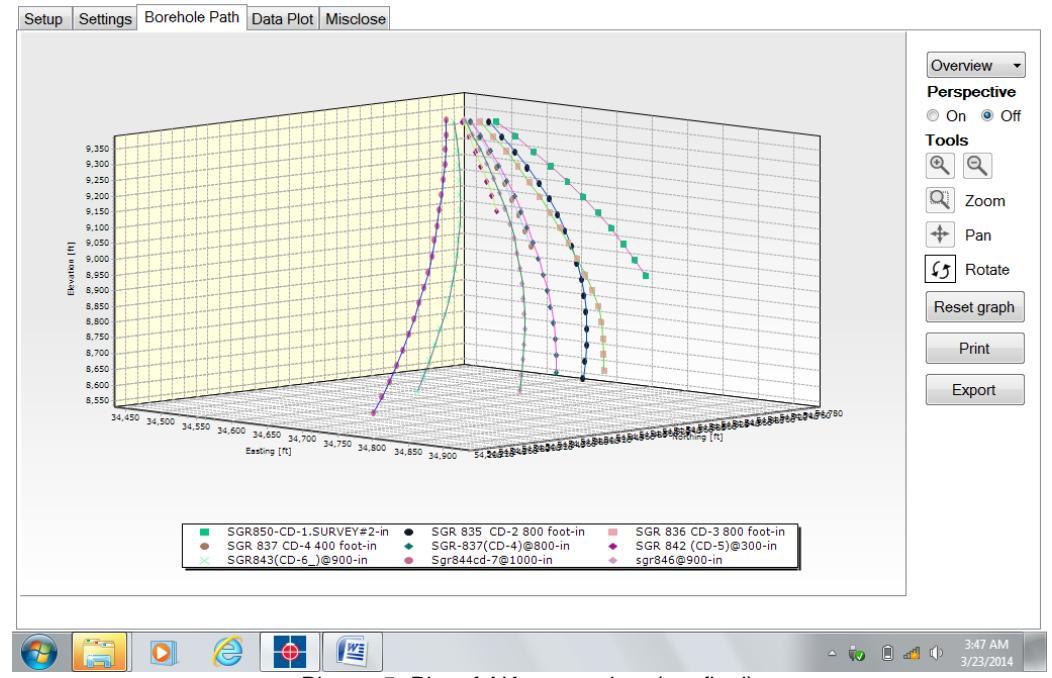
Picture 5- Plot of AK survey data (not final)

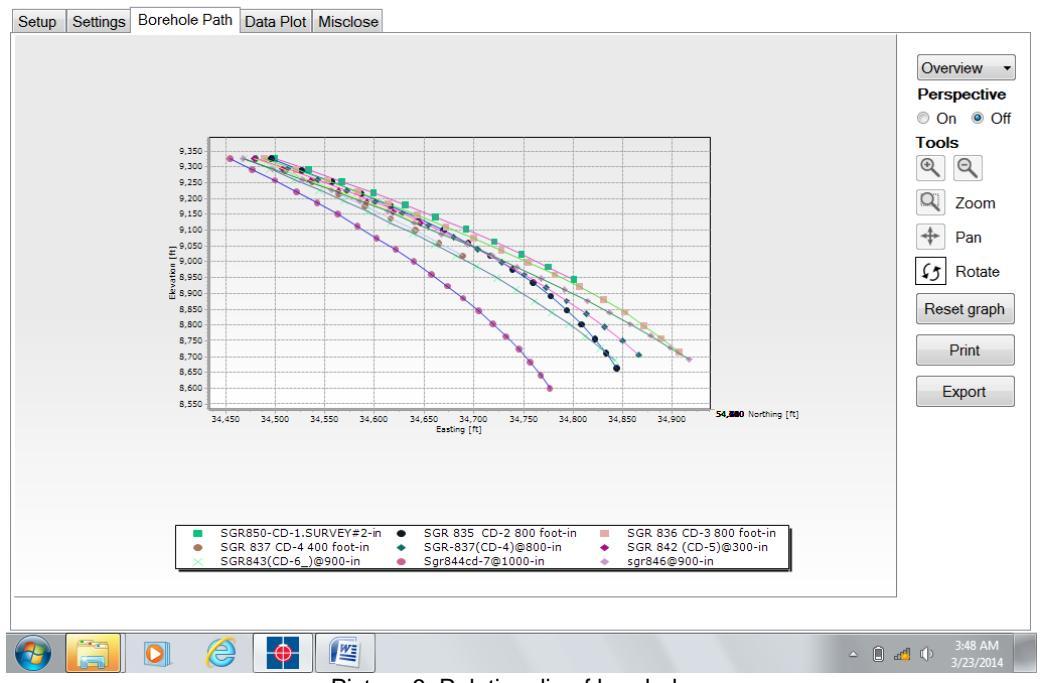
Picture 6: Relative dip of boreholes.

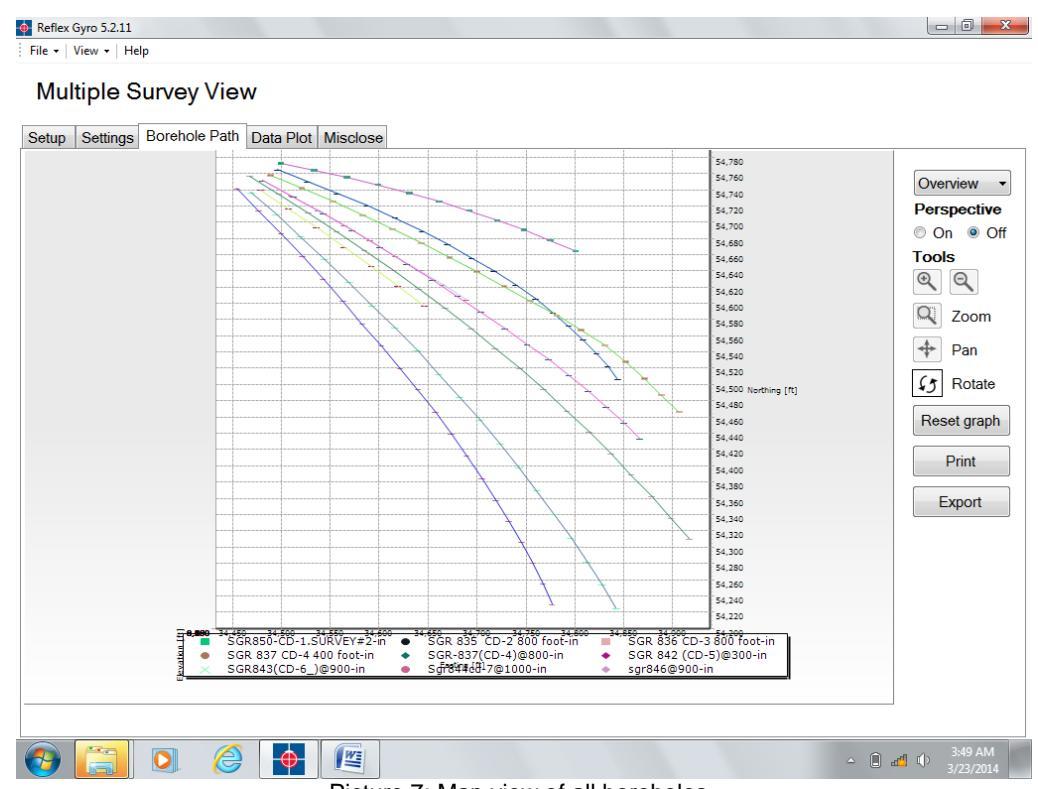
Picture 7: Map view of all boreholes.
