COLORADO DIVISION OF RECLAMATION, MINING AND SAFETY
MINERALS PROGRAM INSPECTION REPORT
PHONE: (303) 866-3567

MINE NAME: Neal Pit	MINE/PROSPECTING ID#: M-1983-148	MINERAL: Sand and gravel	COUNTY: Montrose
INSPECTION TYPE: Preoperation Inspection	INSPECTOR(S): Wallace H. Erickson	INSP. DATE: April 15, 2015	INSP. TIME: 15:30
OPERATOR: Montrose County	OPERATOR REPRESENTATIVE: Norm David, Dean Cooper	TYPE OF OPERATION: 112c - Construction Regular Operation	
REASON FOR INSPECTION: Preoperation Inspection	BOND CALCULATION TYPE: None	BOND AMOUNT: \$0.00	
DATE OF COMPLAINT: NA	POST INSP. CONTACTS: None	JOINT INSP. AGENCY: None	
WEATHER: Cloudy	INSPECTOR'S SIGNATURE:

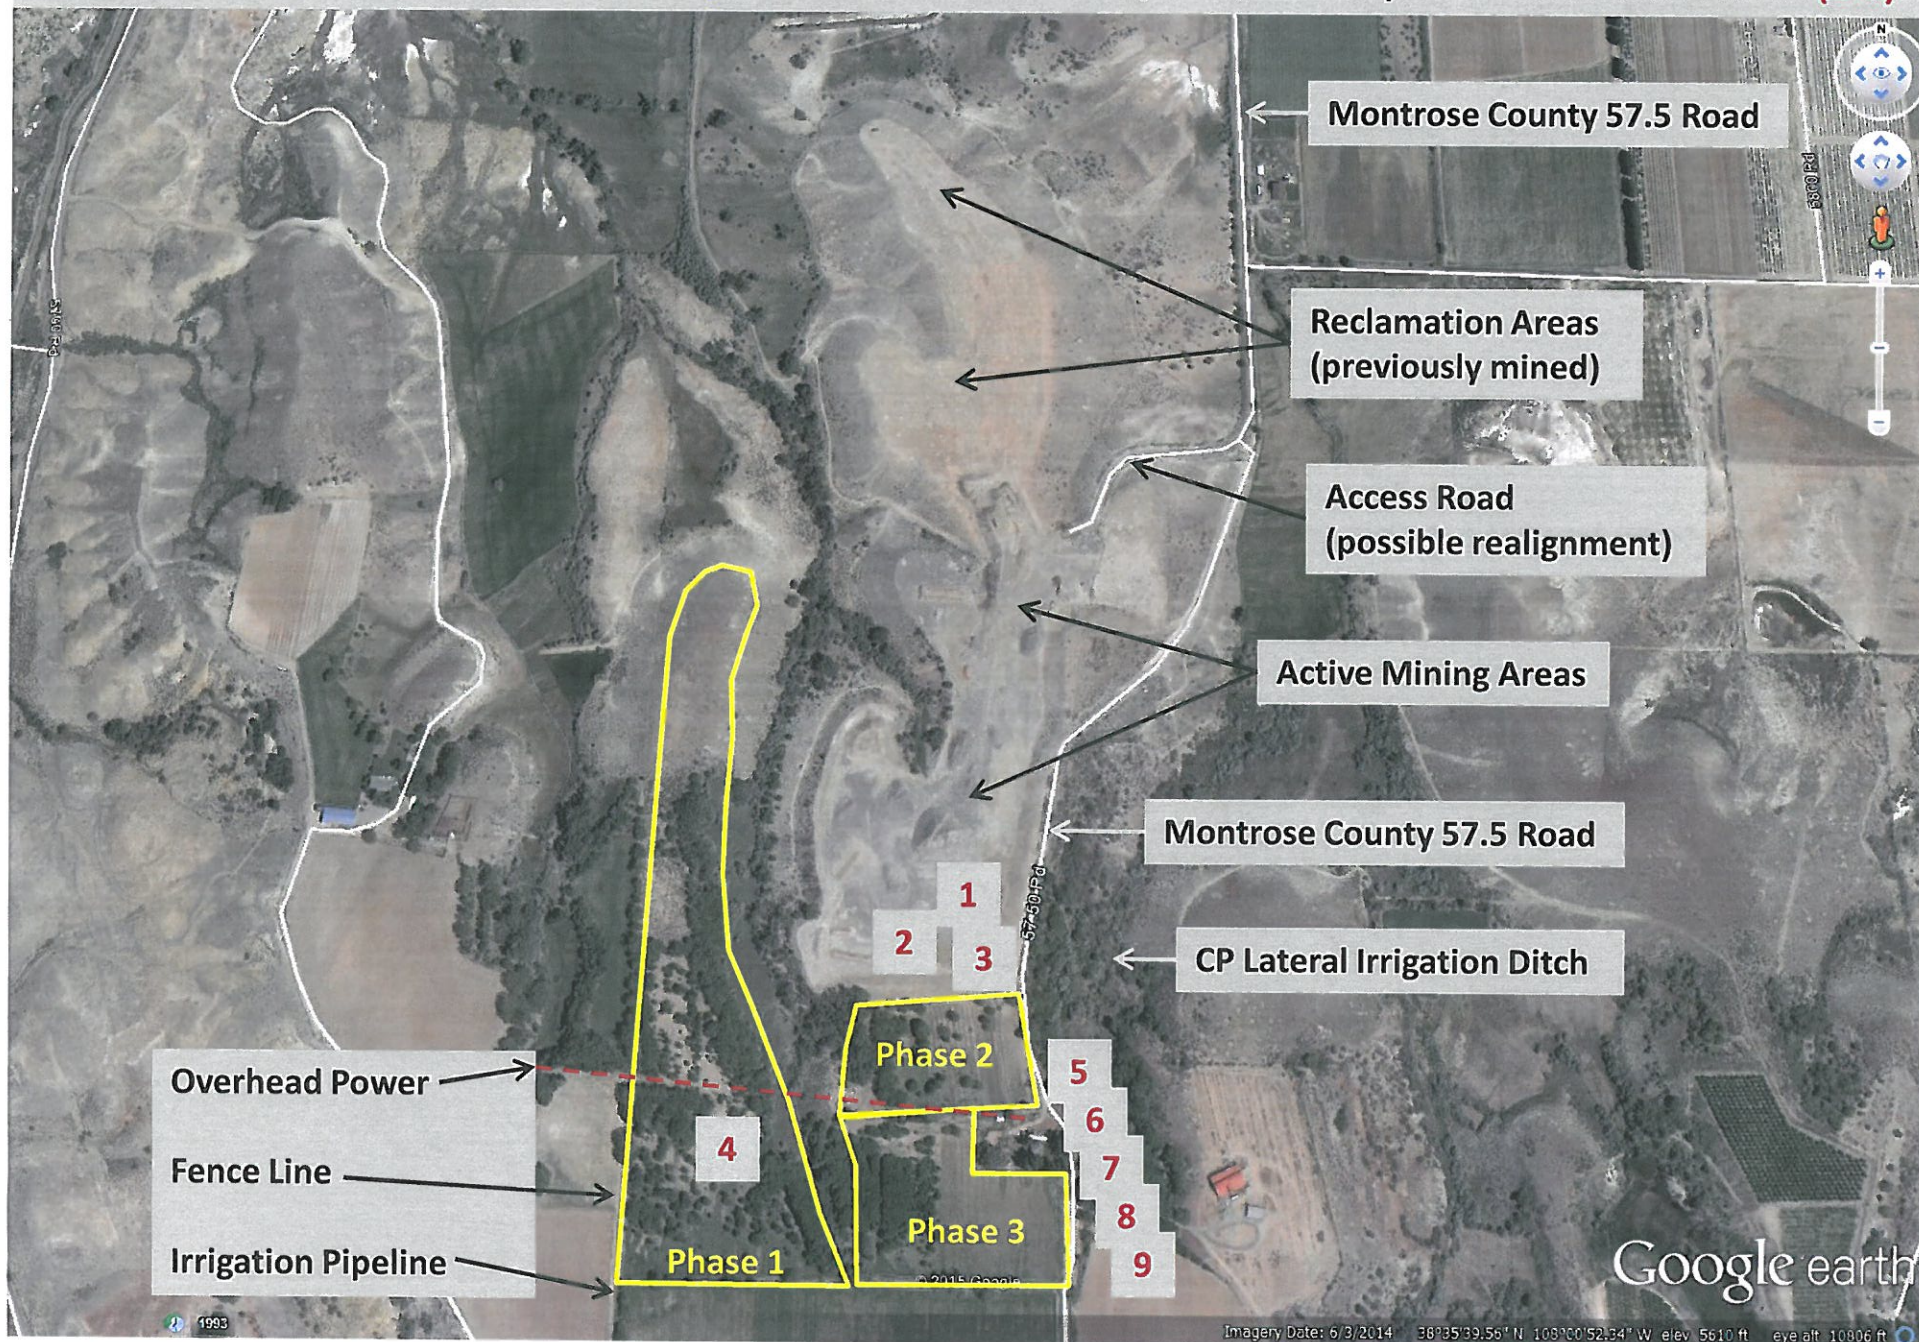
Google Earth image, dated June 3, 2014, showing various features of the Neal Pit, M-1983-148. Lands addressed through AM-01 are indicated in yellow (Phase 1, 2, 3). Photo locations for the April 15, 2015 inspection are indicated in red (1–9).
