**COLORADO DIVISION OF RECLAMATION, MINING AND SAFETY**  
**MINERALS PROGRAM INSPECTION REPORT**  
**PHONE: (303) 866-3567**

<b>MINE NAME:</b> Jemadojin Sand Mine	<b>MINE/PROSPECTING ID#:</b> M-2006-017	<b>MINERAL:</b> Sand	<b>COUNTY:</b> El Paso
<b>INSPECTION TYPE:</b> Surety-Related Inspection	<b>INSPECTOR(S):</b> Timothy A. Cazier	<b>INSP. DATE:</b> June 9, 2015	<b>INSP. TIME:</b> 13:30
<b>OPERATOR:</b> Premier Silica LLC	<b>OPERATOR REPRESENTATIVE:</b> George Munger, Jim Barnes	<b>TYPE OF OPERATION:</b> 112c - Construction Regular Operation

# M-2006-017 Jemadojin Sand Mine

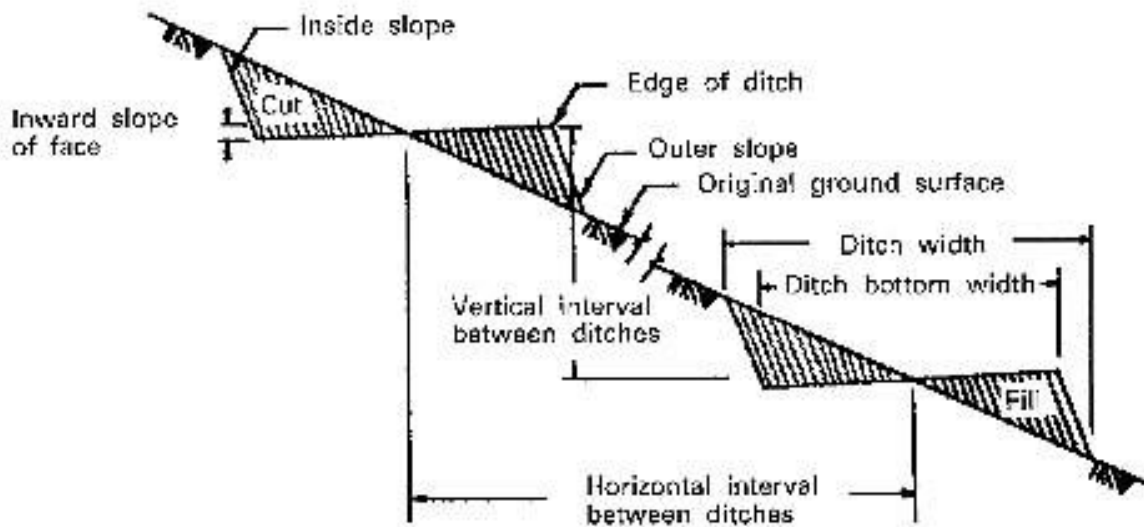
Pit & Permit Area: No additional disturbance was noted from the previous inspection. However, due to recent heavy rains additional erosion has occurred. This was most evident in the diversion cut on the north end of the site. **Photos 2** and **3** illustrate the difference. This inspector recommended contacting the local County Extension Agent for seed mix options and implementing best management practices (BMPs) such as contour furrowing (also called contour bunding – see **diagram** below and **Photo 4** as an example) on the diversion cut and pit slopes. Note: if the seed mix needs to be changed, the Division will require a technical revision (TR) to the permit.

1. Contour furrowing BMPs should be implemented on the diversion cut and pit slopes.
2. The will recommend the MLRB grant the requested five-year TC extension after a written commitment to continue mining the site is recieved from either the Operator or the land owner.
3. Future annual reports should reflect the affected area to be 35 acres until a release request is received and approved by the Division.
