**COLORADO DIVISION OF RECLAMATION, MINING AND SAFETY**  
**MINERALS PROGRAM INSPECTION REPORT**  
**PHONE: (303) 866-3567**

<b>MINE NAME:</b> West Rifle Pit	<b>MINE/PROSPECTING ID#:</b> M-1981-006	<b>MINERAL:</b> Sand and gravel	<b>COUNTY:</b> Garfield
<b>INSPECTION TYPE:</b> Surety Release Inspection	<b>INSPECTOR(S):</b> Amy C. Yeldell	<b>INSP. DATE:</b> June 22, 2015	<b>INSP. TIME:</b> 08:00
<b>OPERATOR:</b> Central Aggregates, Inc.	<b>OPERATOR REPRESENTATIVE:</b> Gilbert Lee	<b>TYPE OF OPERATION:</b> 112c - Construction Regular Operation

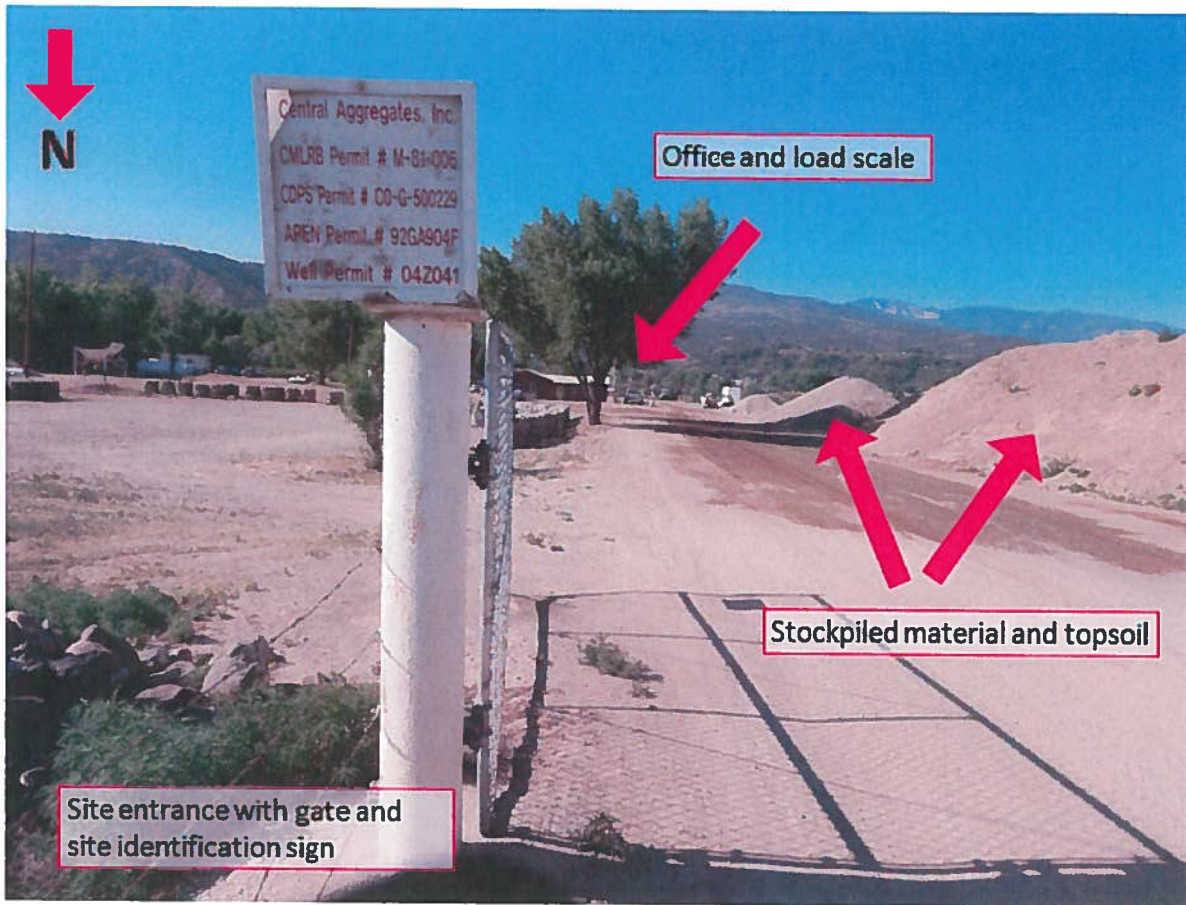
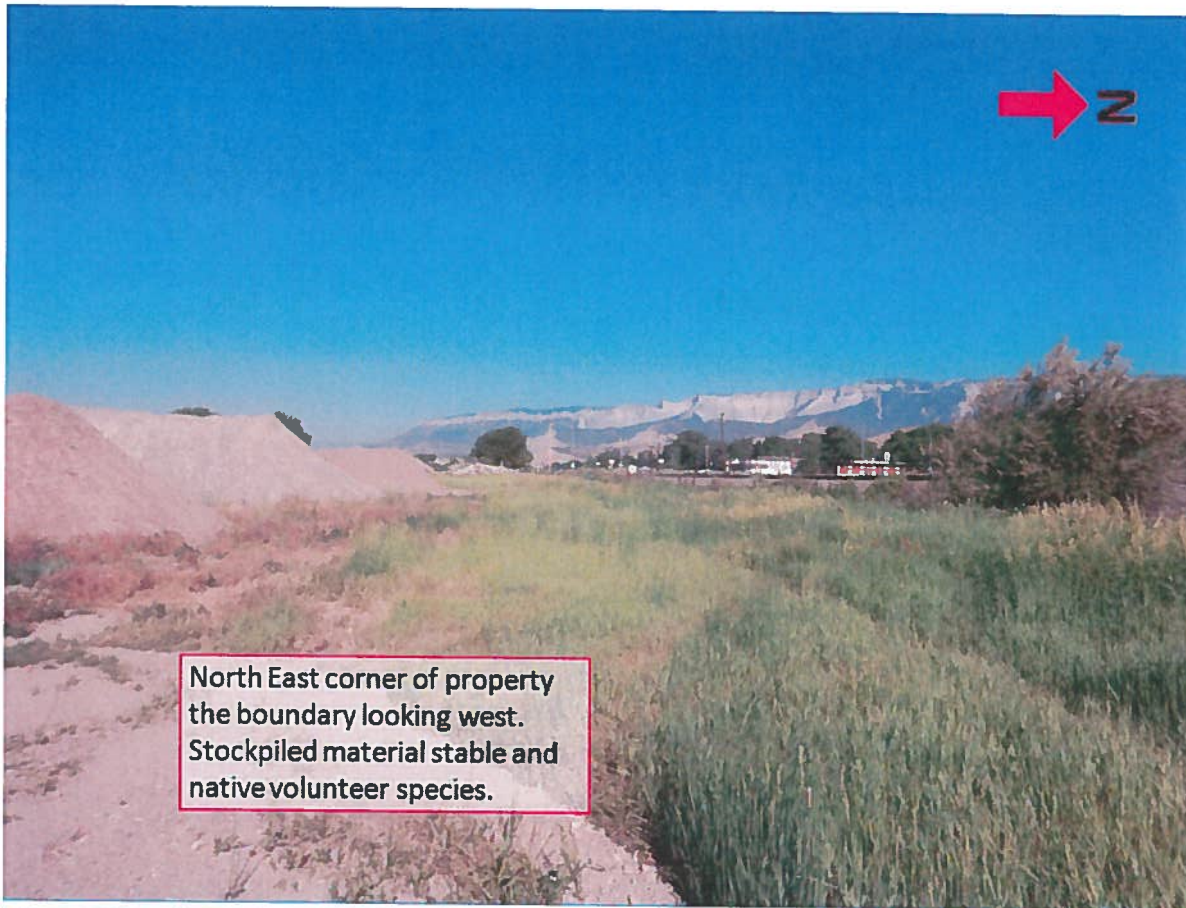
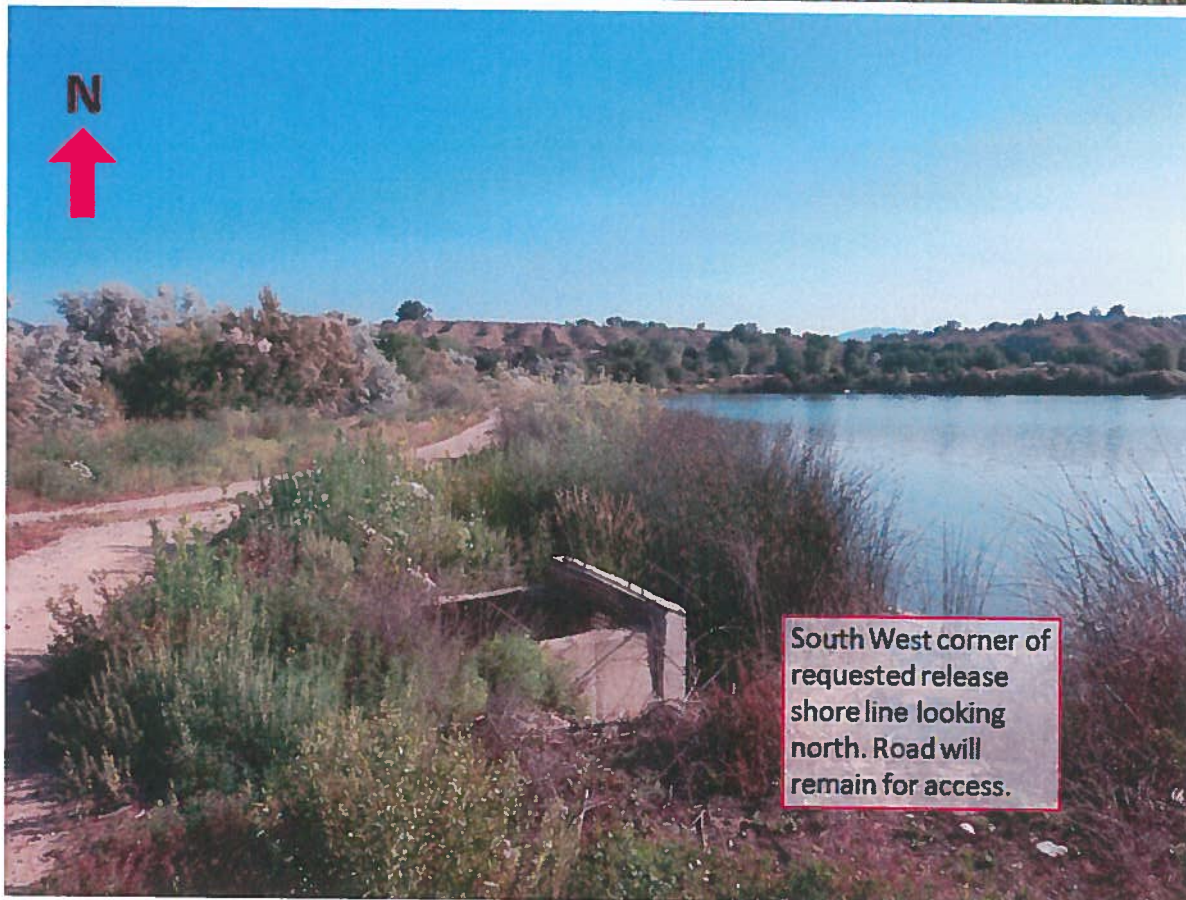
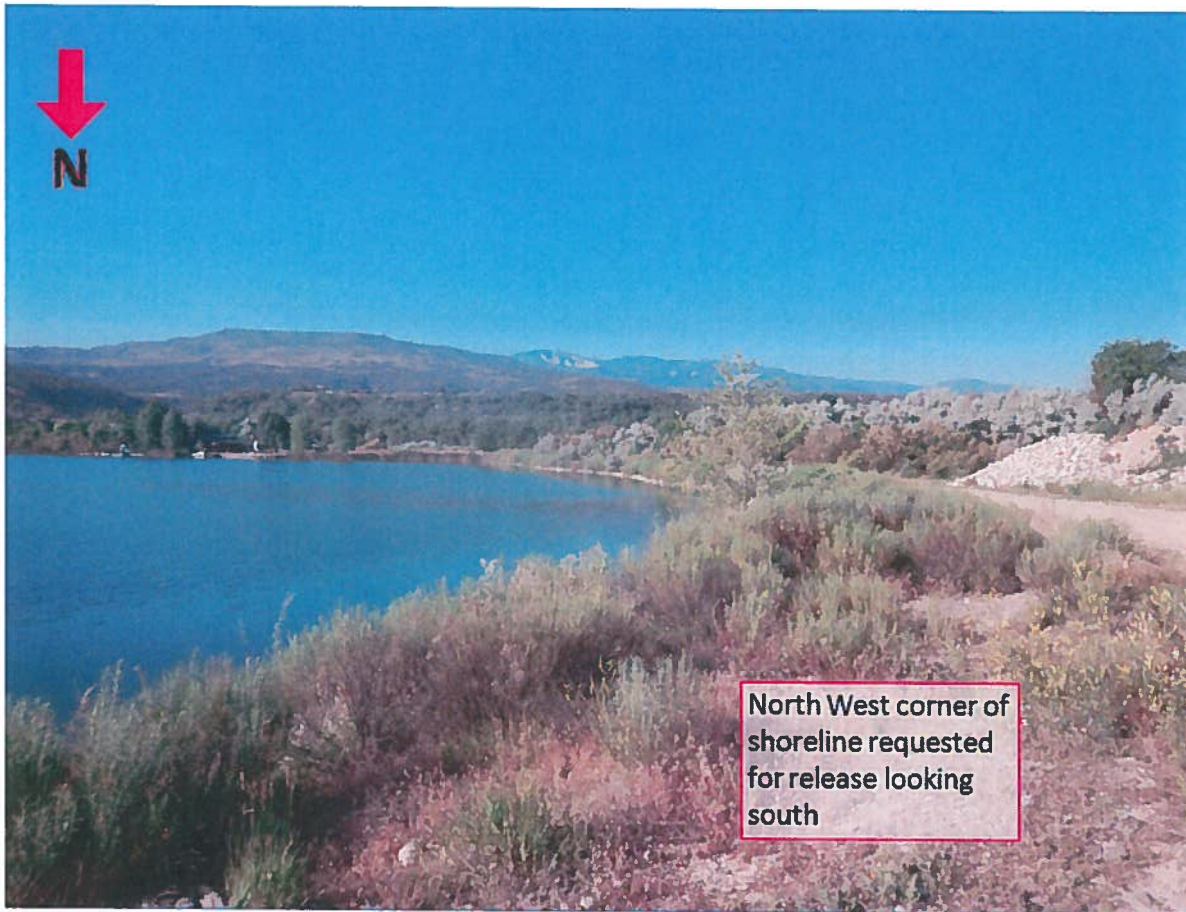
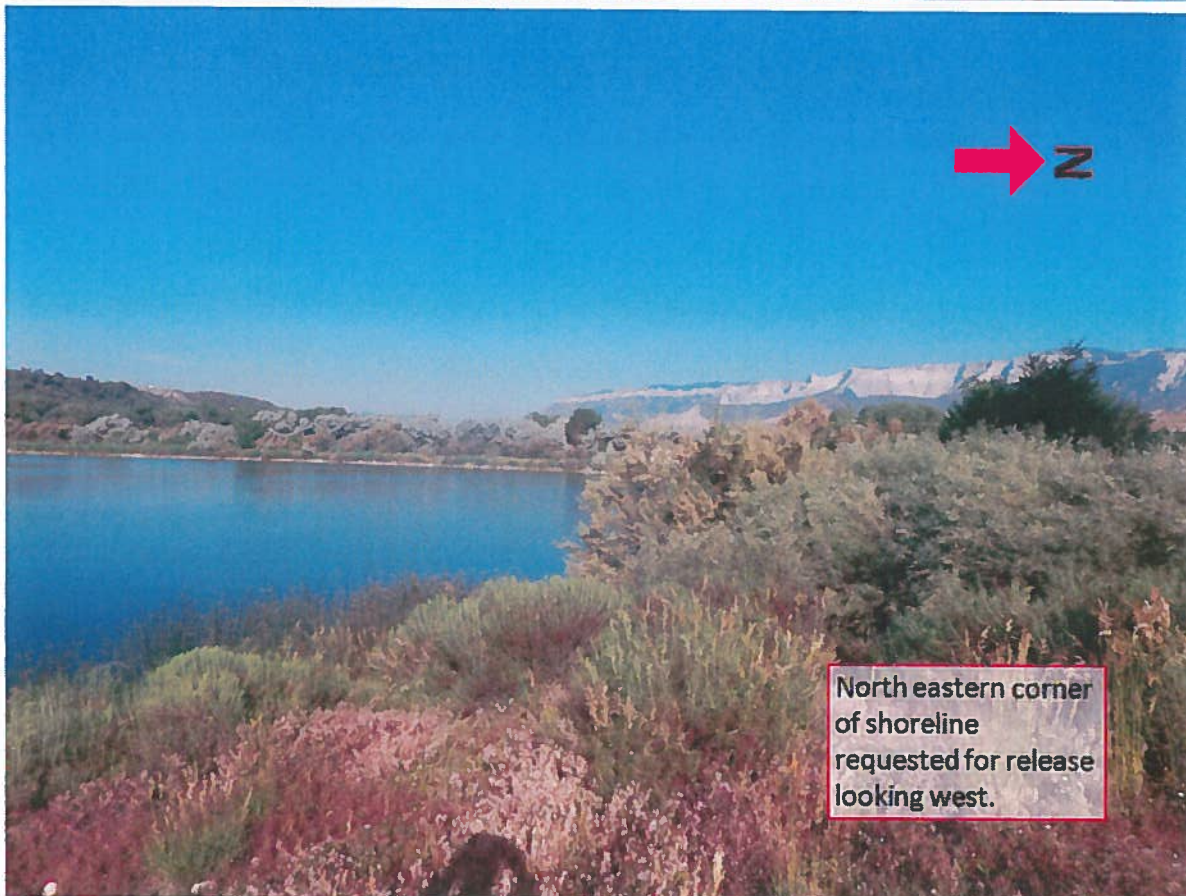
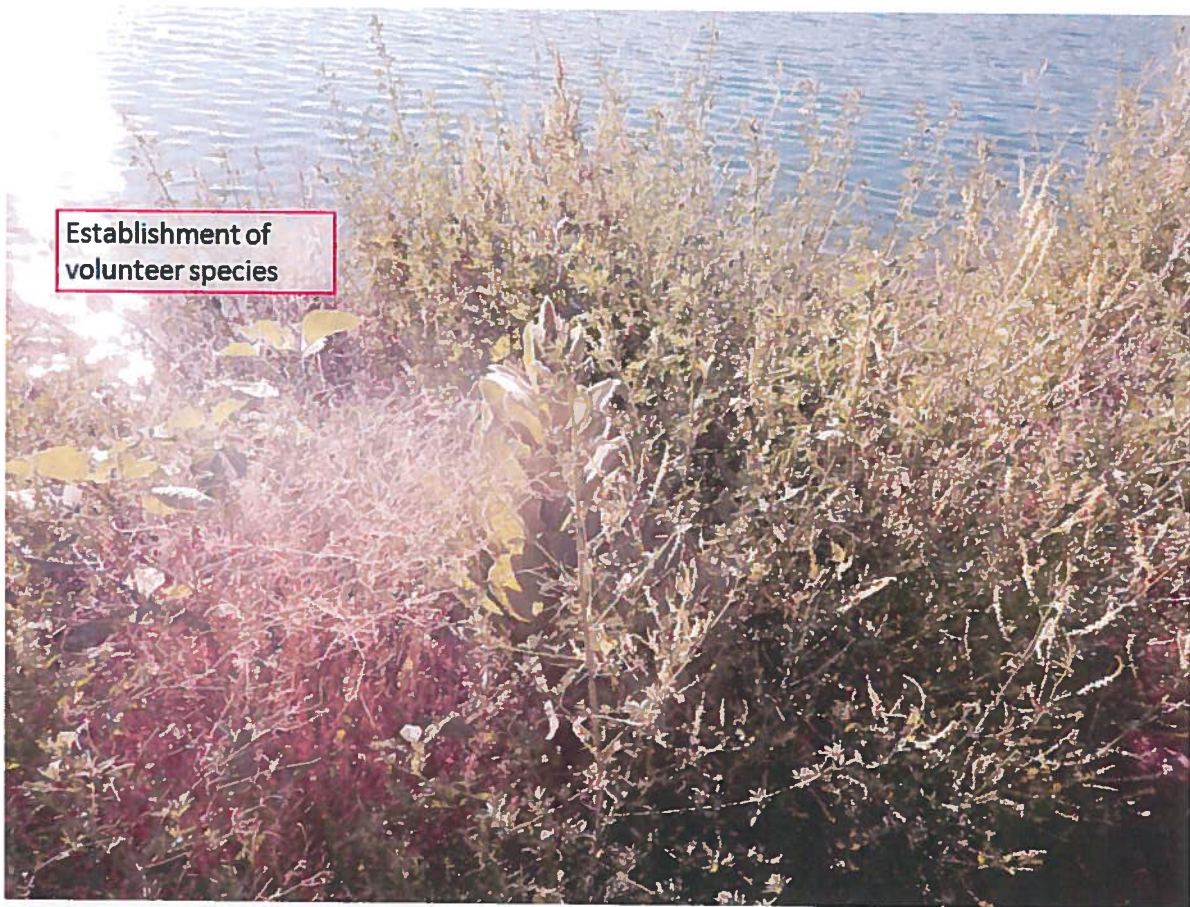
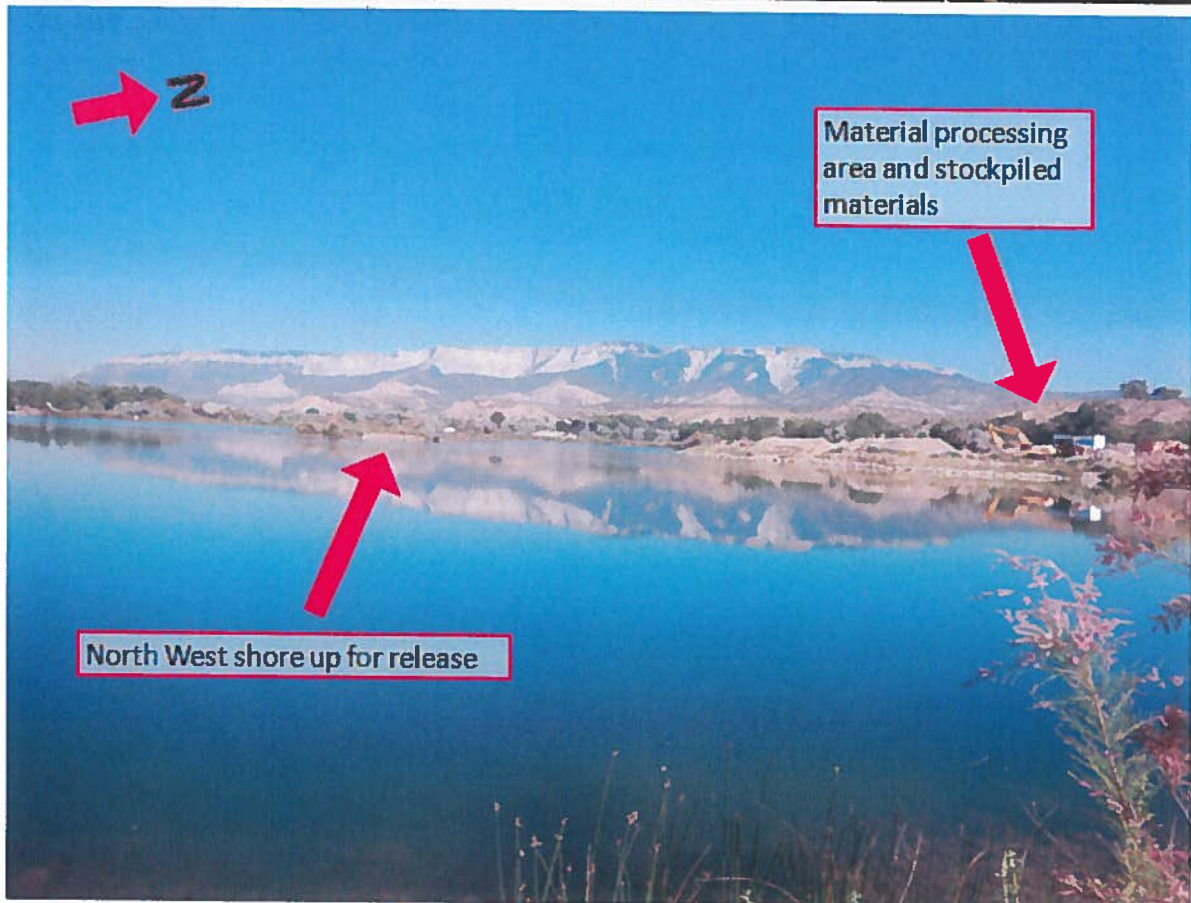
The north and west shorelines were inspected for reclamation success. The difficulties of establishing vegetation was expressed by the operator, and it was noted that several attempts had been made. The site had been broadcast seed several times with little success. The last time the operator also utilized hydromulch to improve success rates. Several volunteer species helped improve reclamation success as well. The site is now stabilized with native vegetation and a density that meets the minimum requirements necessary for reclamation success. It is noted that the majority of vegetation established is not grasses species from the approved seed mix. However, this vegetation is representative to adjacent riparian areas.

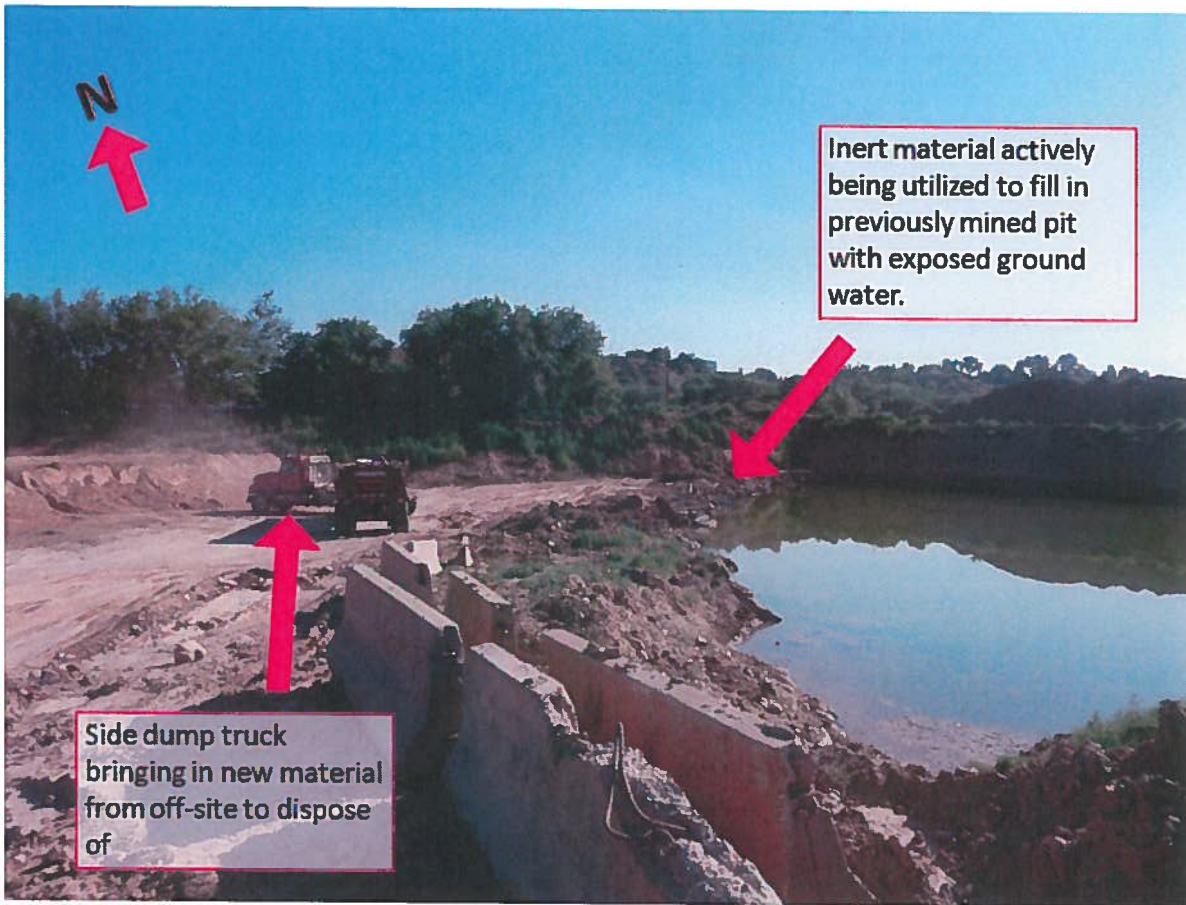
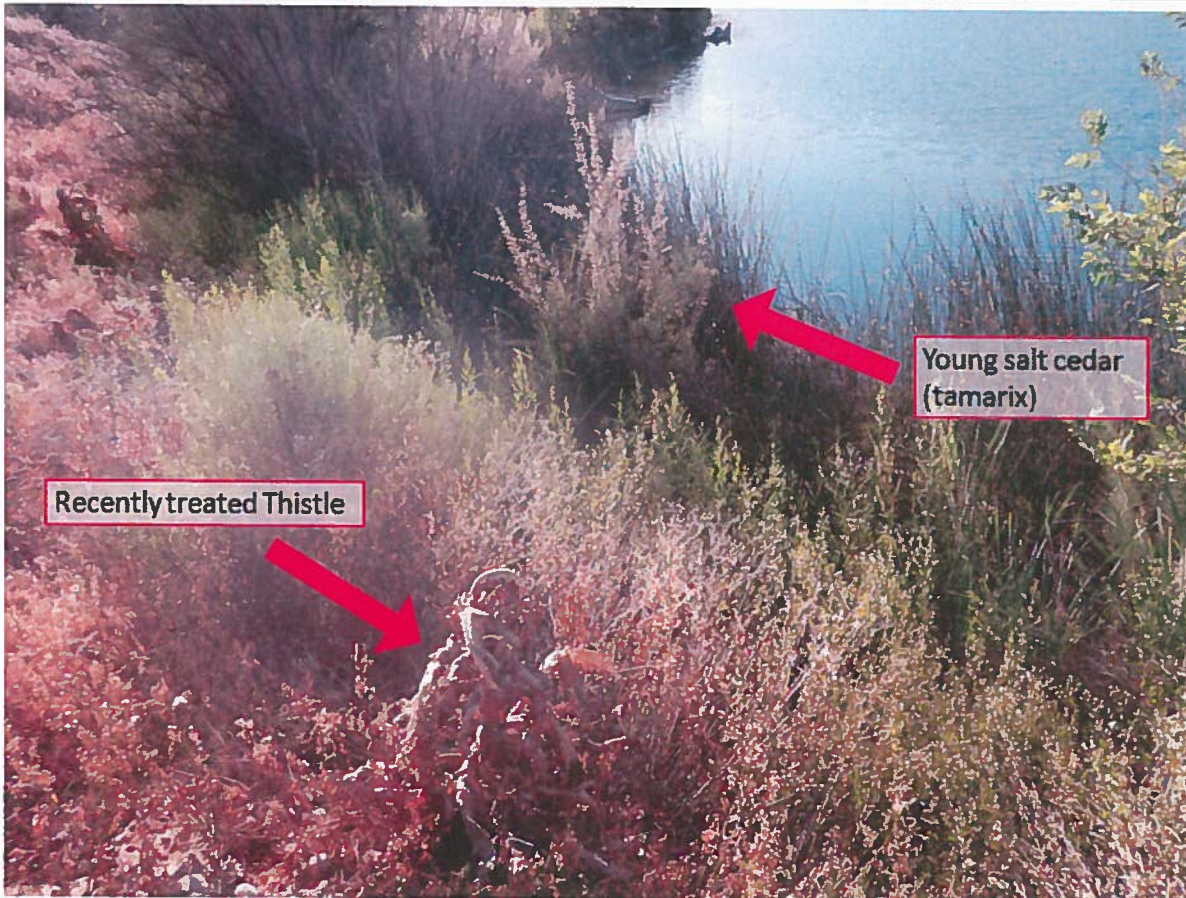
It was observed that offsite fill material was being utilized to fill in areas that had been mined where ground water was exposed. Mr. Lee explained the material was from local construction jobs and that the generators knew the requirements for inert material but that no certification beyond a verbal agreement was made with them. He said that the West Rifle Pit had an affidavit on file with the Division. At this time, the Division has no record of that file. The operator shall provide the Division with a copy of the referenced affidavit or obtain a new one addressing all requirements pursuant to Rule 3.1.5(9).

**PROBLEM/POSSIBLE VIOLATION:** Problem: The site is utilizing off-site fill without prior approval by the Division per 3.1.5(9) of the Rule.

**CORRECTIVE ACTION DUE DATE:** 8/03/15
