COLORADO DIVISION OF RECLAMATION, MINING AND SAFETY
MINERALS PROGRAM INSPECTION REPORT
PHONE: (303) 866-3567

| MINE NAME: Sievers Pit | MINE/PROSPECTING ID#: M-1977-098 | MINERAL: Sand and gravel | COUNTY: Garfield |
| INSPECTION TYPE: Monitoring | INSPECTOR(S): Stephanie J. Mitchell | INSP. DATE: March 11, 2015 | INSP. TIME: 10:00 |

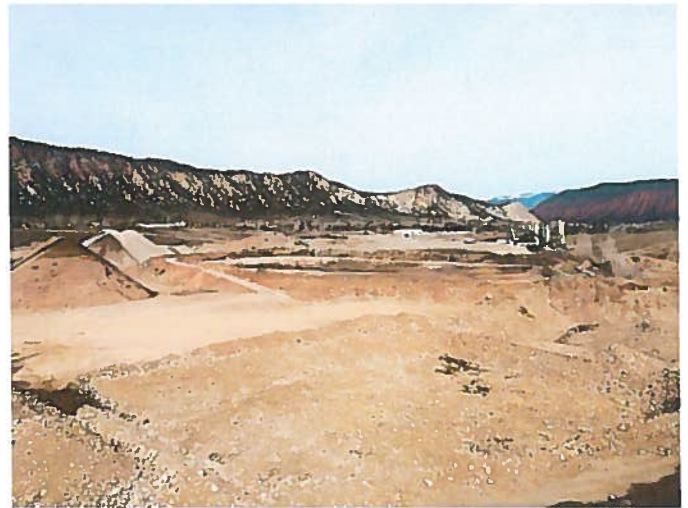
Adequate mine identification signage was noted at the entrance to the site. The affected area was adequately marked with fencing. The Southeast permit boundary was protected by a berm.

Southeast perimeter protected by berm

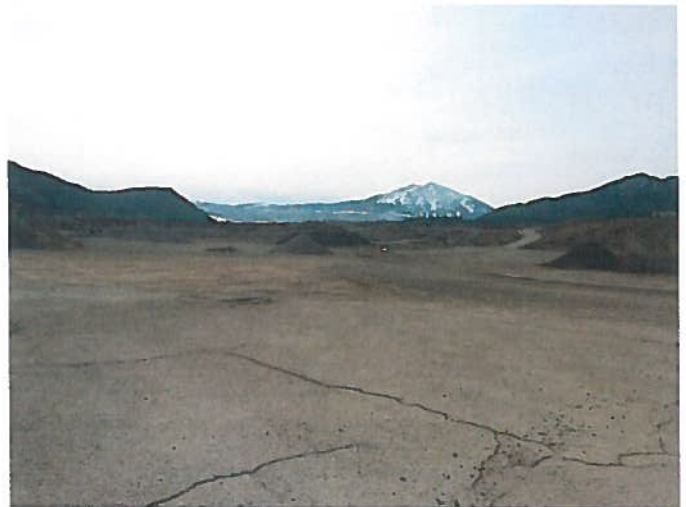
Material Stockpiles
