MINE NAME:	MINE/PROSPECTING ID#:	MINERAL:	COUNTY:
Powderwash Pit No. 66	M-2005-006	Sand and gravel	Moffat
INSPECTION TYPE:	INSPECTOR(S):	INSP. DATE:	INSP. TIME:
Monitoring	Amy C. Yeldell	August 4, 2015	11:30
OPERATOR:	OPERATOR REPRESENTATIVE:	TYPE OF OPERATION:	
Moffat County	Billy Mack	112c - Construction Regular Operation

INSPECTION TOPIC: Sediment Control

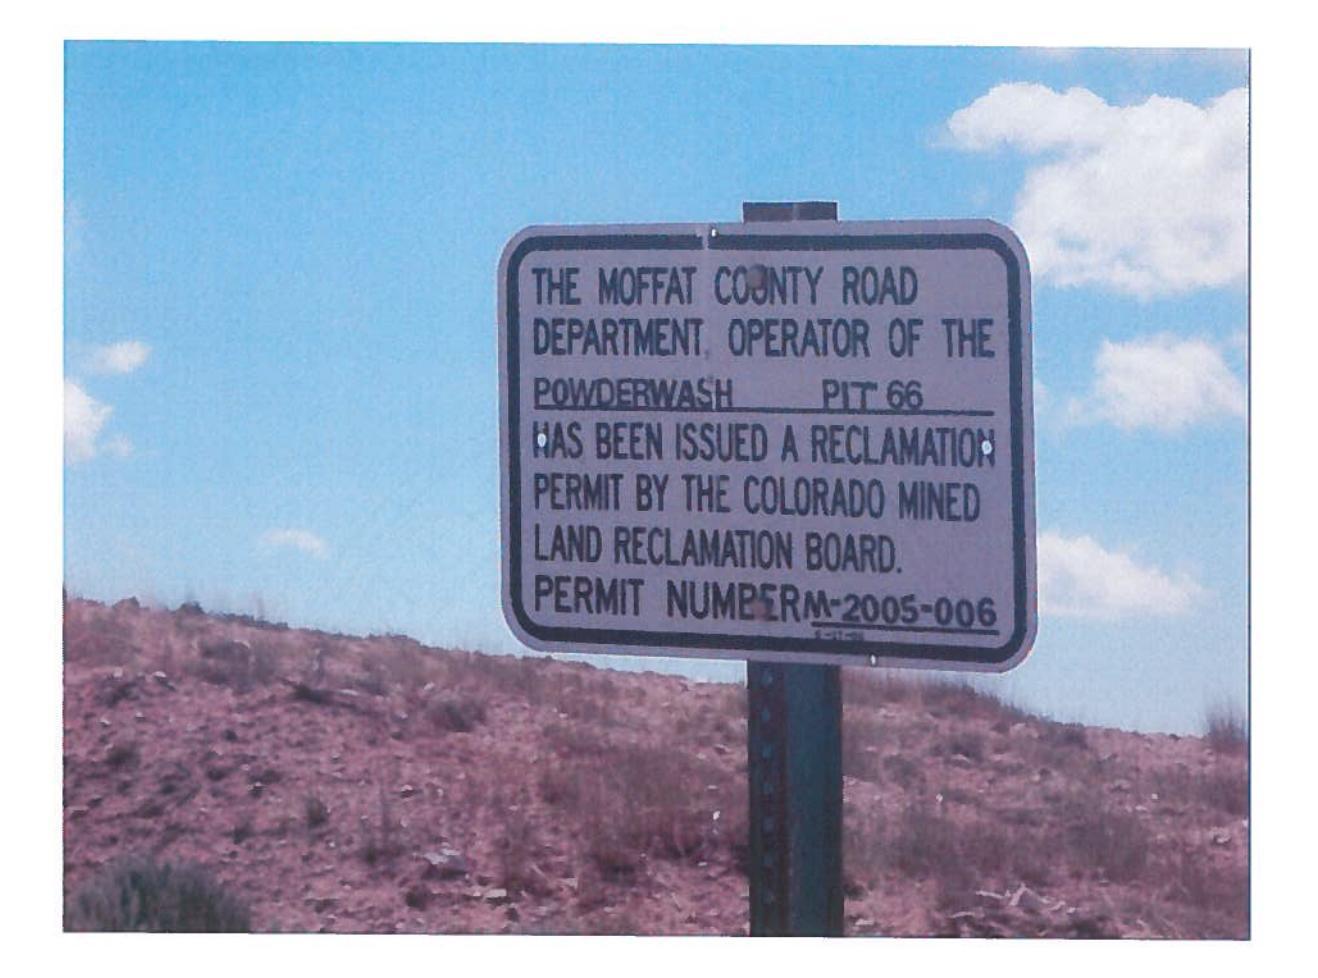
PROBLEM/POSSIBLE VIOLATION: Problem: Erosion gullies and ruts were observed on-site. Sedimentation of ditches and check dams also observed and potentially impacts the integrity of the SWMP. This is a problem at this time for failure to protect the affected land from erosion pursuant to C.R.S. 34-32.5-116 (4) (j). **CORRECTIVE ACTIONS:** The operator shall provide photo documentation to the Division verifying erosion gullies and ruts have been repaired, and that the site has have been reconstructed and stabilized to prevent erosion damage by the corrective action date.

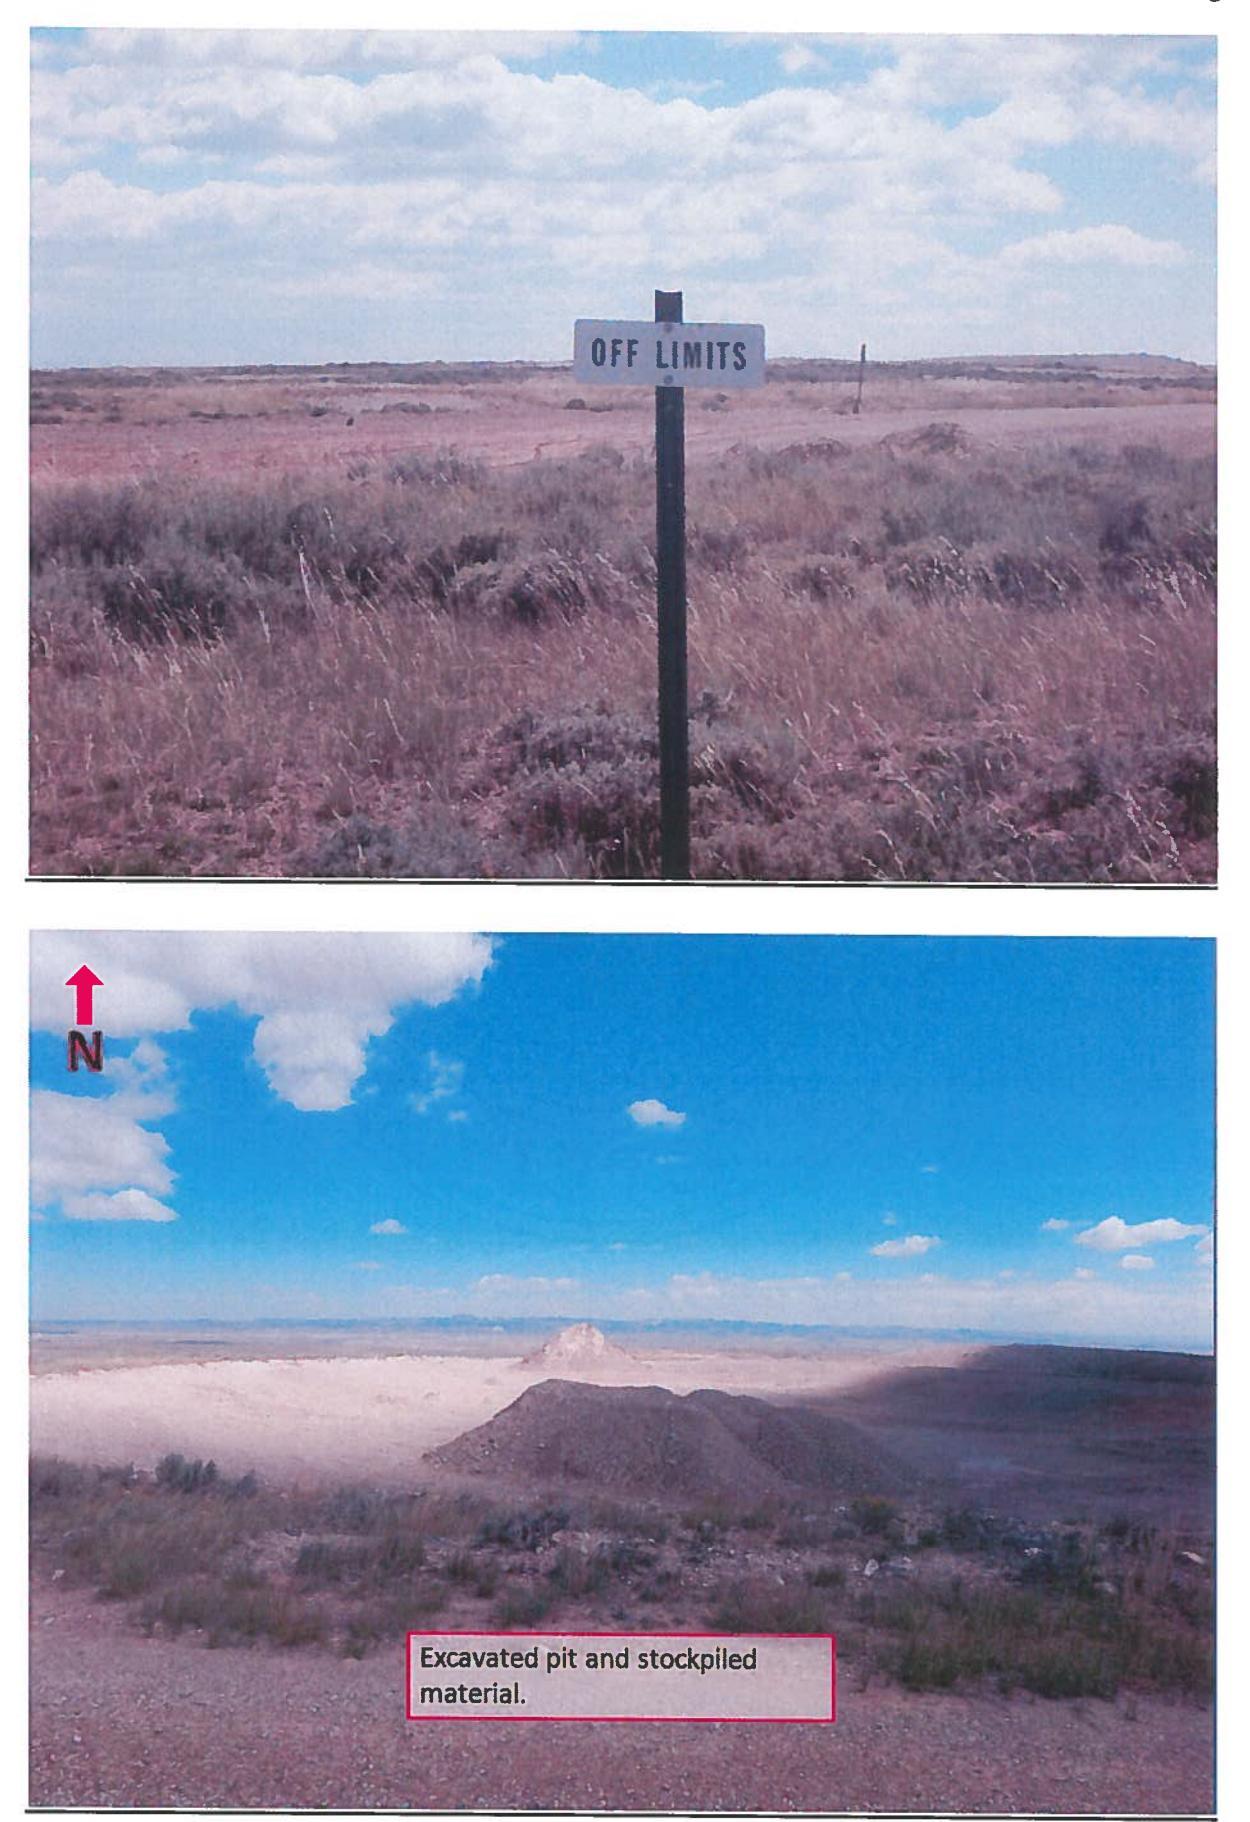
These topsoil and stockpiles piles are also used to control stormwater and prevent material from leaving the site. Due to a monsoonal storm burst the night before significant water retention was observed. There is evidence of evaporating and infiltration at a significant rate. The operator is aware of the 72 hour rule and will follow up as needed. Minor riling and erosion was also noted as a result of the significant storm even. No material left the site, all sediment was carried into the pit bottom. Ditches and check dams used for stormwater control were nearly full as the result of sedimentation. This sedimentation and erosion potentially impacts the integrity of the SWMP. This erosion is cited as a problem. The Division requests that the operator send photo documentation that the slopes have been re-stabilized and that stormwater BMPs have been repaired and are functional again.

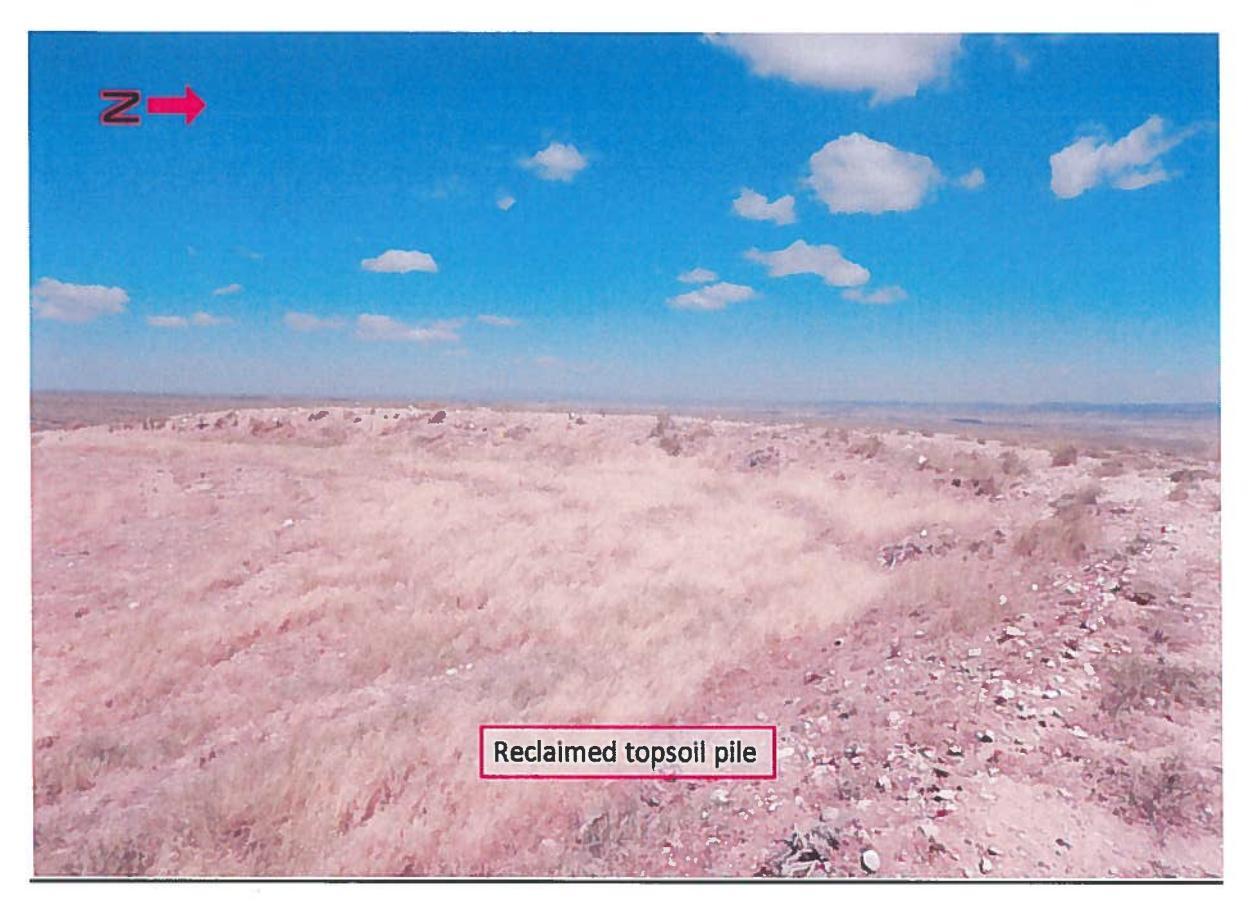
Riling present on stockpiled material but no threat of offsite damages
