COLORADO DIVISION OF RECLAMATION, MINING AND SAFETY
MINERALS PROGRAM INSPECTION REPORT
PHONE: (303) 866-3567

MINE NAME: J & J Pit	MINE/PROSPECTING ID#: M-1985-001	MINERAL: Sand and gravel	COUNTY: La Plata
INSPECTION TYPE: Monitoring	INSPECTOR(S): Lucas J. West	INSP. DATE: August 10, 2015	INSP. TIME: 12:45
OPERATOR: Glacier Gravel Products	OPERATOR REPRESENTATIVE: Landowner and Operating Company	TYPE OF OPERATION: 110c - Construction Limited Impact	
REASON FOR INSPECTION: Normal I&E Program	BOND CALCULATION TYPE: Separate Cover	BOND AMOUNT: \$8,457.58	
DATE OF COMPLAINT: NA	POST INSP. CONTACTS: None	JOINT INSP. AGENCY: None	
WEATHER: Clear	INSPECTOR'S SIGNATURE:

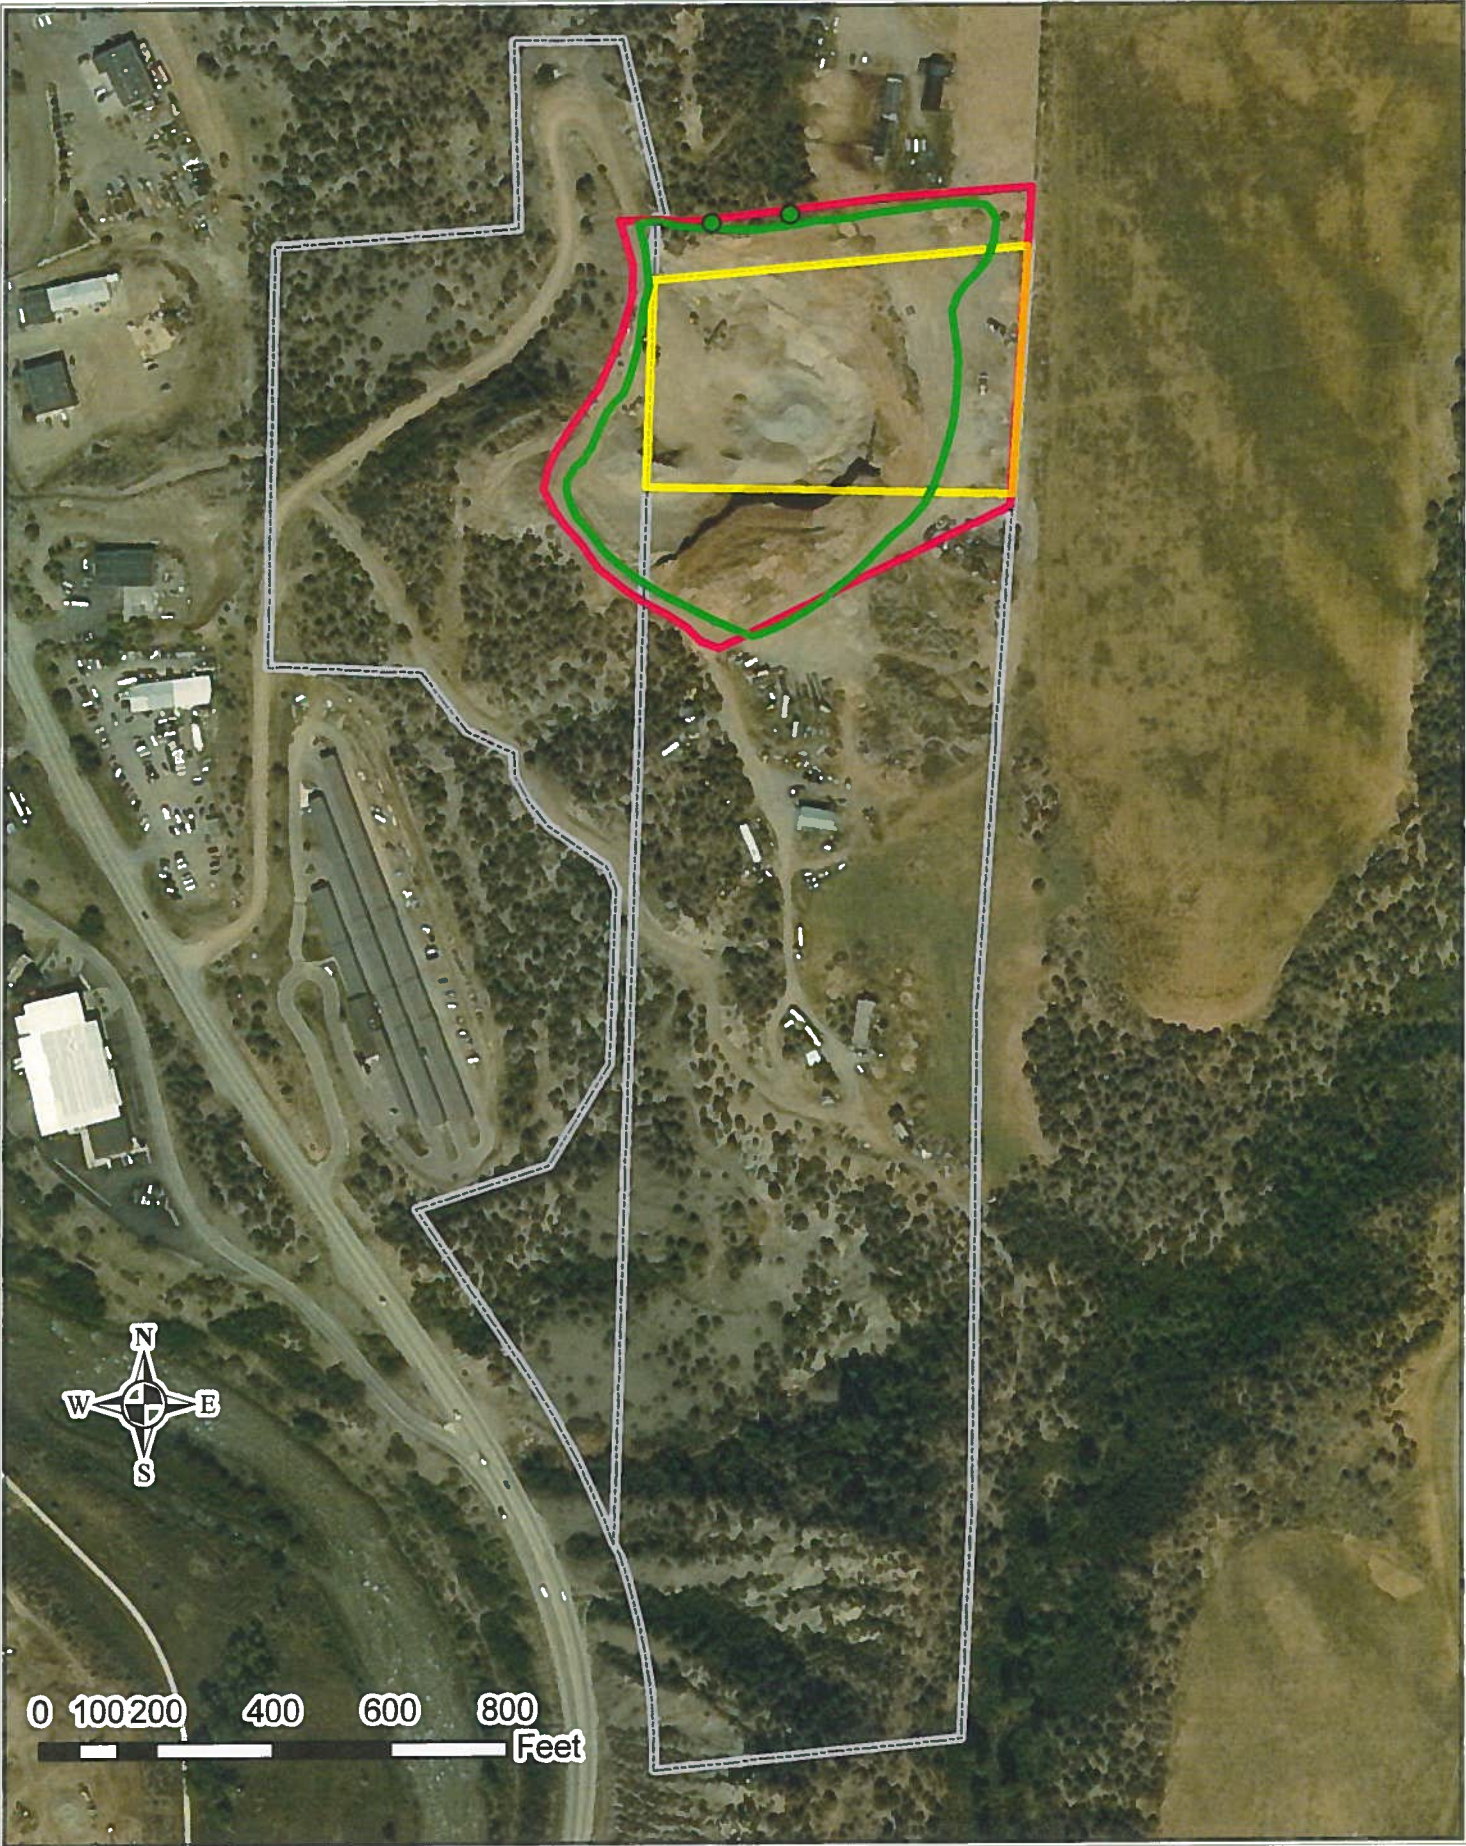
M-1985-001 J&J (Helmricks) Pit

If the utility lines are found to be inside the permit boundaries the permit holder will be required to submit a Technical Revision which demonstrates compliance with Rule 6.3.12- Exhibit L- Permanent Man Made structures prior to any further excavations in this area. The permit holder assumes all liability and responsibilities if the Divisions recommendation of no further excavations in this area is not followed.

Powerpoles
