COLORADO DIVISION OF RECLAMATION, MINING AND SAFETY
MINERALS PROGRAM INSPECTION REPORT
PHONE: (303) 866-3567

MINE NAME: Hindmarsh Sandstone	MINE/PROSPECTING ID#: M-2006-009	MINERAL: Sandstone (silica, stone quartzite)	COUNTY: Montezuma
INSPECTION TYPE: Monitoring	INSPECTOR(S): Lucas J. West	INSP. DATE: August 12, 2015	INSP. TIME: 09:00
OPERATOR: Mesa Sandstone, LLC	OPERATOR REPRESENTATIVE: William and Kay Goode	TYPE OF OPERATION: 112c - Construction Regular Operation

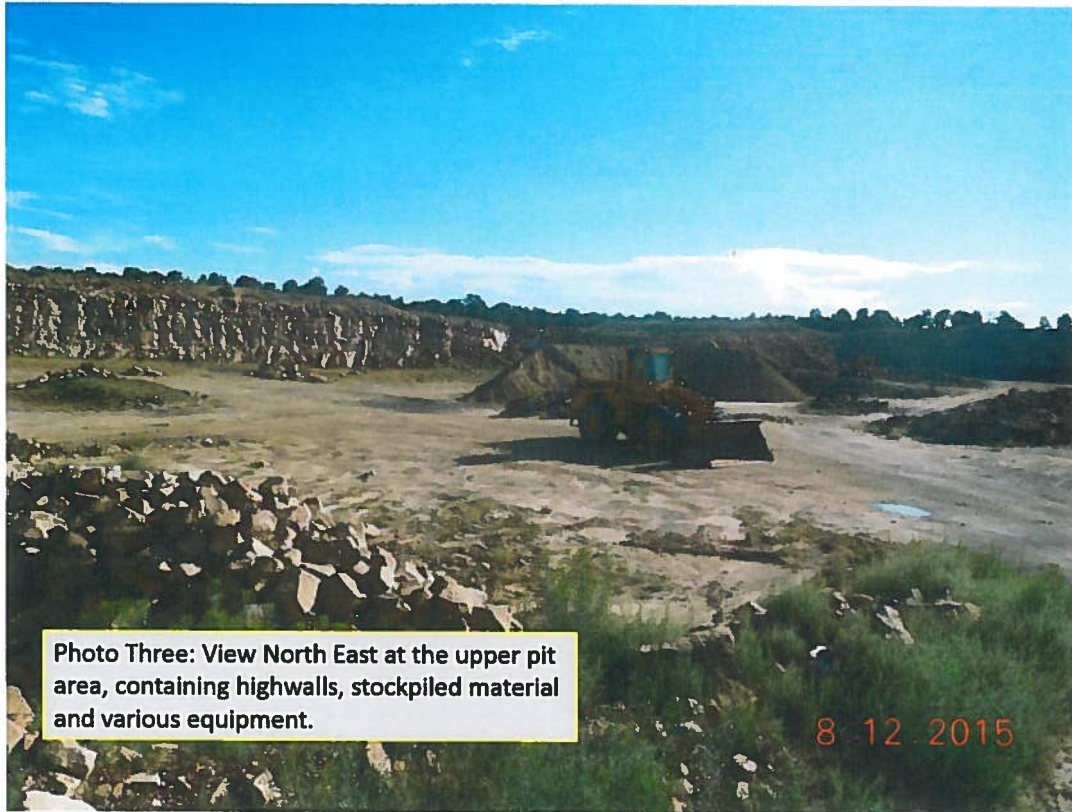
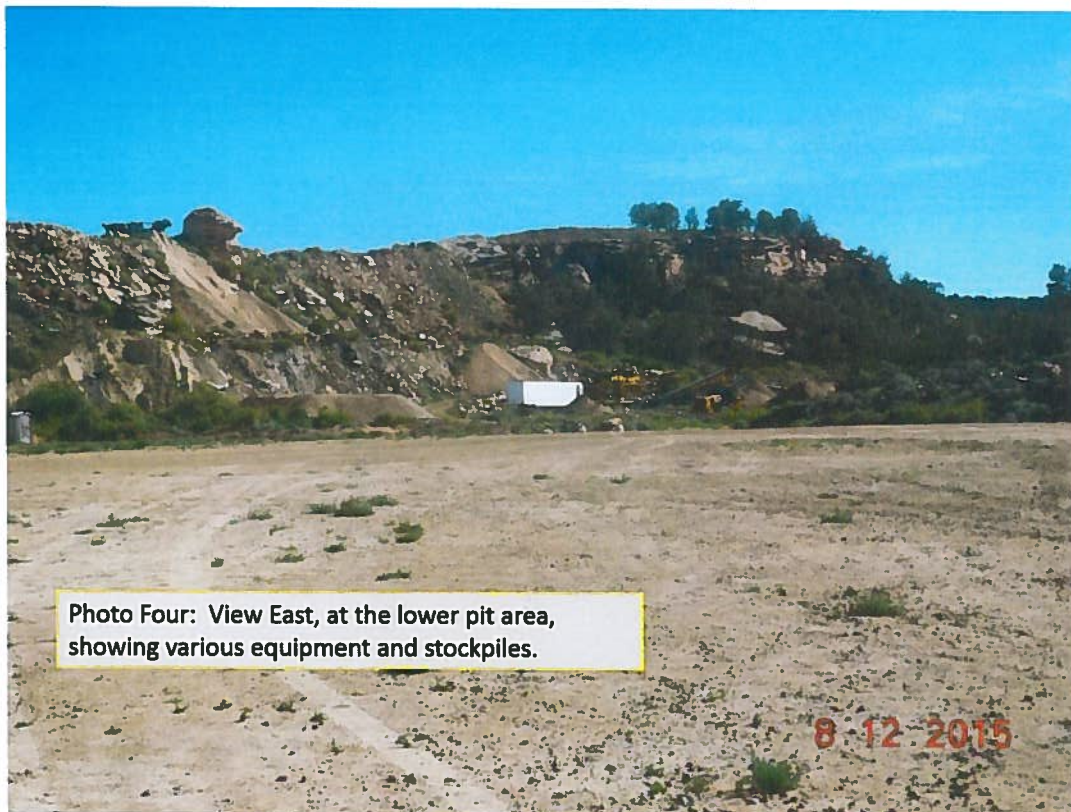
As seen in Photos One and Two, mine identification signs and permit boundary markers were observed. Site conditions were consistent with the descriptions contained within the annual report. The operator is the surface and subsurface property owner. Mining is being conducted by the use of blasting, crushing and screening material. Equipment, including a crusher, loader and conveyors were observed onsite as seen in Photos Three and Four. The site was not active during this inspection. No explosives are stored onsite, as the operator only blasts as new material is needed. Stockpiled material was observed on the pit floor, and appeared to be stable. The site consists of two main areas, an upper portion where the highwalls and some material stockpiles are located as seen in Photo Four, and a lower area. Protective safety berms were observed around all highwalls located in the upper area. The lower area is used for crushing and screening material as well as loading trucks. A scale and scale house is located adjacent to the access road at the entrance to the lower area.
