COLORADO DIVISION OF RECLAMATION, MINING AND SAFETY
MINERALS PROGRAM INSPECTION REPORT
PHONE: (303) 866-3567

MINE NAME: Wagner Pit	MINE/PROSPECTING ID#: M-2010-002	MINERAL: Sand and gravel	COUNTY: Moffat
INSPECTION TYPE: Monitoring	INSPECTOR(S): Amy C. Yeldell	INSP. DATE: September 9, 2015	INSP. TIME: 10:30
OPERATOR: Wagner Rock LLC	OPERATOR REPRESENTATIVE: None	TYPE OF OPERATION: 110c - Construction Limited Impact

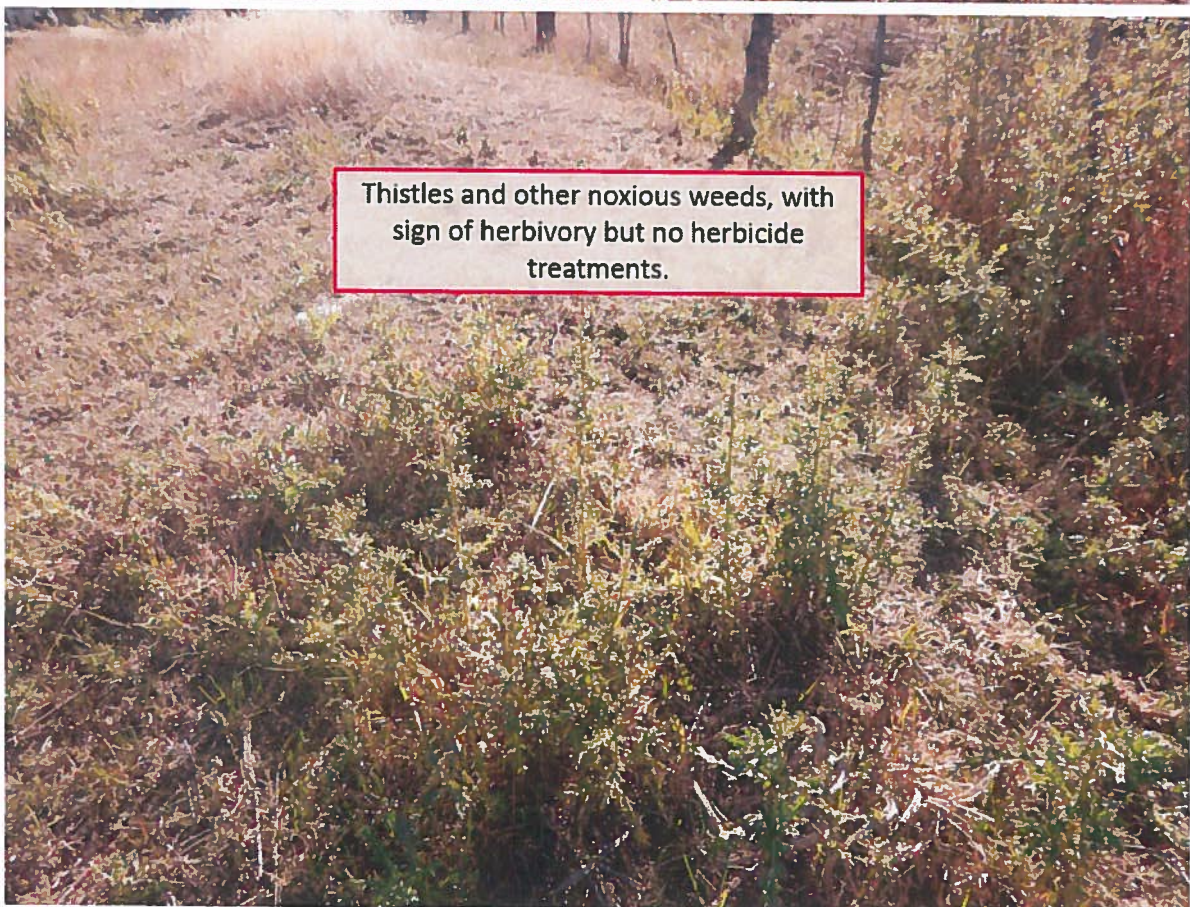
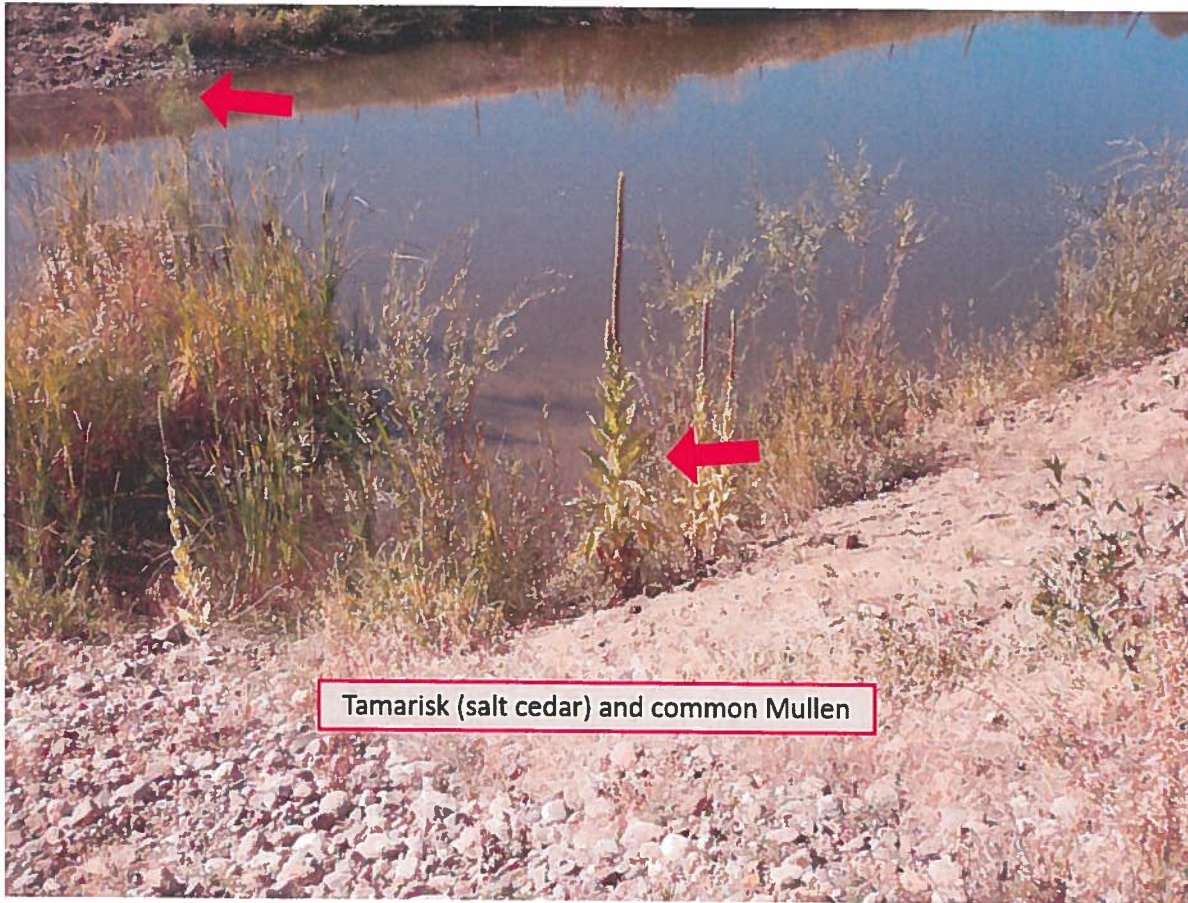
PROBLEM/POSSIBLE VIOLATION: Problem: There are state-listed noxious weeds present on site. This is a problem for failure to employ weed control methods for state listed noxious weed species within the permitted area, and to reduce the spread of weeds to nearby areas as required by Section 3.1.10 (6) of the rule.

Weeds are present in the disturbed portions of the permit boundary. In phone conversations the operator indicated that all weeds had been treated. Visual inspection by staff found untreated weeds such as; tamarisk, thistles, cheat grass, common Mullen and Russian thistle to be present. This is cited as a problem. This late in the year it is likely too late to effectively treat many of the weeds but the operator is encouraged to make an effort where applications may be effective. The operator shall implement a weed management plan to more aggressively manage the various state listed noxious weeds. Please submit a weed management plan in the form of a technical revision by the corrective action date.
