**COLORADO DIVISION OF RECLAMATION, MINING AND SAFETY
MINERALS PROGRAM INSPECTION REPORT
PHONE: (303) 866-3567**

MINE NAME: Ignacio Pit	MINE/PROSPECTING ID#: M-1992-054	MINERAL: Sand and gravel	COUNTY: La Plata
INSPECTION TYPE: Monitoring	INSPECTOR(S): Lucas J. West	INSP. DATE: October 7, 2015	INSP. TIME: 14:45
OPERATOR: LBCR, LLC	OPERATOR REPRESENTATIVE: Jay Nielson, Crossfire Aggregate Services	TYPE OF OPERATION: 112c - Construction Regular Operation

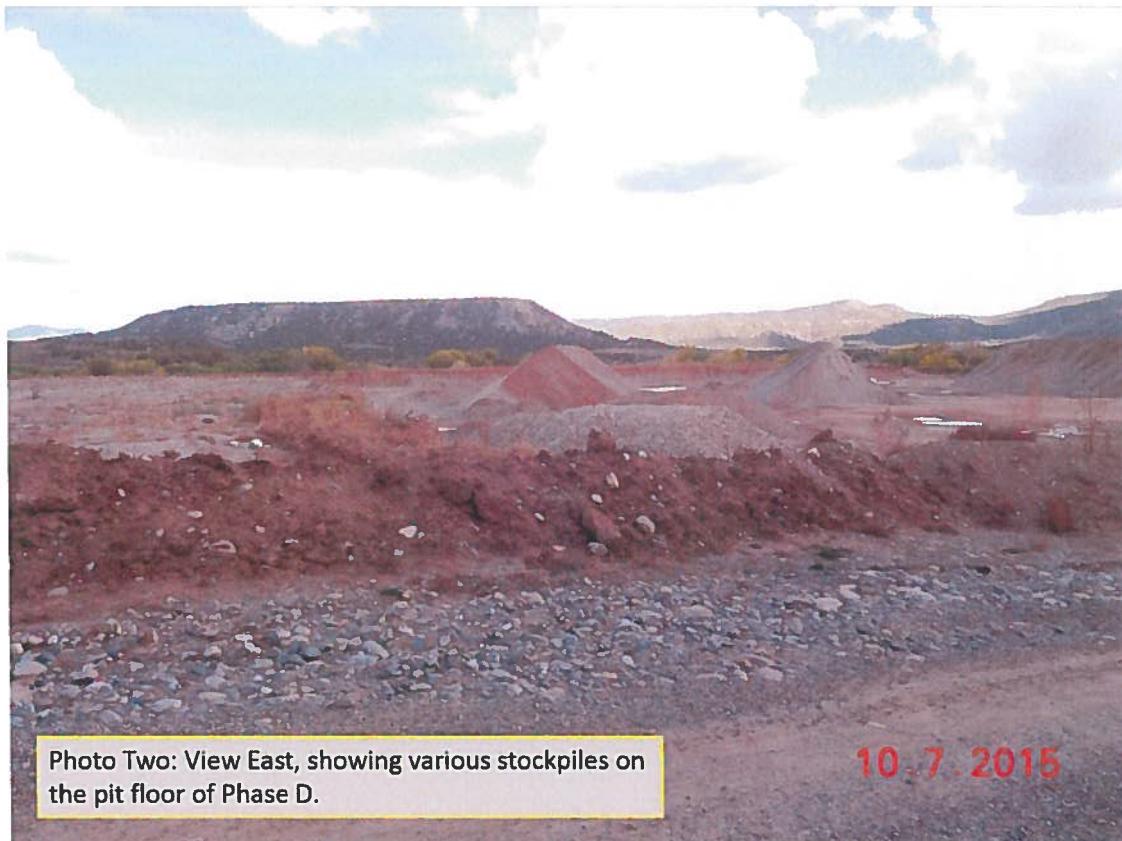
The Permit is located just west of County Road 172, South of Ignacio. The site is a phased mining operation currently being mined in Phase D. Proper signage was observed during the time of the inspection as seen in Photo One, as well as Permit Boundary Markers by way of earthen berms, fencing and T-posts. The site was not active during the time of the inspection, however equipment was observed on site. Several stockpiles were located on the pit floor of the active phase as seen in Photo Two. All slopes within the disturbed area, including the stockpiled material and mining highwalls are stable and show no signs of erosion. The Operator expressed that currently, and in future phases of mining, they would maintain an approximate 20 foot buffer from the East Permit Boundary as seen in Photo Three. The Fence delineating the Eastern Permit Boundary is part of an easement associated with the County Road. Standing water was observed in the pit floor due to recent precipitation events, the site does not encounter groundwater during their mining operations.
