COLORADO DIVISION OF RECLAMATION, MINING AND SAFETY
MINERALS PROGRAM INSPECTION REPORT
PHONE: (303) 866-3567

MINE NAME: Moon Pit No 2	MINE/PROSPECTING ID#: M-1977-443	MINERAL: Sand and gravel	COUNTY: Moffat
INSPECTION TYPE: Surety-Related Inspection	INSPECTOR(S): Amy C. Yeldell	INSP. DATE: December 24, 2015	INSP. TIME: 13:30
OPERATOR: Northwest Aggregates, Inc.	OPERATOR REPRESENTATIVE: Jack Paulson & Penny Lewis	TYPE OF OPERATION: 110c - Construction Limited Impact	
REASON FOR INSPECTION: Surety Related	BOND CALCULATION TYPE: Complete Bond	BOND AMOUNT: \$16,500.00	
DATE OF COMPLAINT: NA	POST INSP. CONTACTS: None	JOINT INSP. AGENCY: None	
WEATHER: Cloudy	INSPECTOR'S SIGNATURE:

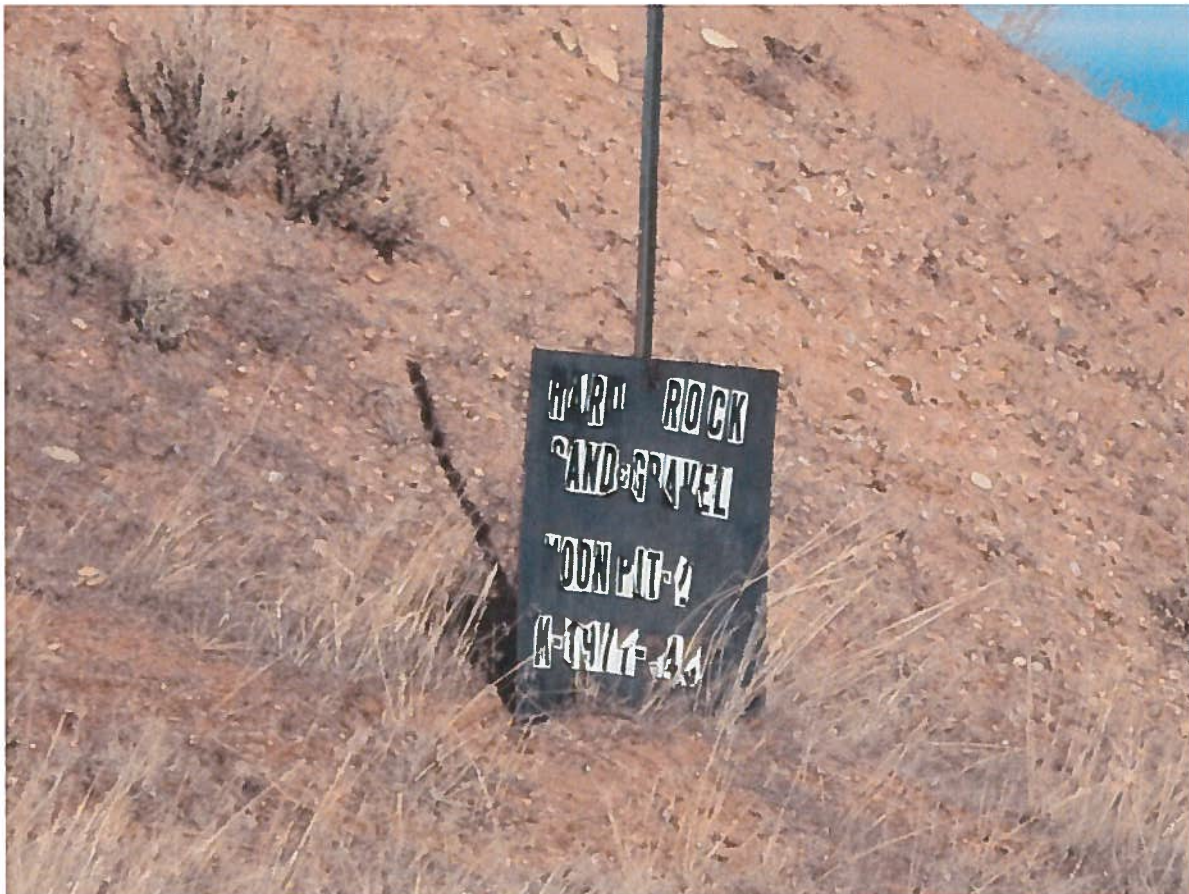
The mine sign was in place however the lettering has be weathered by the elements. This is not cited as a problem since the sign will need to be replace since the operator name has changed. The sign must comply with Rule 3.1.12. The northern permit boundary adjacent to pre-existing mining was unclear. Boundary markers didn't not clearly delineate the permit area. This is cited as a problem. Please remark the permit boundary and send the Division photo documentation by the corrective action date.
