112c Annual Report

Geotechnical Addendum

January 2016
Project 1600260

This report summarizes geotechnical observations gathered on January 11 and 12, 2016 at the Morrison Quarry, operated by Aggregate Industries (AI). This report supplements the “2015 Notice of Intent to Continue Mining Operations / Annual Report” for the Morrison Quarry. Rock characteristics such as joint and foliation orientation, shear zones, faults, and instability zones were mapped for areas mined in 2015. Recommendations provided for mine highwall configurations provided are based on GEI Consultants, Inc. (GEI) observations and data analysis. This addendum provides information required by Permit Amendment #5 (carried over from Permit Amendment #3 and #4) to Mining Permit M-1973-021.

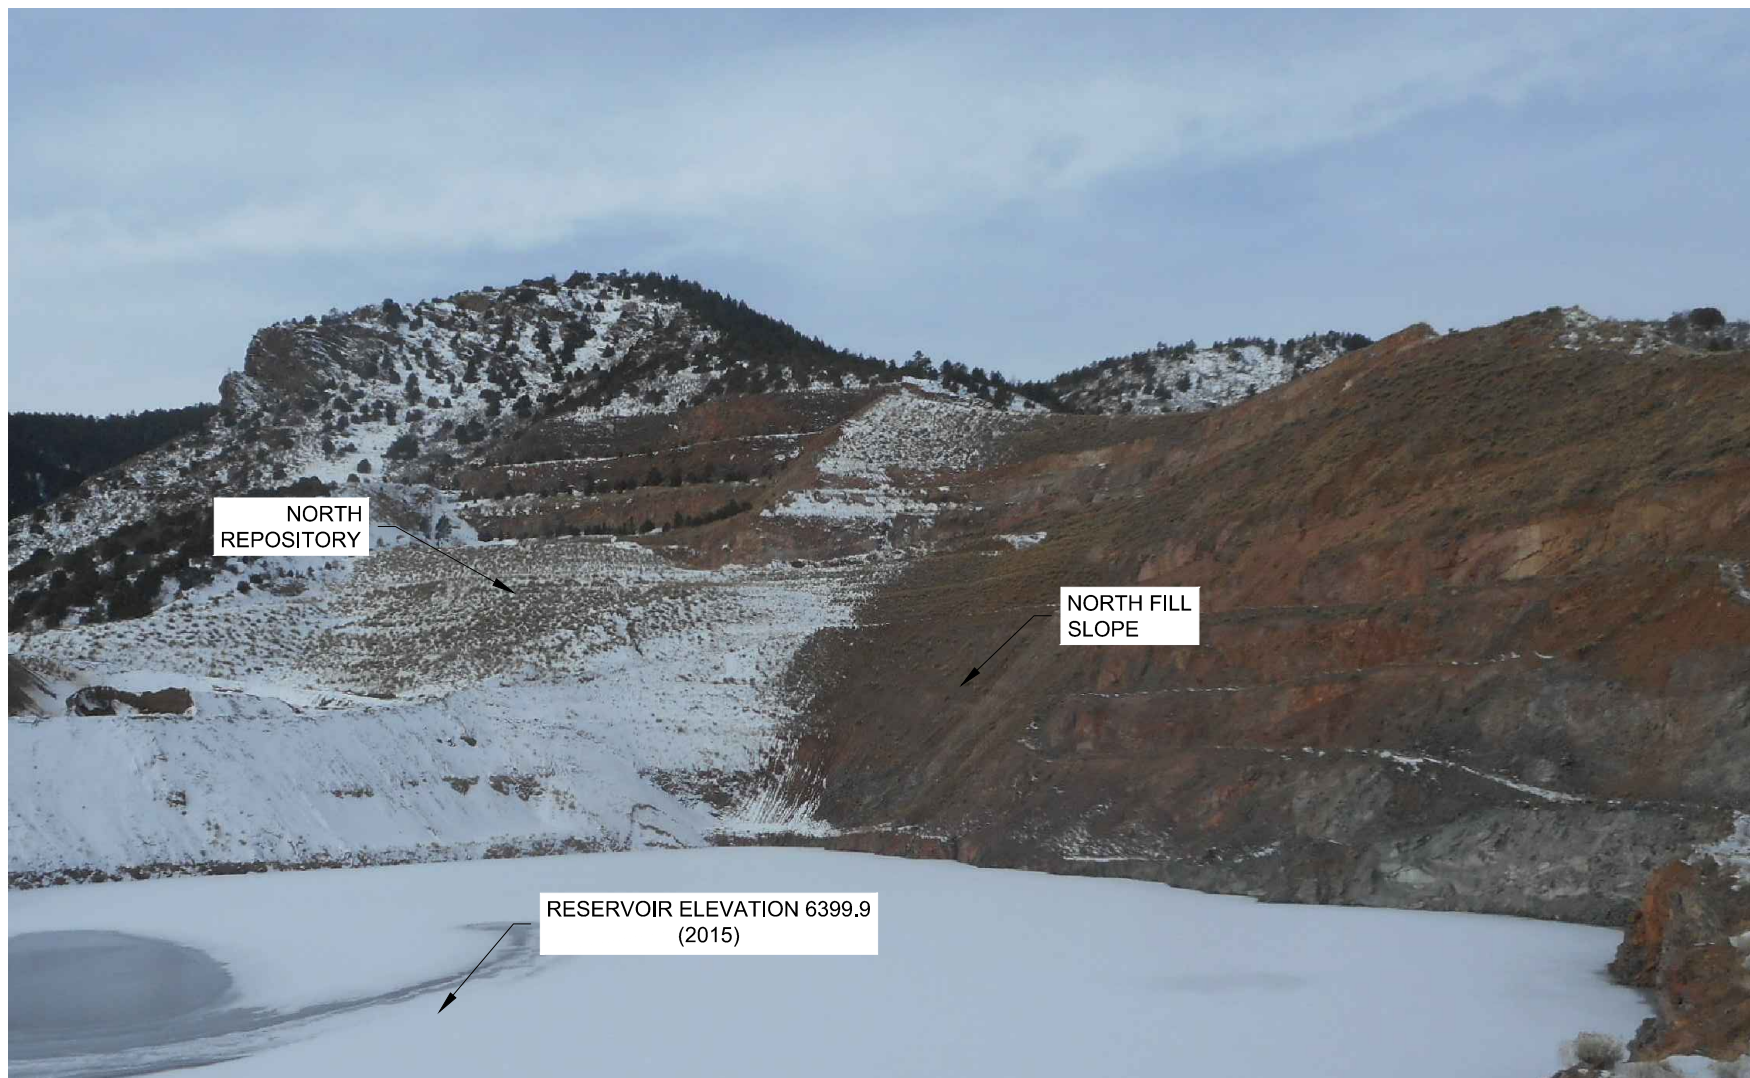
GEI Consultants	CURRENT CONFIGURATION OF NORTH QUARRY	
Aggregate Industries		Project 1600260	January 2016
			Figure 2

Mining in the North Quarry was completed in 2007 therefore no mining activity occurred in the North Quarry in 2015. The North Quarry is currently being used as a raw water storage reservoir for the Town of Morrison and production water storage for AI. The pond has a water elevation of approximately 6400 feet above MSL. Figure 2 shows the current configuration of the North Quarry, including the reservoir and the North Repository. A minor rockfall disturbance, possibly caused by freeze-thaw action, was noted in the northeast corner in 2014 (Fig. 28). GEI did not observe a change in the rockfall disturbance in 2015.

No mining within the North Quarry occurred in 2015 and no major rock disturbances were noted, so no new orientation data was obtained during the 2015 review. Observations of the existing highwalls and benches, the repaired north slope, and the north repository area were conducted. Local raveling of rocks and minor instabilities were noted within the main trunk of the North Quarry. These instabilities and raveling events are assumed to be a result of adverse joint conditions, rock alteration, or freeze thaw weathering cycles. Typically, rocks loosened in this manner will be small (usually less than 18 inches) and will likely be contained on the benches. A minor rockfall event was noted in the northeast corner of the North Quarry at approximate elevation (El.) 6454 feet in 2014. The rockfall (Fig. 28) was mainly contained on the bench immediately below, with a few rock fragments extending beyond. GEI did not observe any changes in the rockfall disturbance in 2015. No instability was noted on the reposed north slope or the north repository.

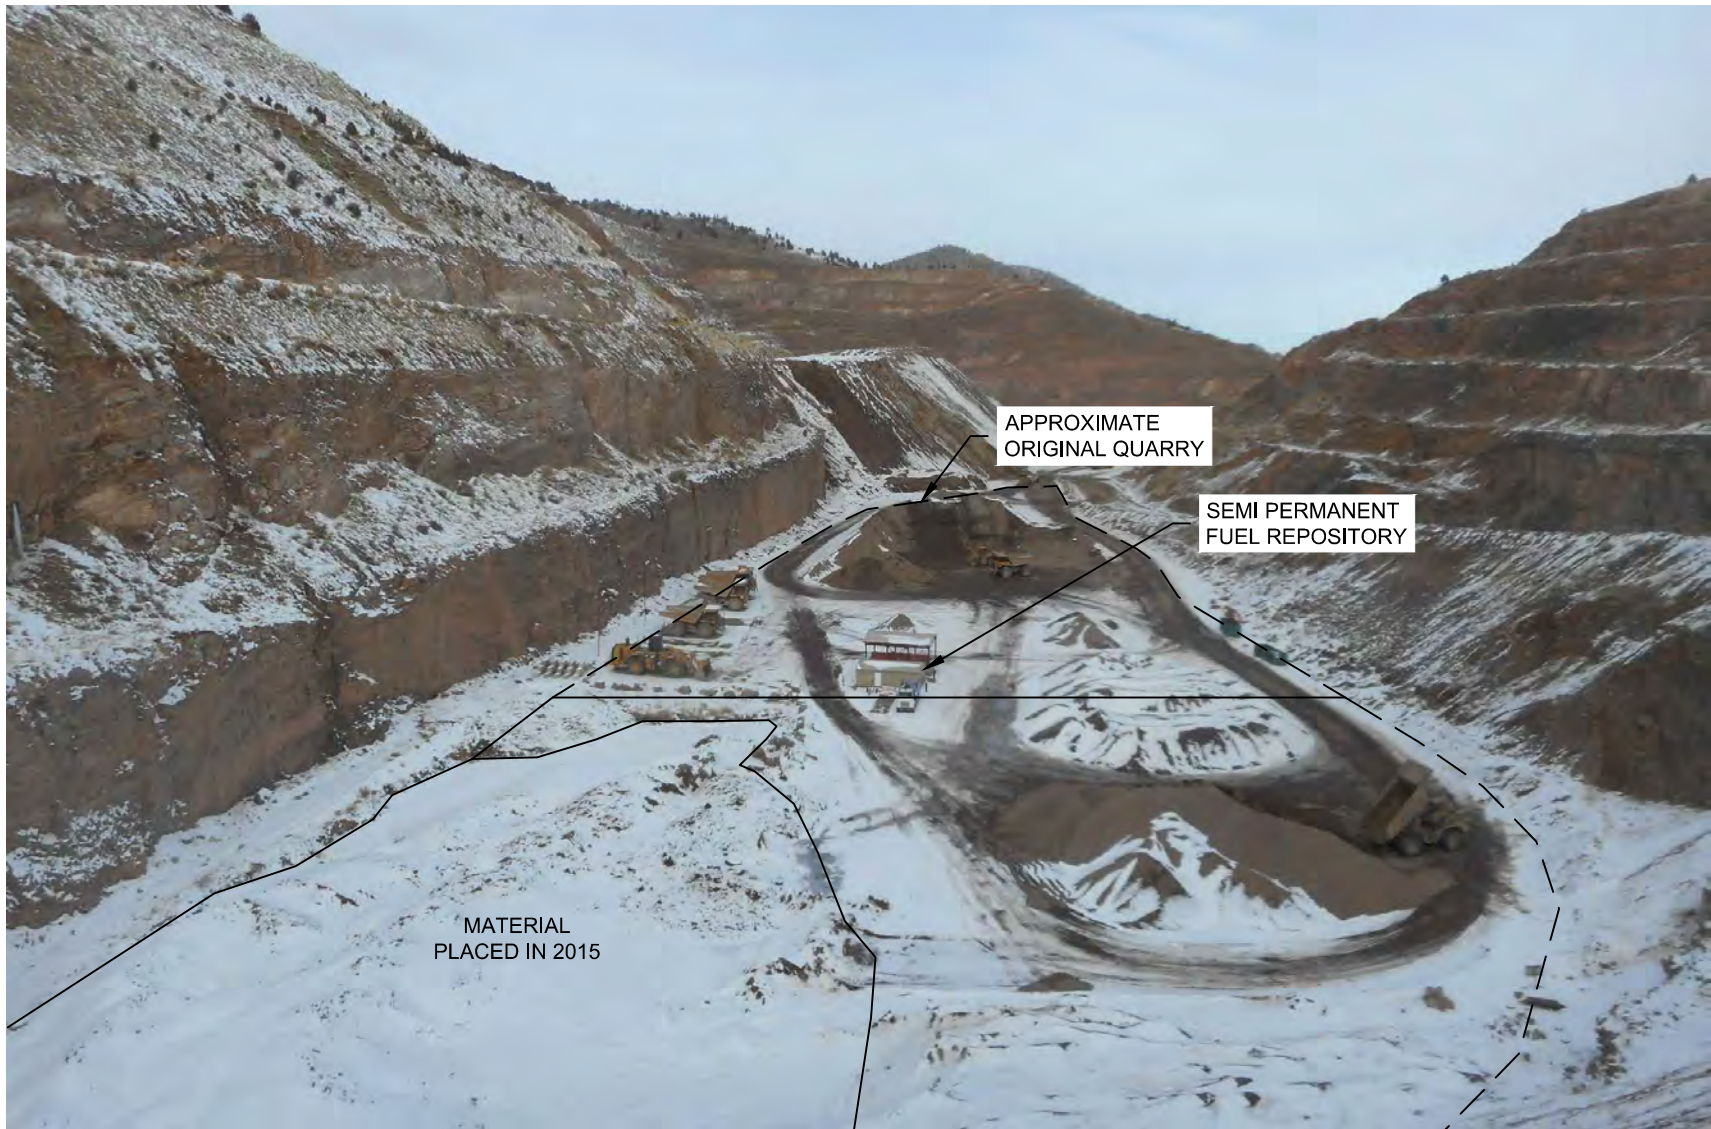
GEI Consultants	CURRENT CONFIGURATION OF CENTRAL QUARRY	
Aggregate Industries		Project 1600260	January 2016 Figure 3

Some material stripped from areas within the South Quarry in 2015 was deposited in the Central Quarry as part of ongoing quarry reclamation. The area of current reclamation is being filled with jade air fines. The current level of the fill was visibly close to the existing grade in the quarry at an approximate elevation of 6500 feet. The reclamation began at the northern end of the quarry and has continued south. 2015 reclamation was conducted as shown in Figure 3.

NOTE: MATERIAL WAS PLACED IN 2015
VIA SLURRY

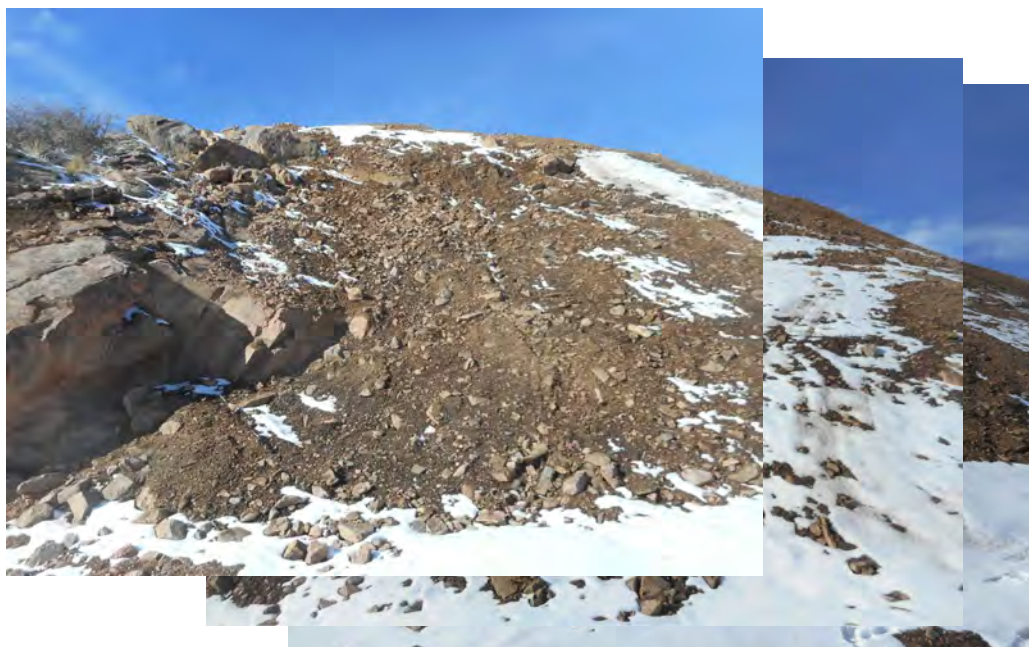
Morrison Quarry	  GEI Consultants	BENCH 7480 (1 OF 2)
Aggregate Industries		Project 1600260
		January 2016
		Figure 7

Photographic documentation of Bench 7480 is presented in Figures 7 and 8.

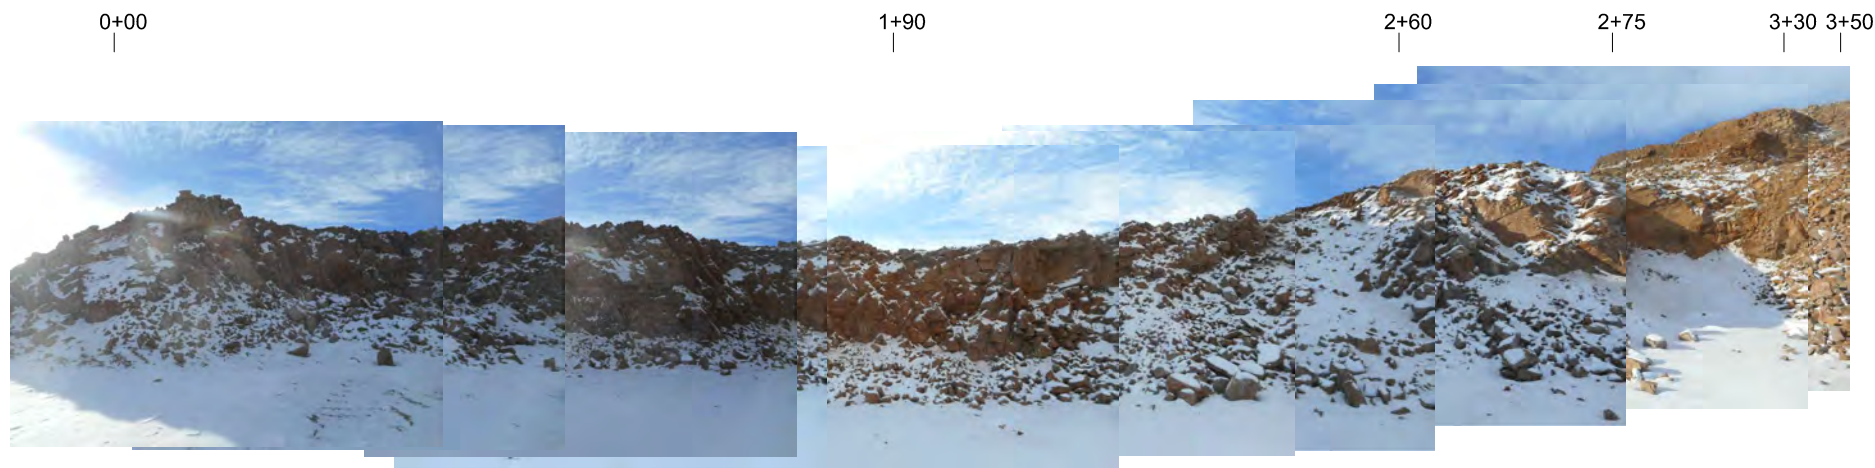
GEI Consultants	BENCH 6900 SECTION A
Aggregate Industries		Project 1600260 January 2016 Figure 20

Figures 20 through 24 present photographic documentation of the Bench 6900 highwall scanline.
