## MEMO

**RE:** Aggregate Industries – WCR, Inc., DRMS Permit No. M-2004-031, Hazeltine Mine  
Enforcement Hearing

Consideration of a possible violation, corrective actions, and civil penalties, for failure to minimize disturbance to the prevailing hydrologic balance in the surrounding area and failure to protect areas outside the affected land from damage.

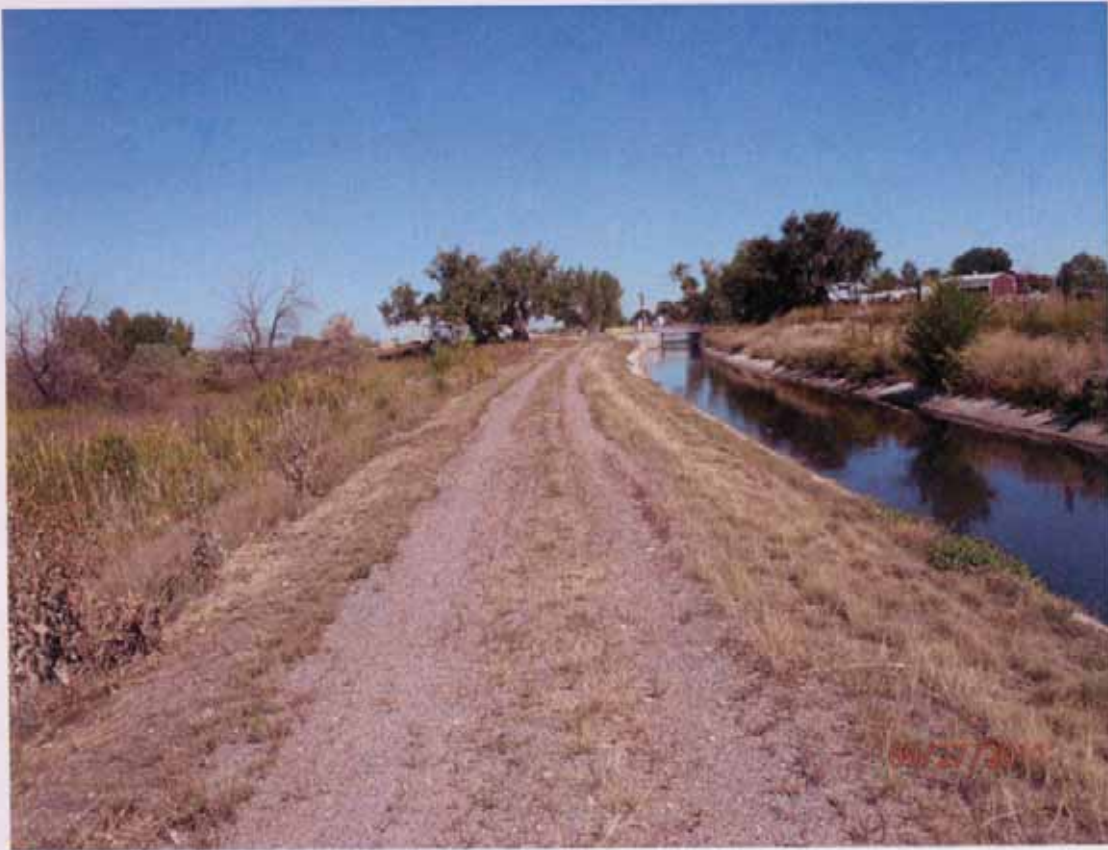
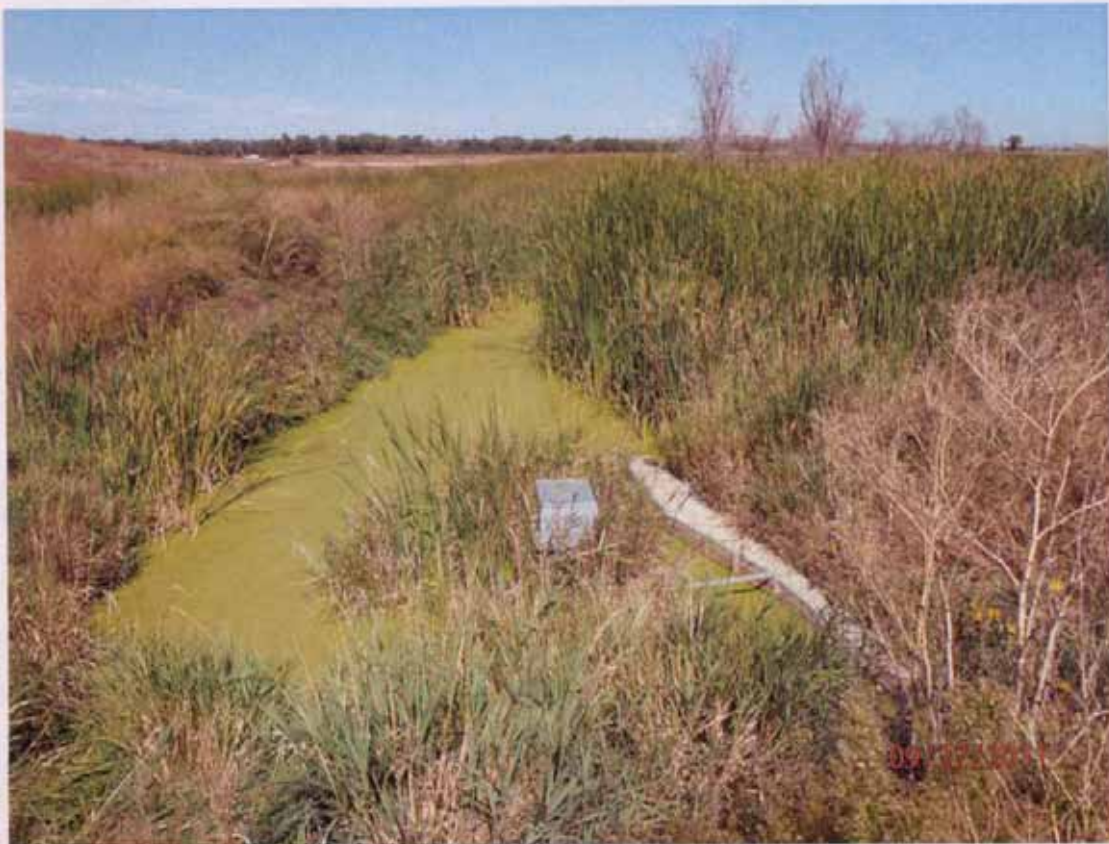
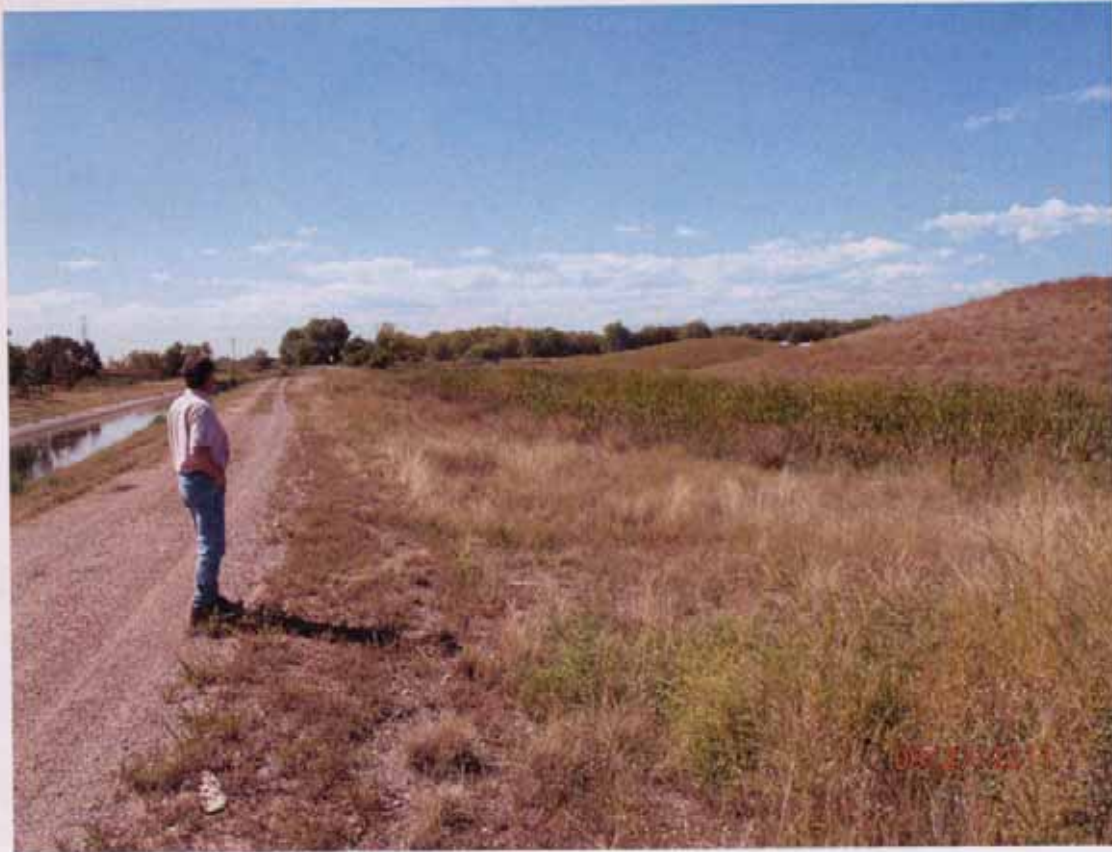
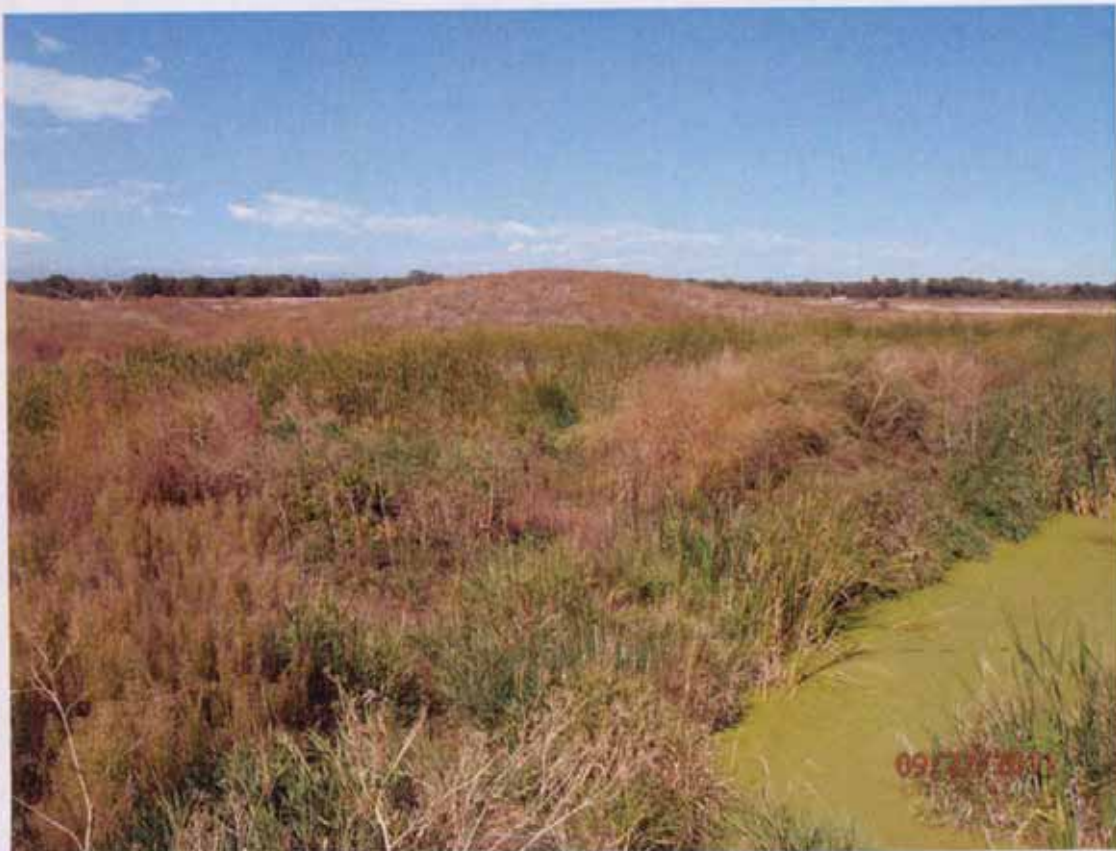
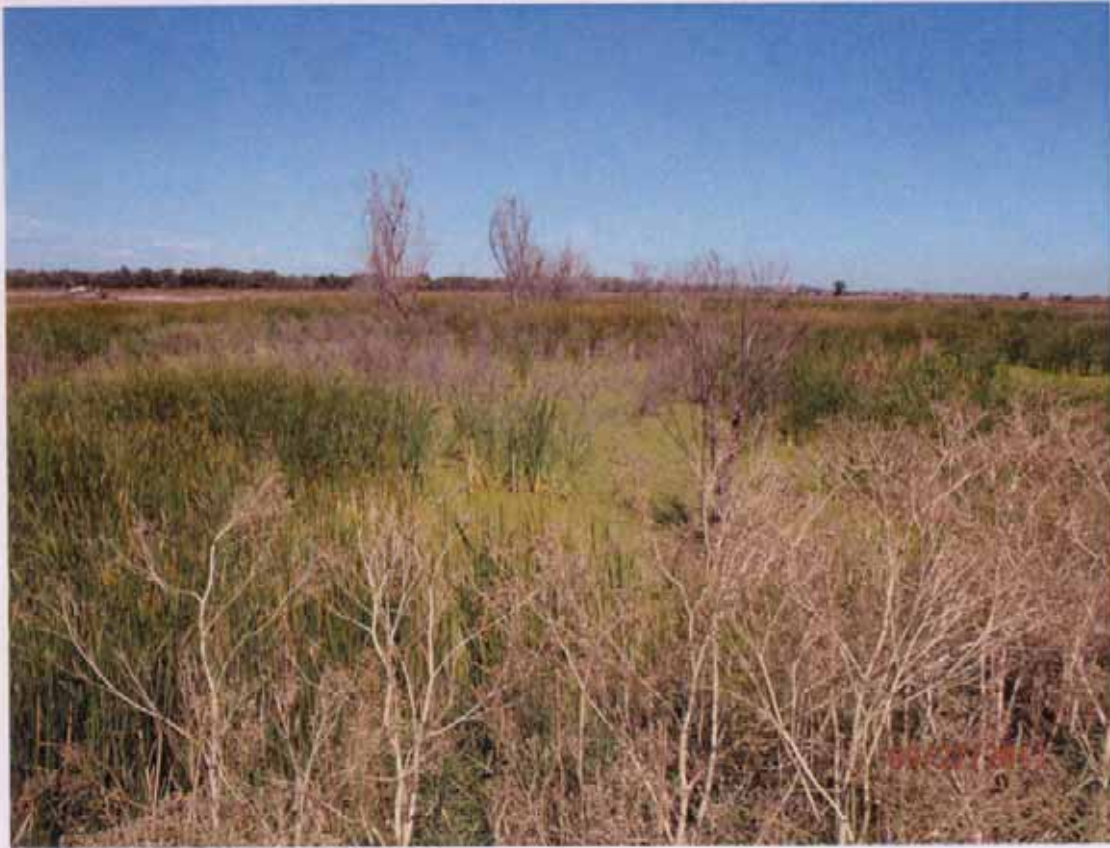
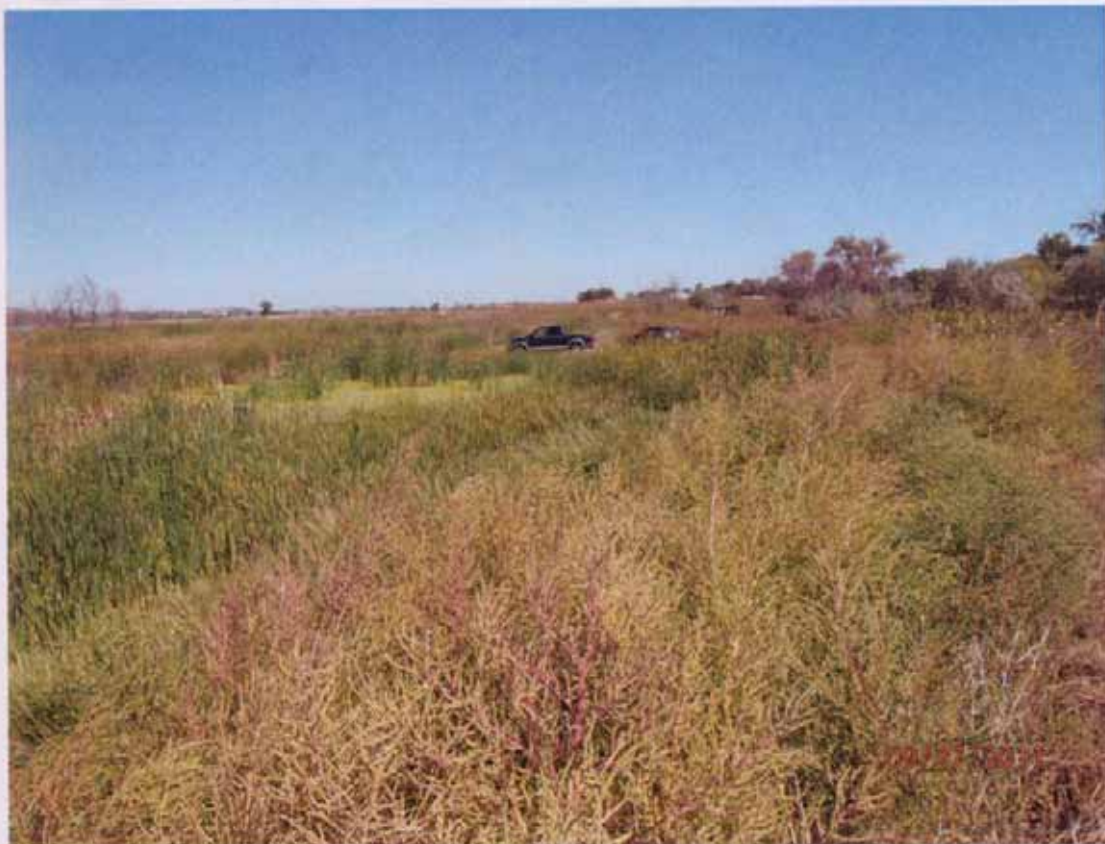
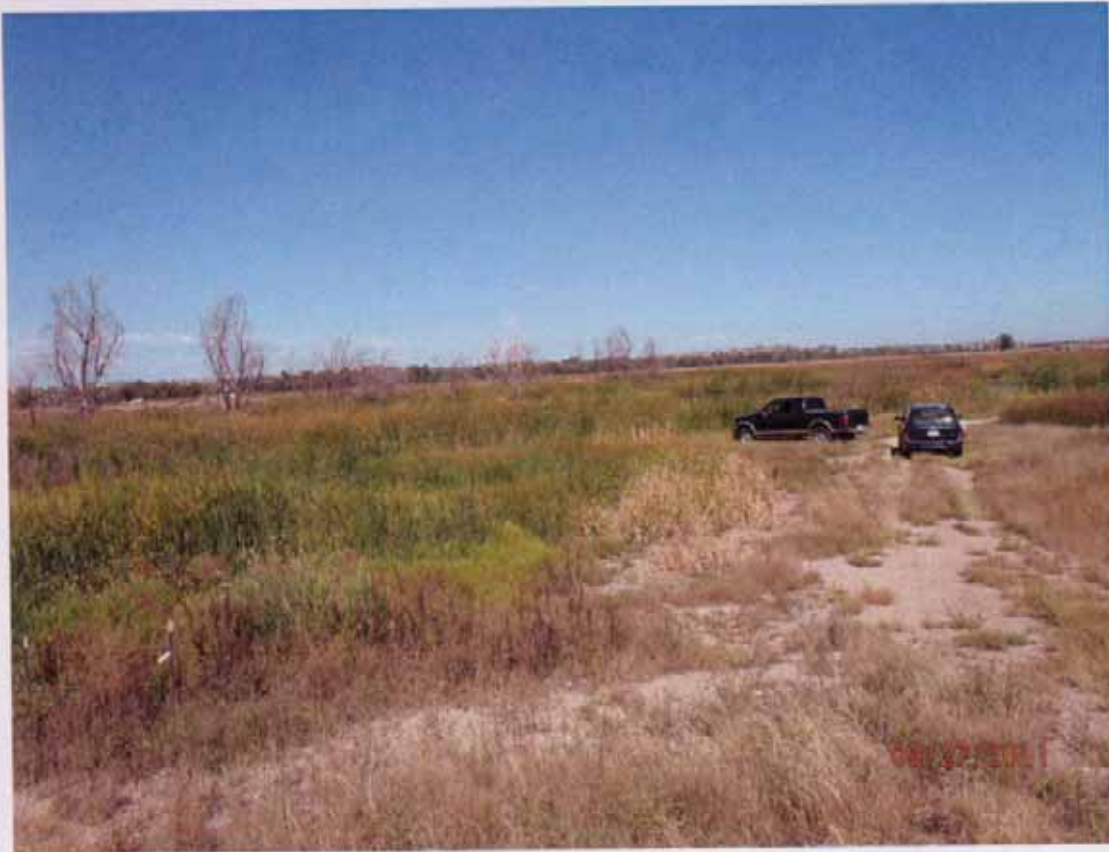
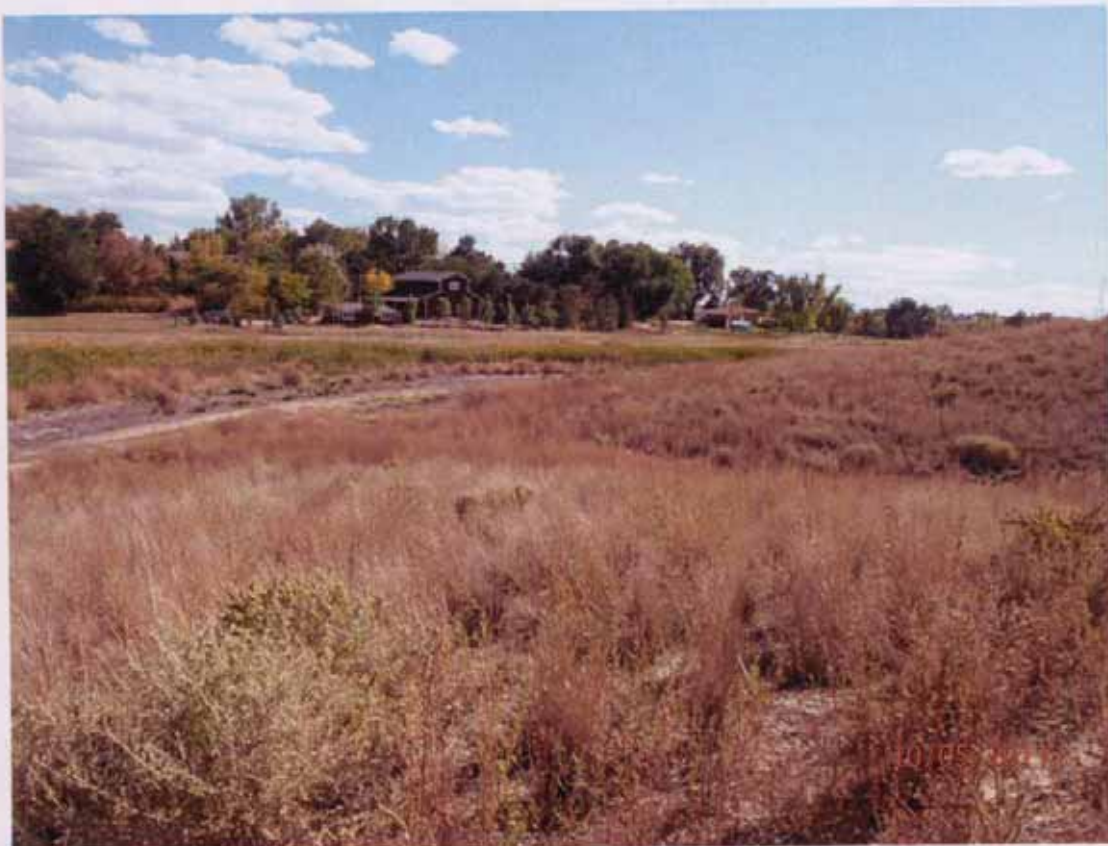
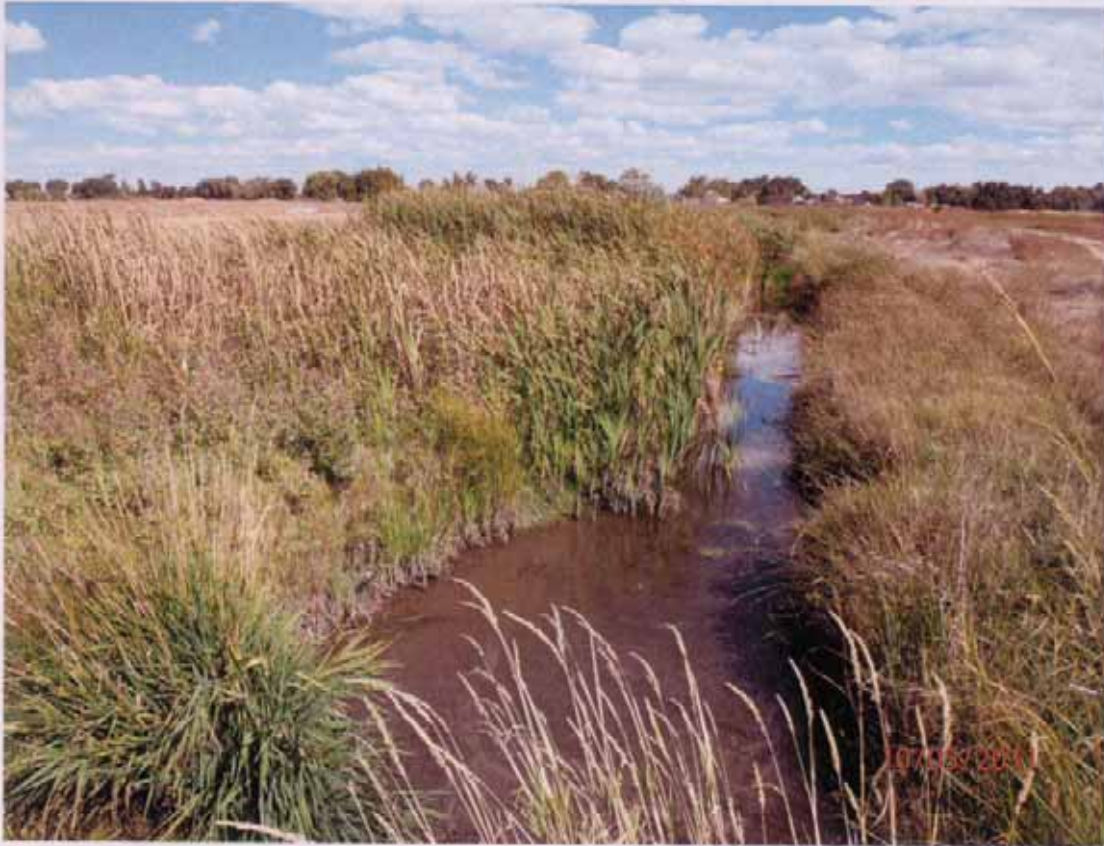
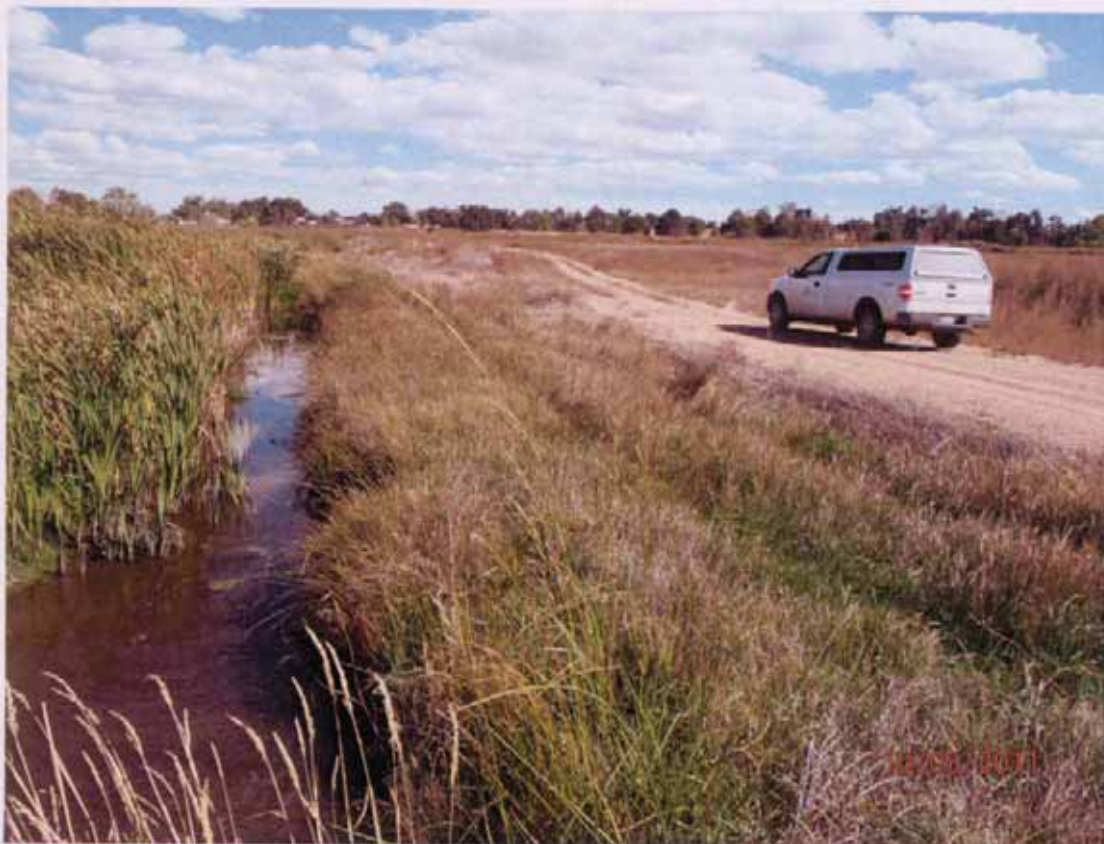
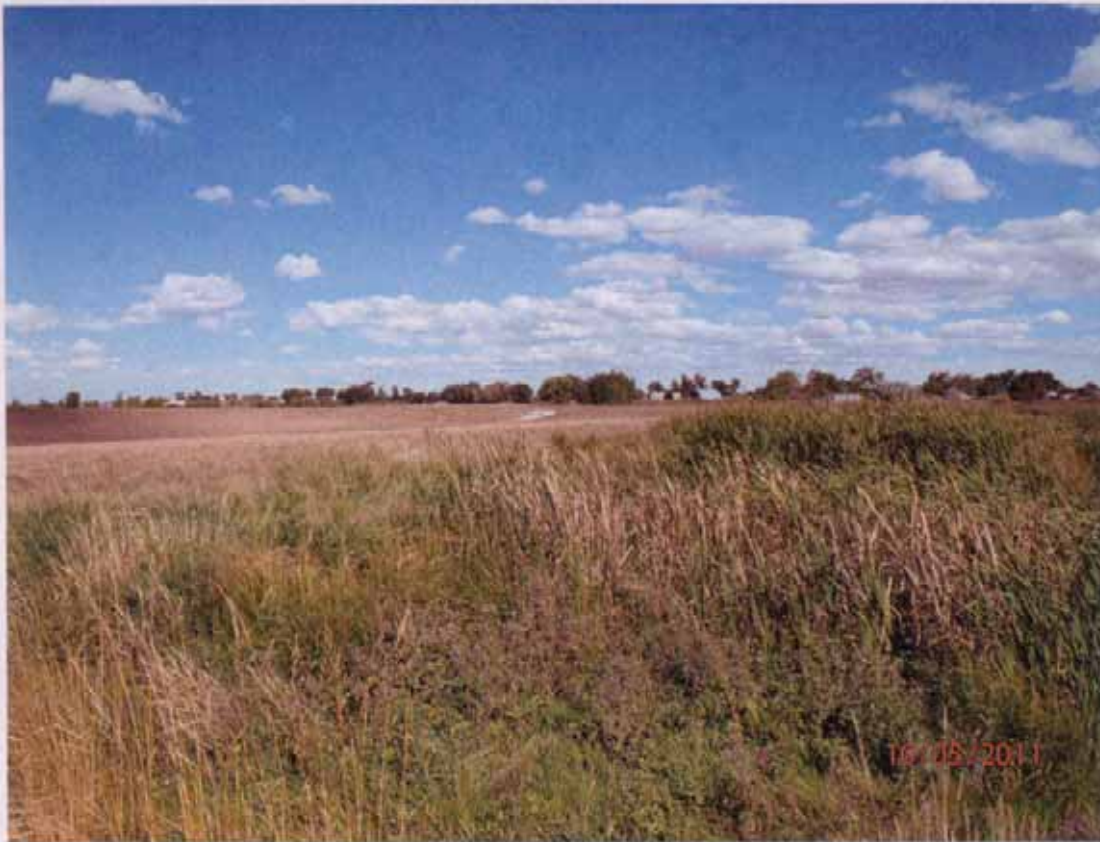
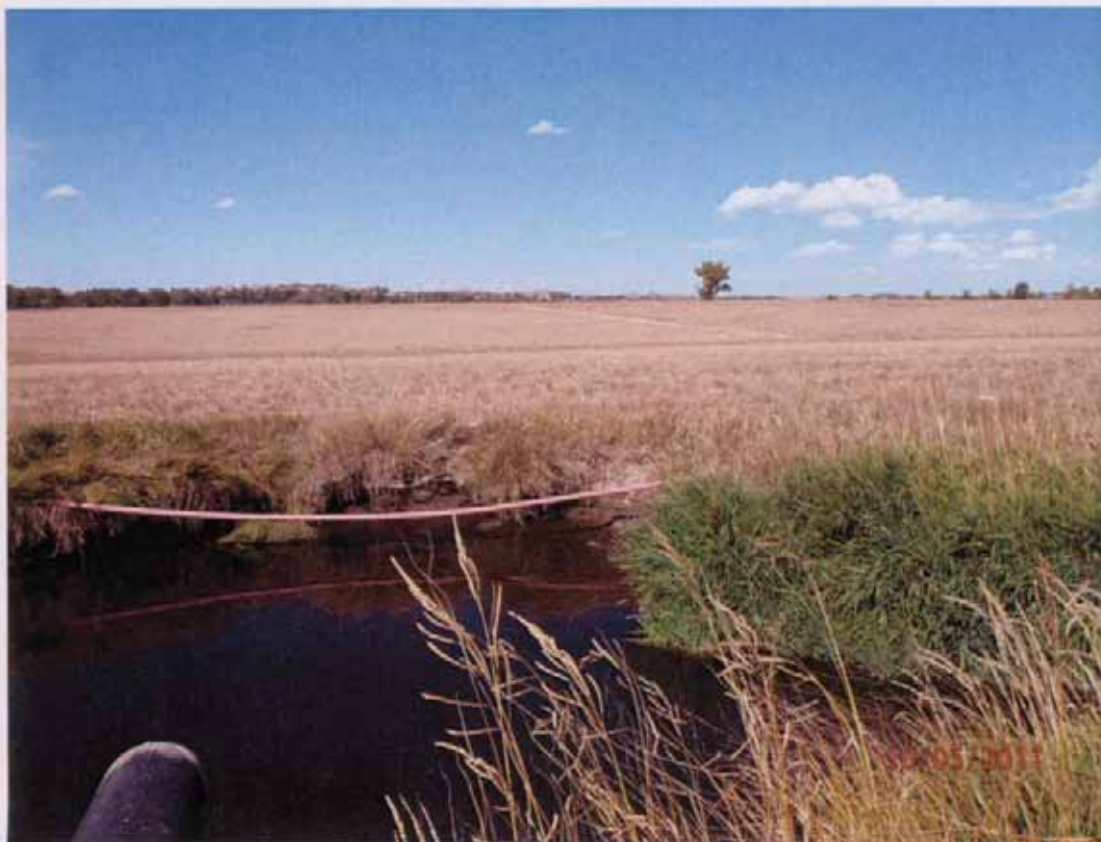
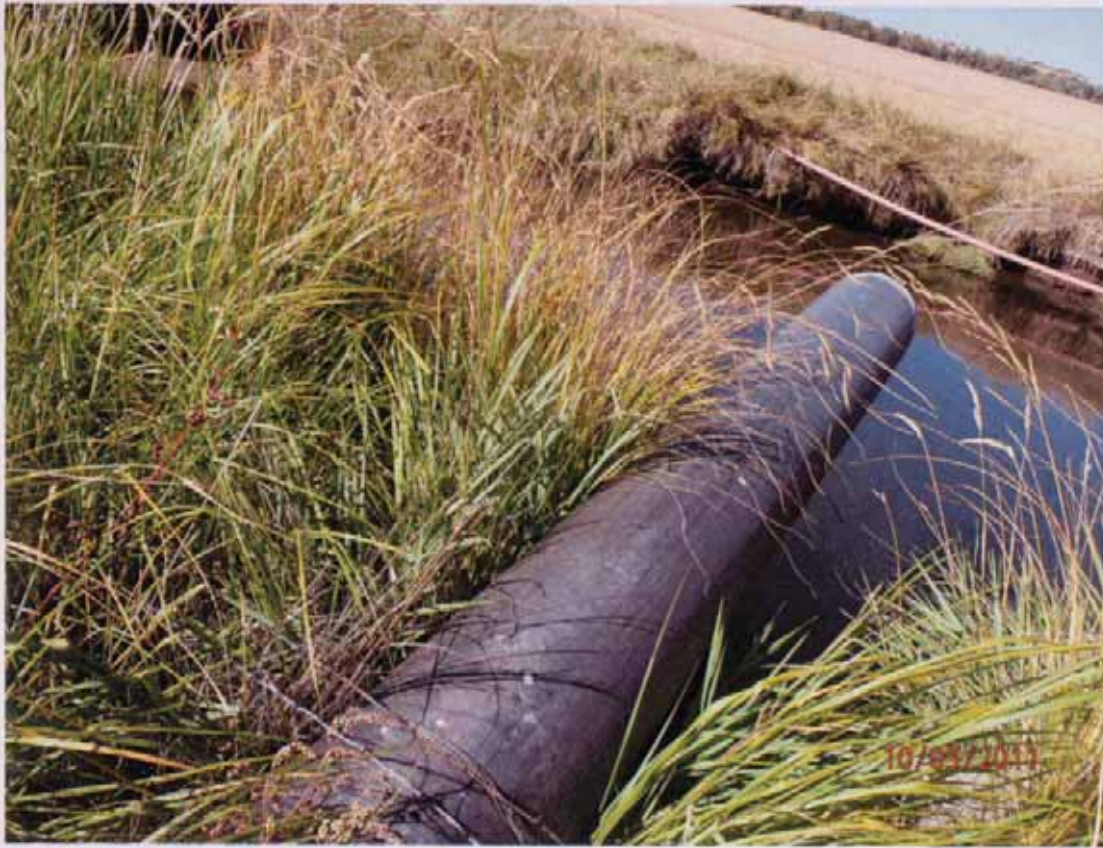
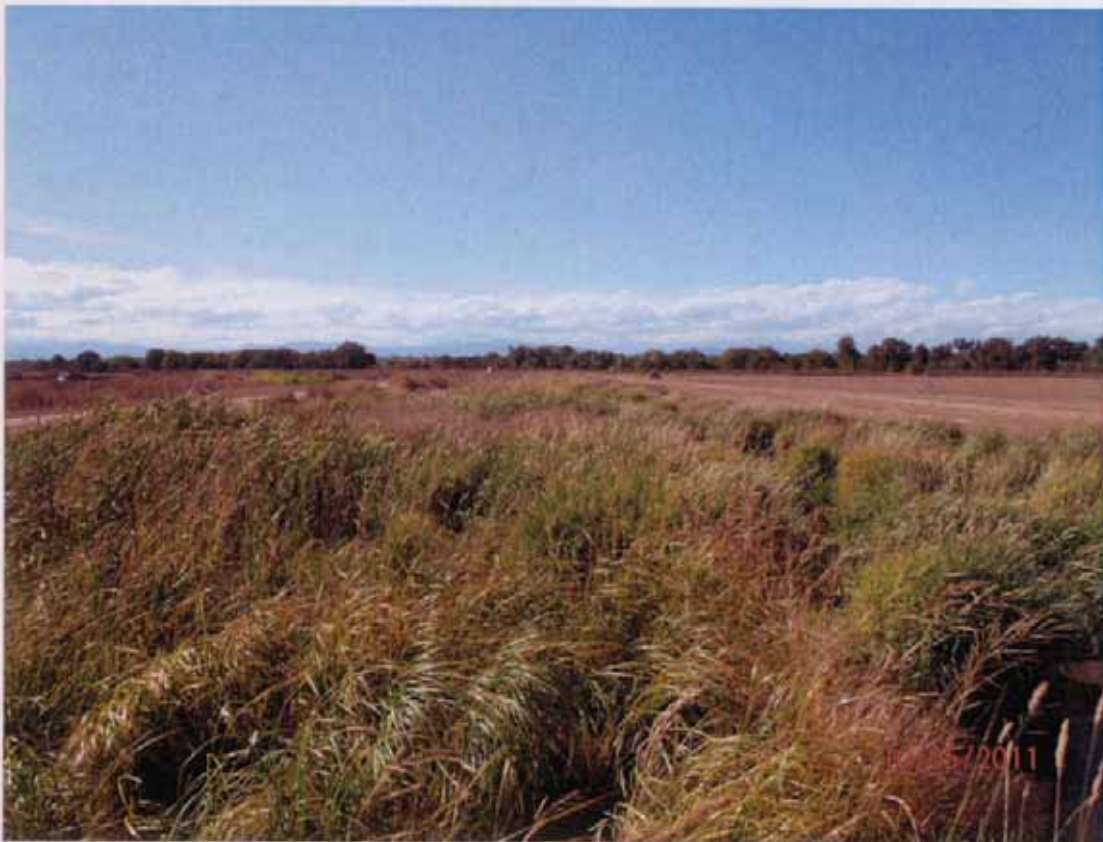
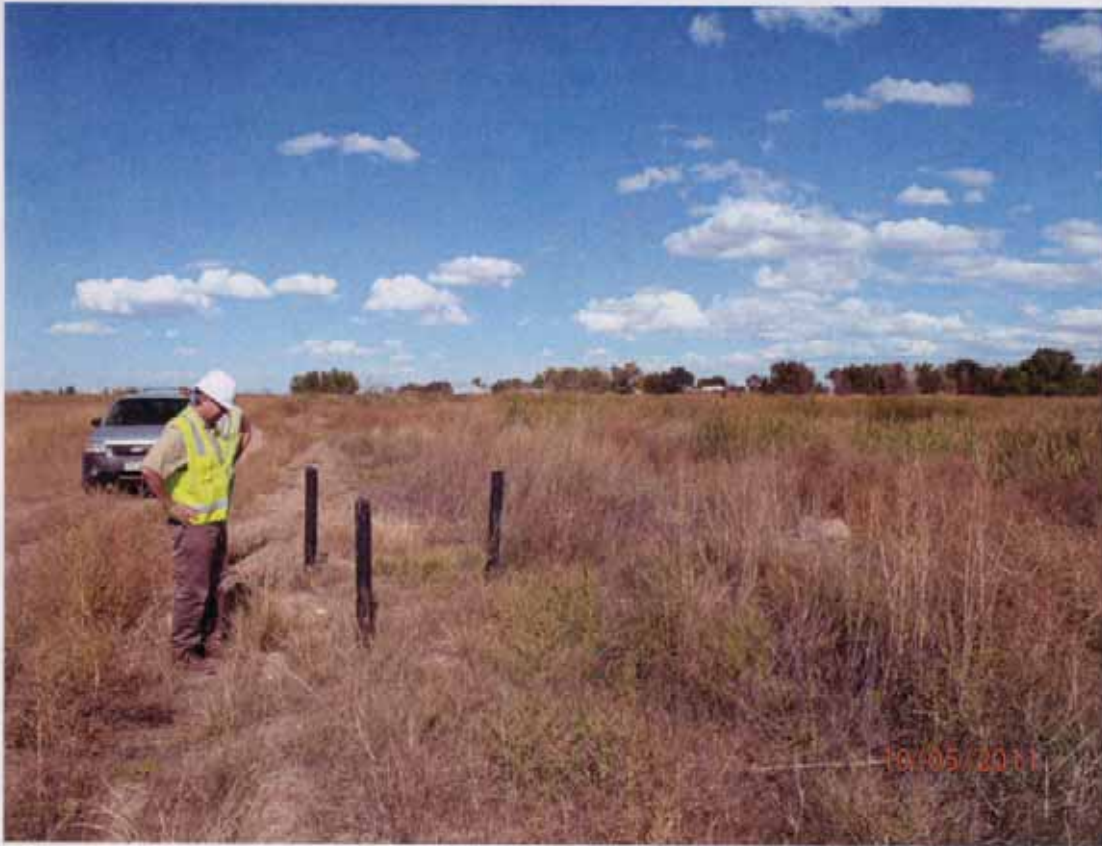
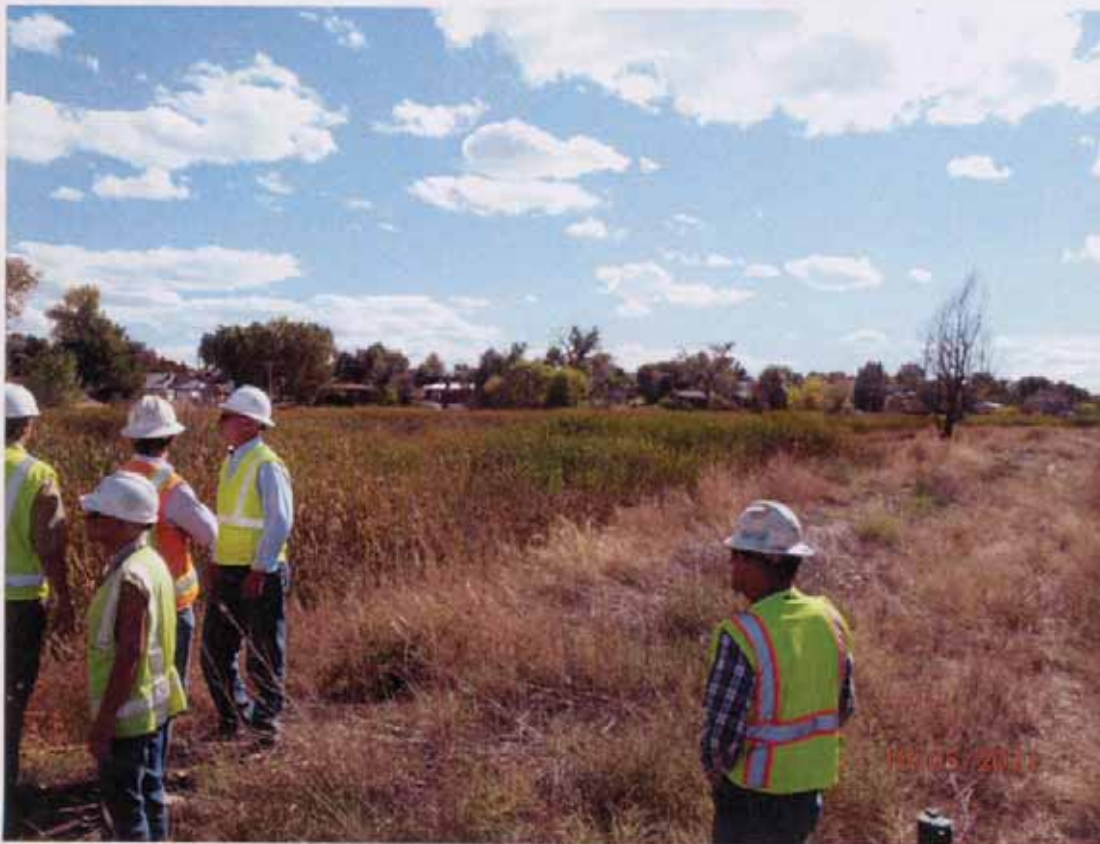
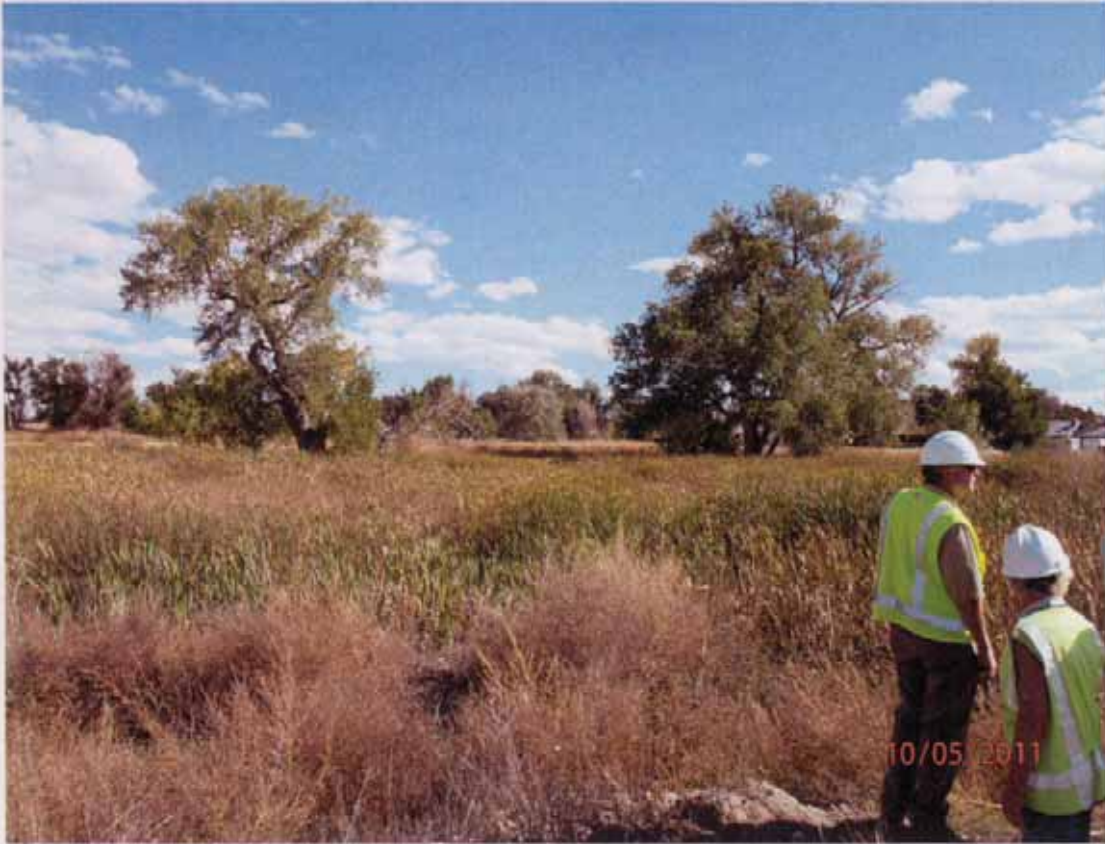
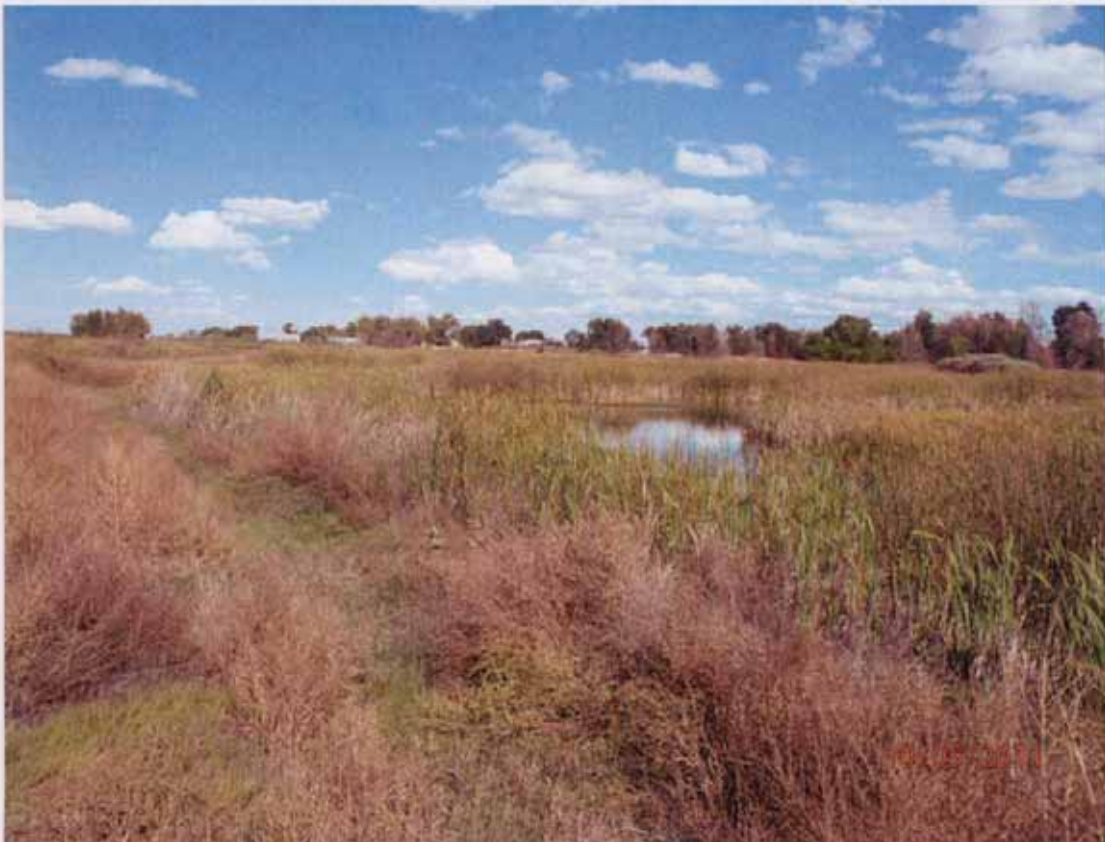
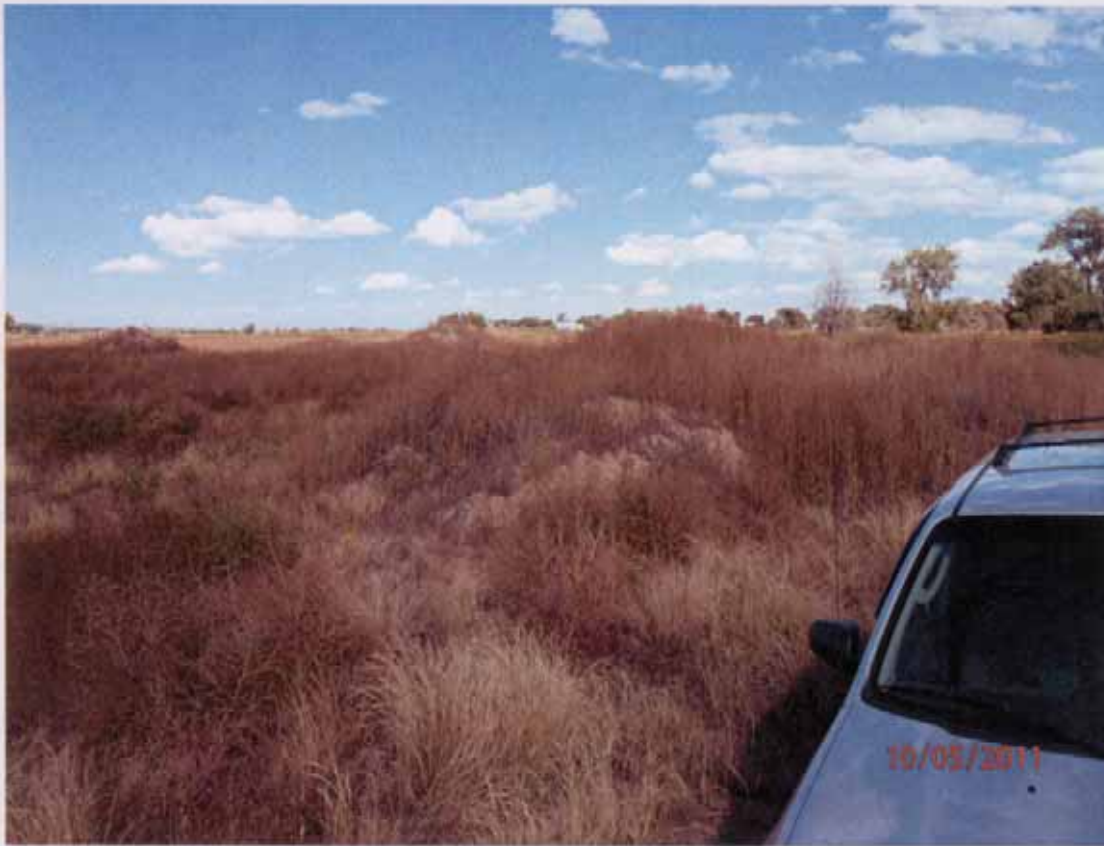
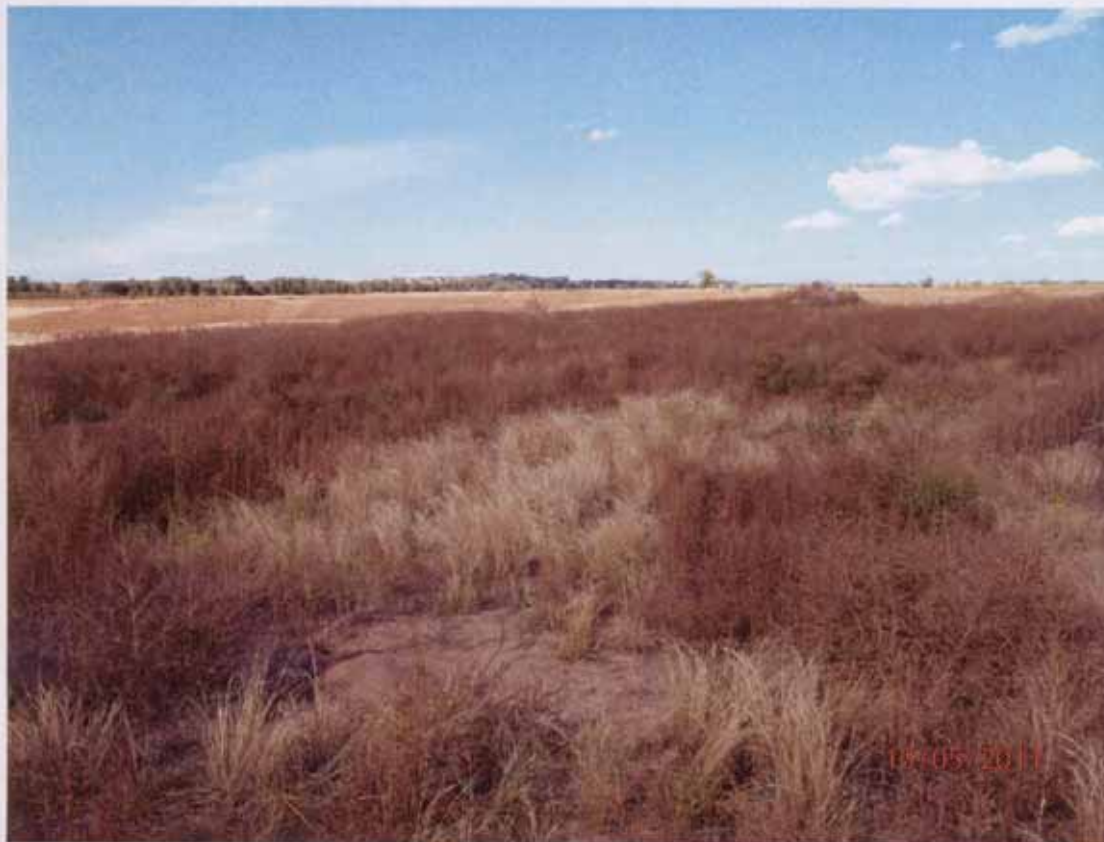
**PHOTOGRAPHS**

**PROBLEM/POSSIBLE VIOLATION:** (PB) The slurry wall installed in 2005, lacking means of ground water conveyance around the pit, is causing ground water mounding and elevated ground water levels upgradient of the site. This is causing the water table to rise to the point that areas that were dry before the slurry wall installation are now saturated, and in some places inundated. This represents an Enforcement Problem, and could escalate to a Possible Violation if allowed to continue unabated. The following sections of the Colorado Mined Land Reclamation Act apply: (1) §34-32.5-116(4)(h) for failure to minimize disturbances to the prevailing hydrologic balance of the affected land and of the surrounding area and to the quality and quantity of water in surface and groundwater systems during the mining operation, and (2) §34-32.5-116(4)(i) for failure to protect areas outside of the affected land from slides or damage occurring during the mining operation.

According to company monitoring records, a slurry wall was installed around the site in May or June 2005. The complaint from Mr. Orr alleges that his land was dry before the slurry wall, but after the slurry wall the property "has become unusable due to the amount of water accumulating on it. Most of the site is now a swamp area that was historically dry." We walked the property and observed sizable areas of inundation, standing water, and well-established wetlands. An aerial photo provided by Mr. Orr dated January 2004 shows clearly that the land in question was dry at that time. The latest Google Earth aerial from 2011 now shows substantial visible areas of standing water. Also observed were several large dead trees that Mr. Orr said were living before the slurry wall was installed, suggesting that the elevated ground water conditions killed the trees. The photograph from 2004 appears to indicate that these trees, located near the northwest fringe of the subject property, were alive at that time.

report by Environment, Inc. (attached) corroborates this conclusion. The Bull Seep is able to convey some of the ponded water around the Hazeltine pit, but the current configuration of the seep does not allow it to drain the upgradient ground and maintain historical ground water elevations in the same manner that a deeper feature such as a French Drain might.

Another problem that was observed on the Hazeltine site is an infestation of weeds. The operator is advised that weed control measures must be implemented in time to prevent a re-emergence of this infestation in the Spring of 2012. The Division will check the success of the weed control program in the Spring of 2012.

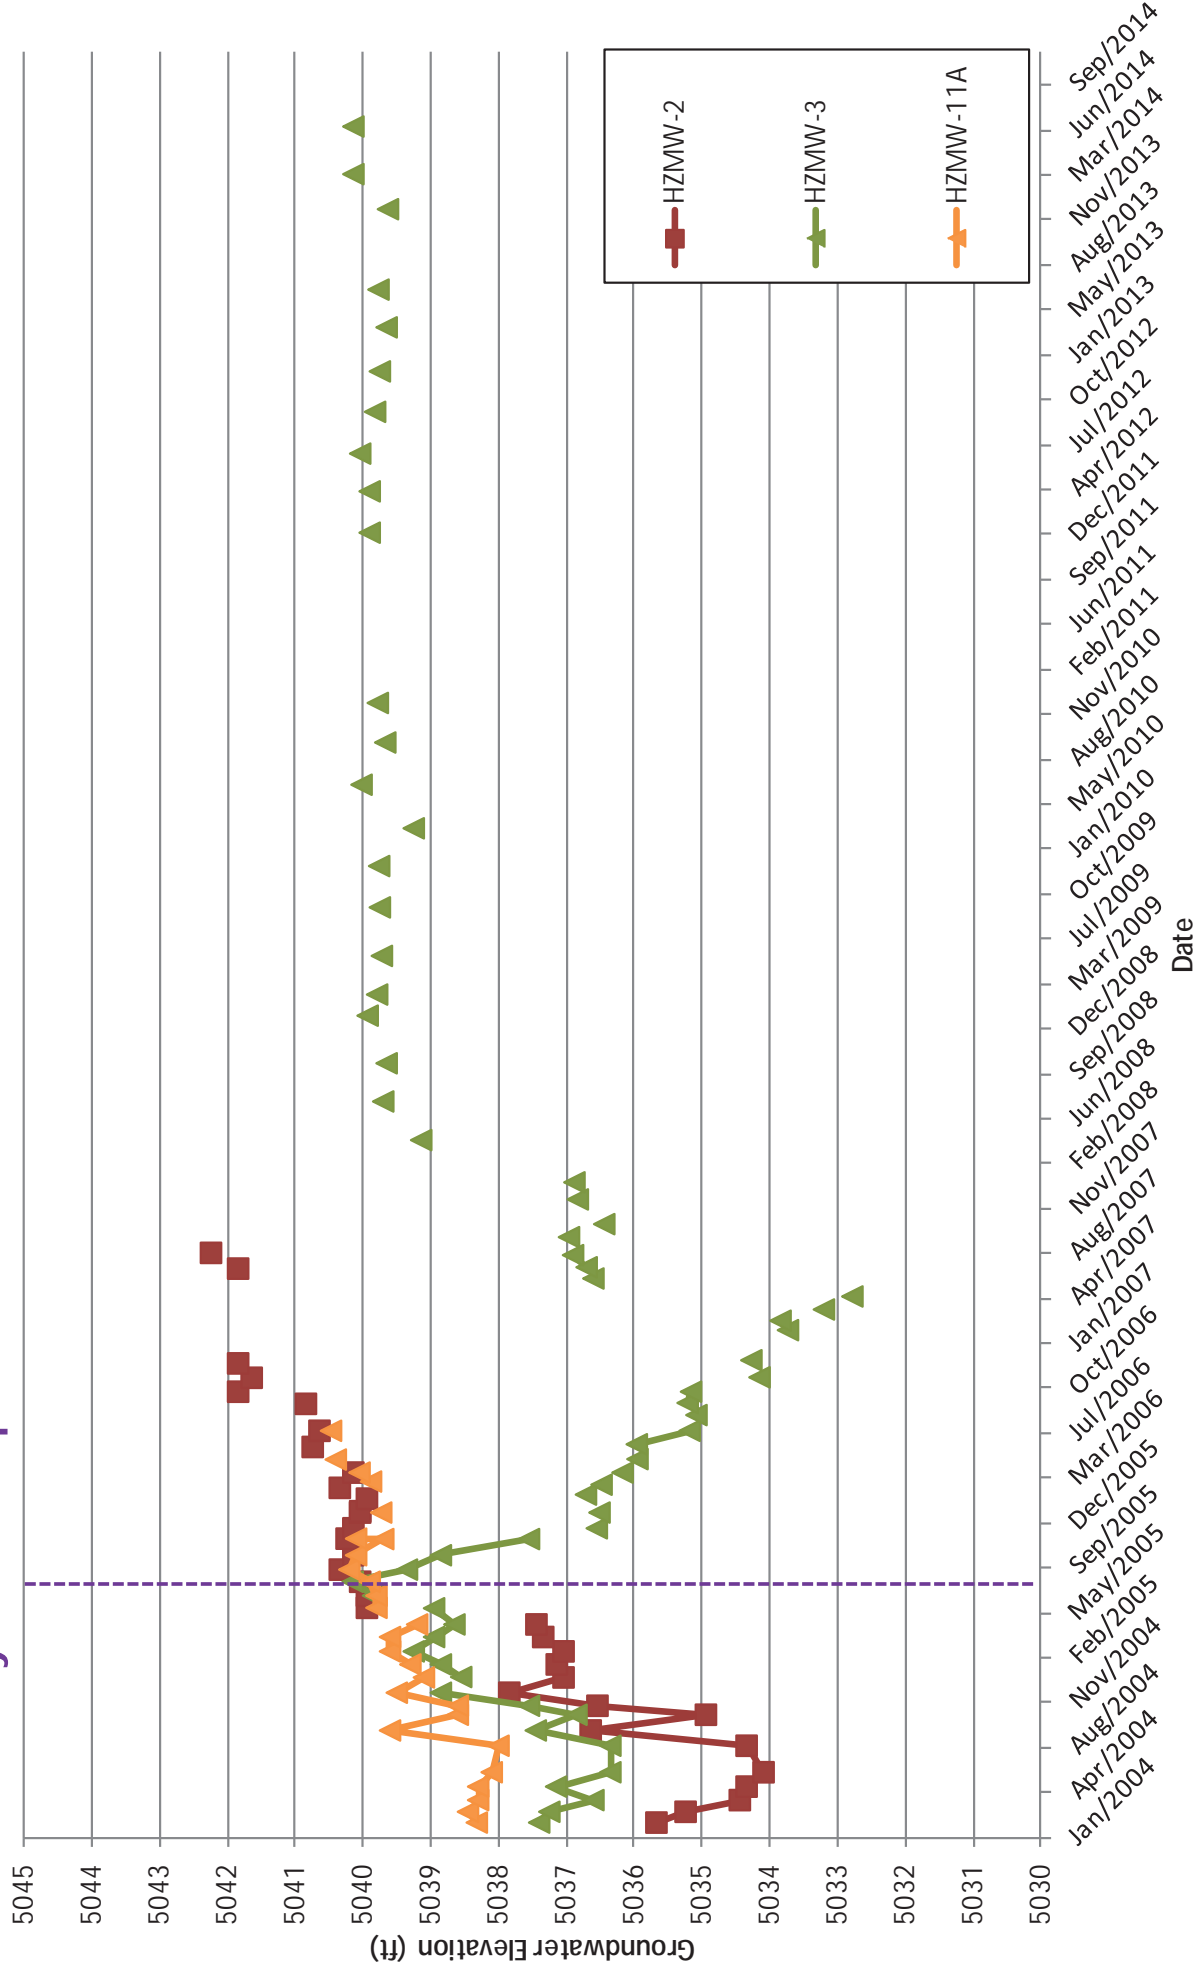
# Groundwater elevation in wells near Orr Property

Slurry wall completed
