## MEMO

**RE:** Aggregate Industries – WCR, Inc., DRMS Permit No. M-2004-031, Hazeltine Mine  
Enforcement Hearing

Consideration of a possible violation, corrective actions, and civil penalties, for failure to minimize disturbance to the prevailing hydrologic balance in the surrounding area and failure to protect areas outside the affected land from damage.

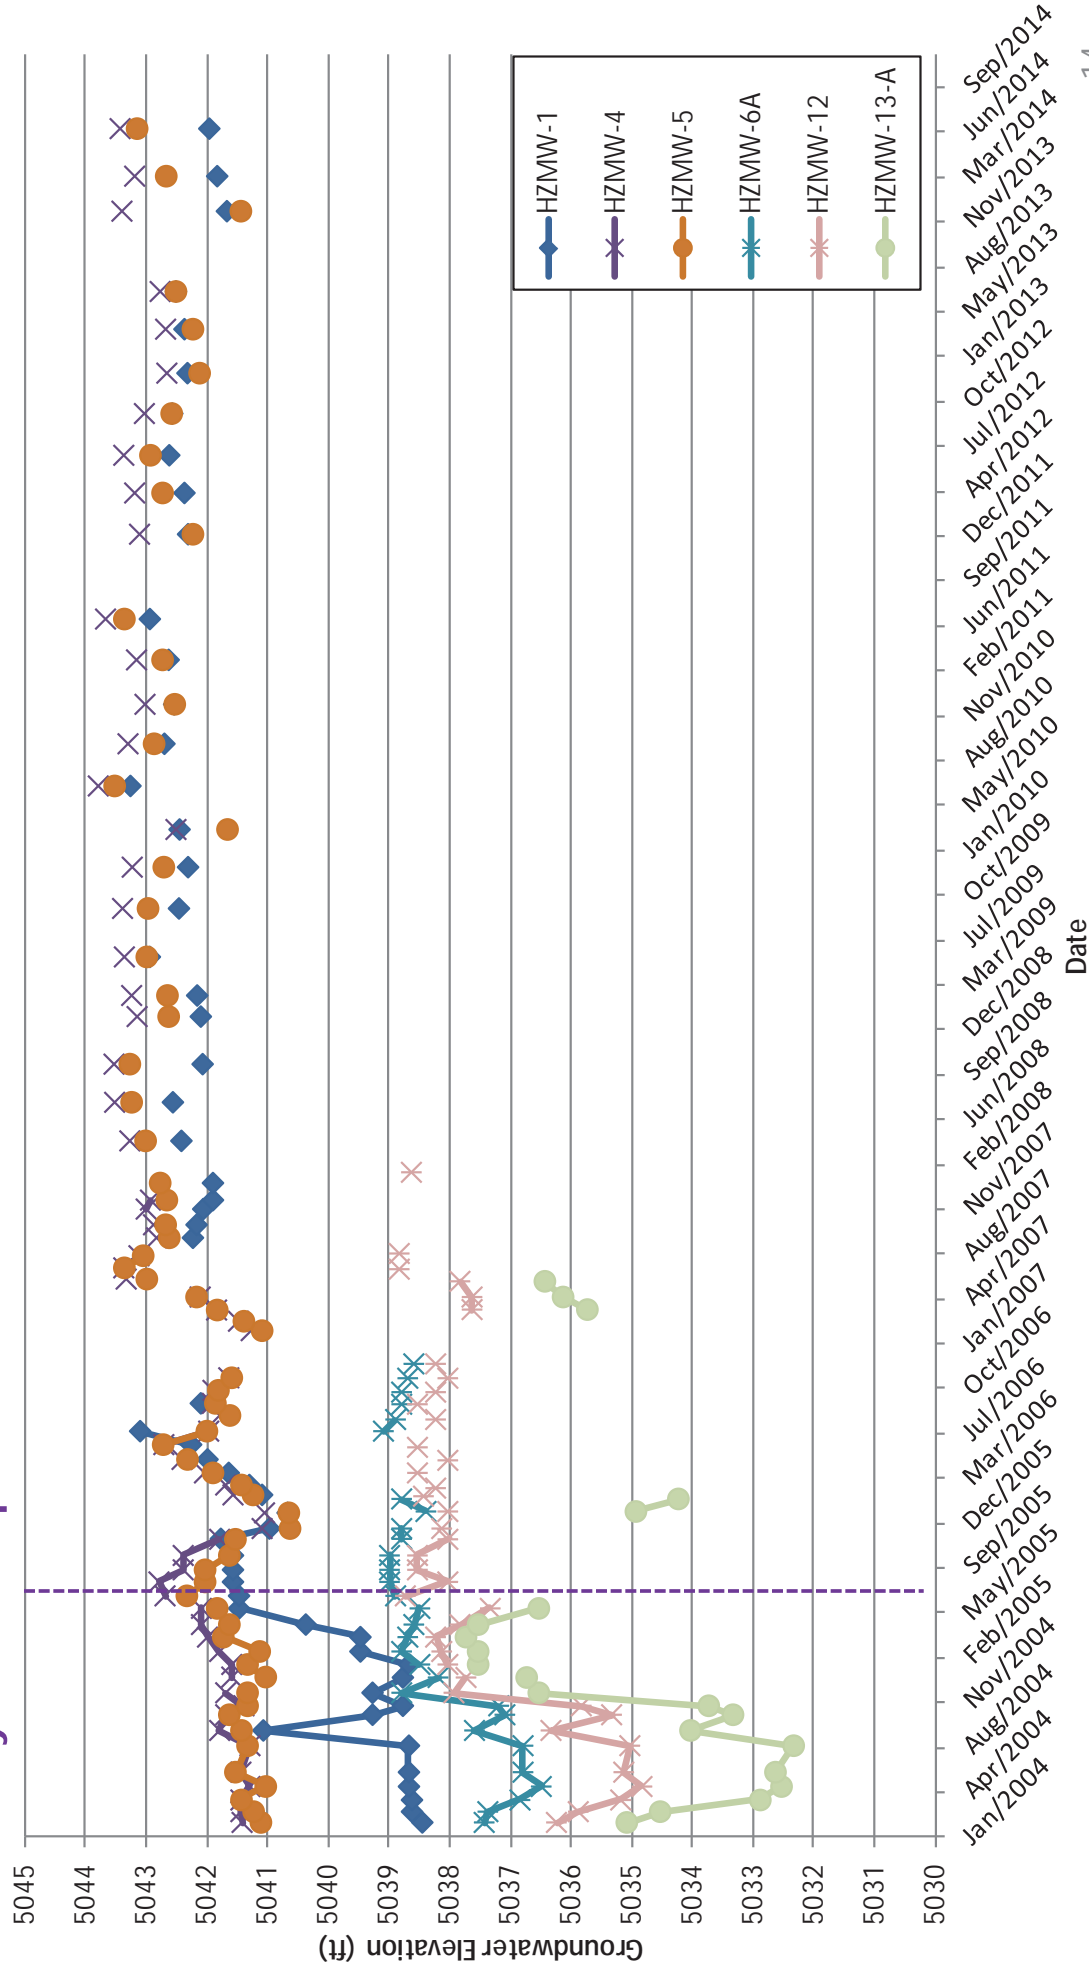
# Groundwater elevation in wells east of the Hazeltime Mine

Slurry wall completed

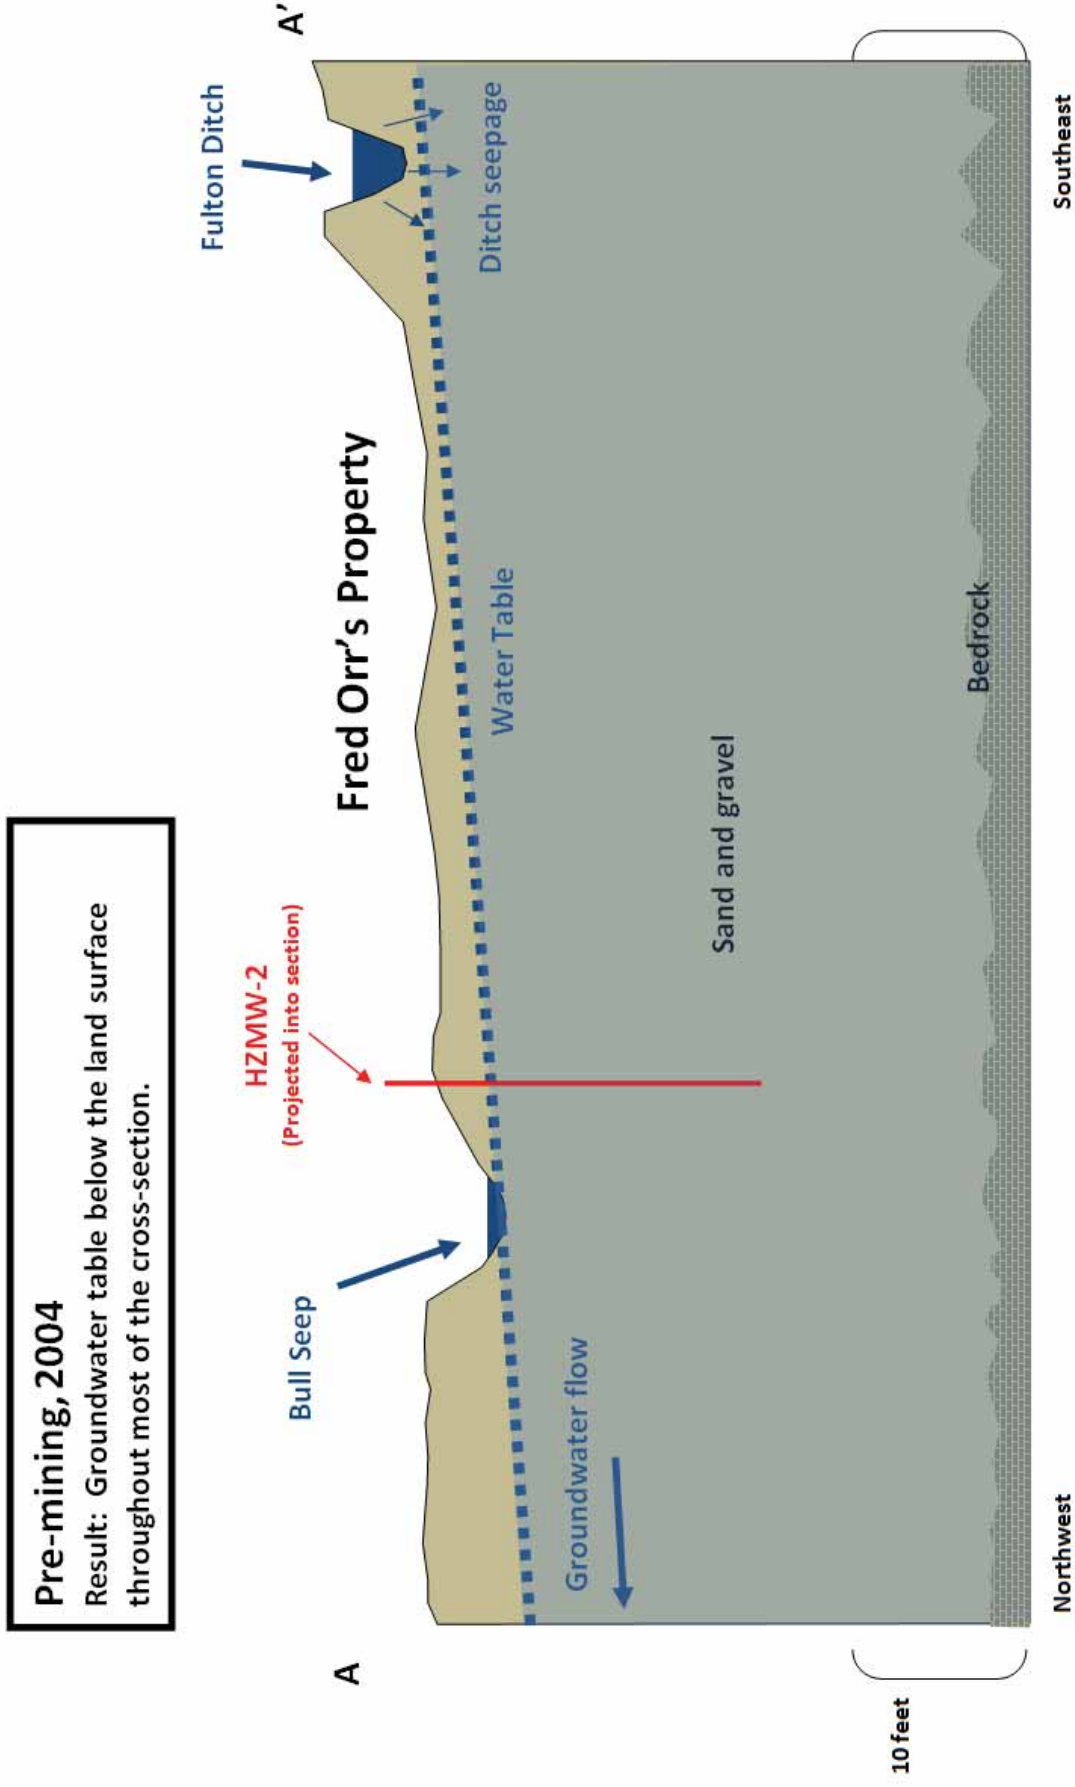
# Groundwater mounding at the Hazeltime Mine

- Observed flooding in Orr pasture.
- Flooding is caused by groundwater mounding.
- Hazeltine Mine is a major cause of the groundwater mounding, as indicated by the hydrogeologic model (cross-section) and historical data.

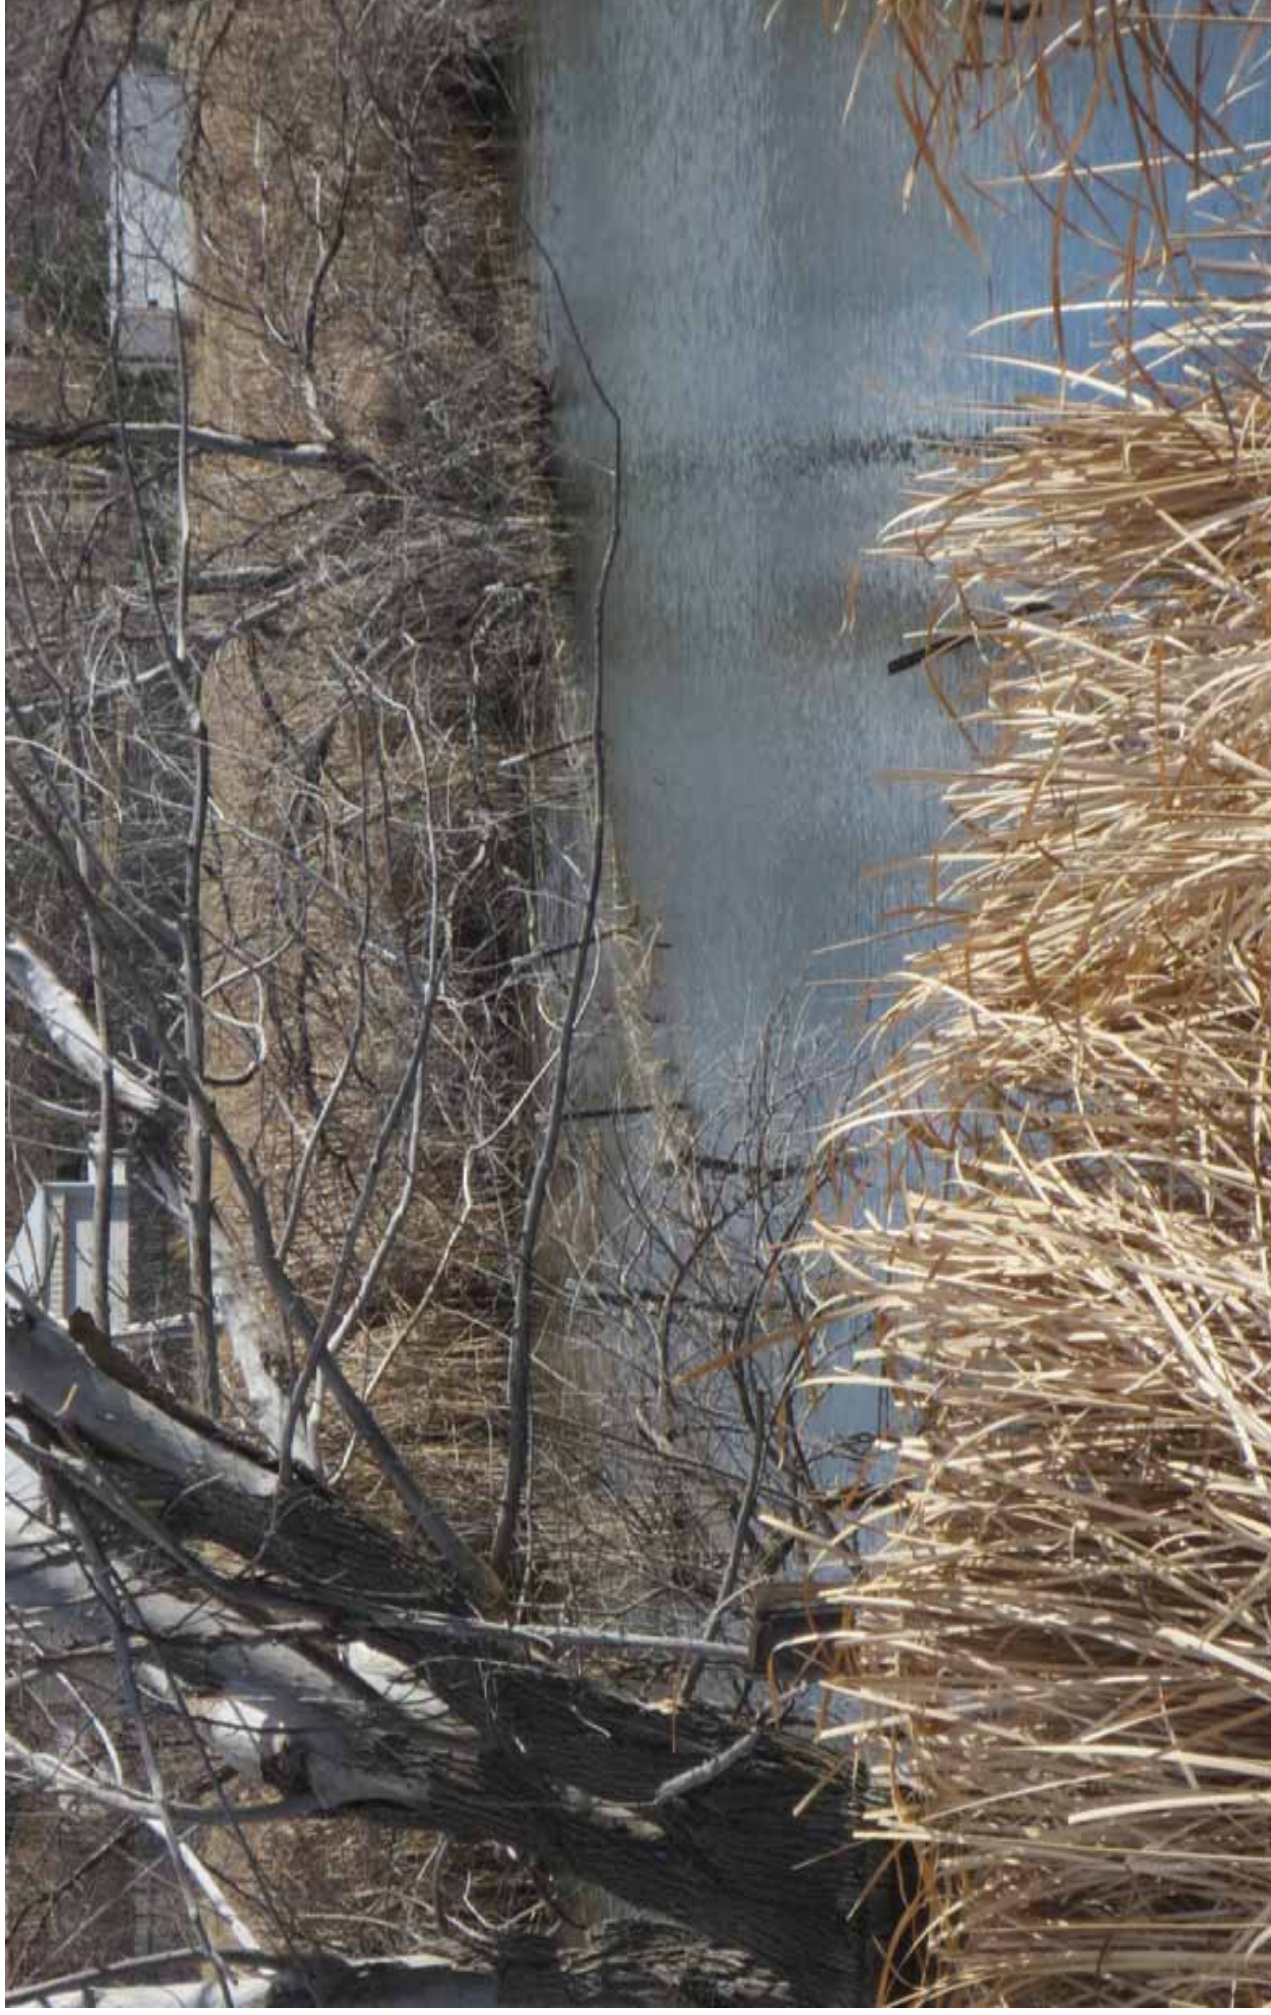
# Inspection May 27, 2014

- March 27 and May 27, 2014 – DRMS Inspections
  - Found groundwater mounding and saturated conditions on the historically dry Orr property.
- May 15, 2014 – Approval of TR-03
  - New screen and Agridrain monitoring.

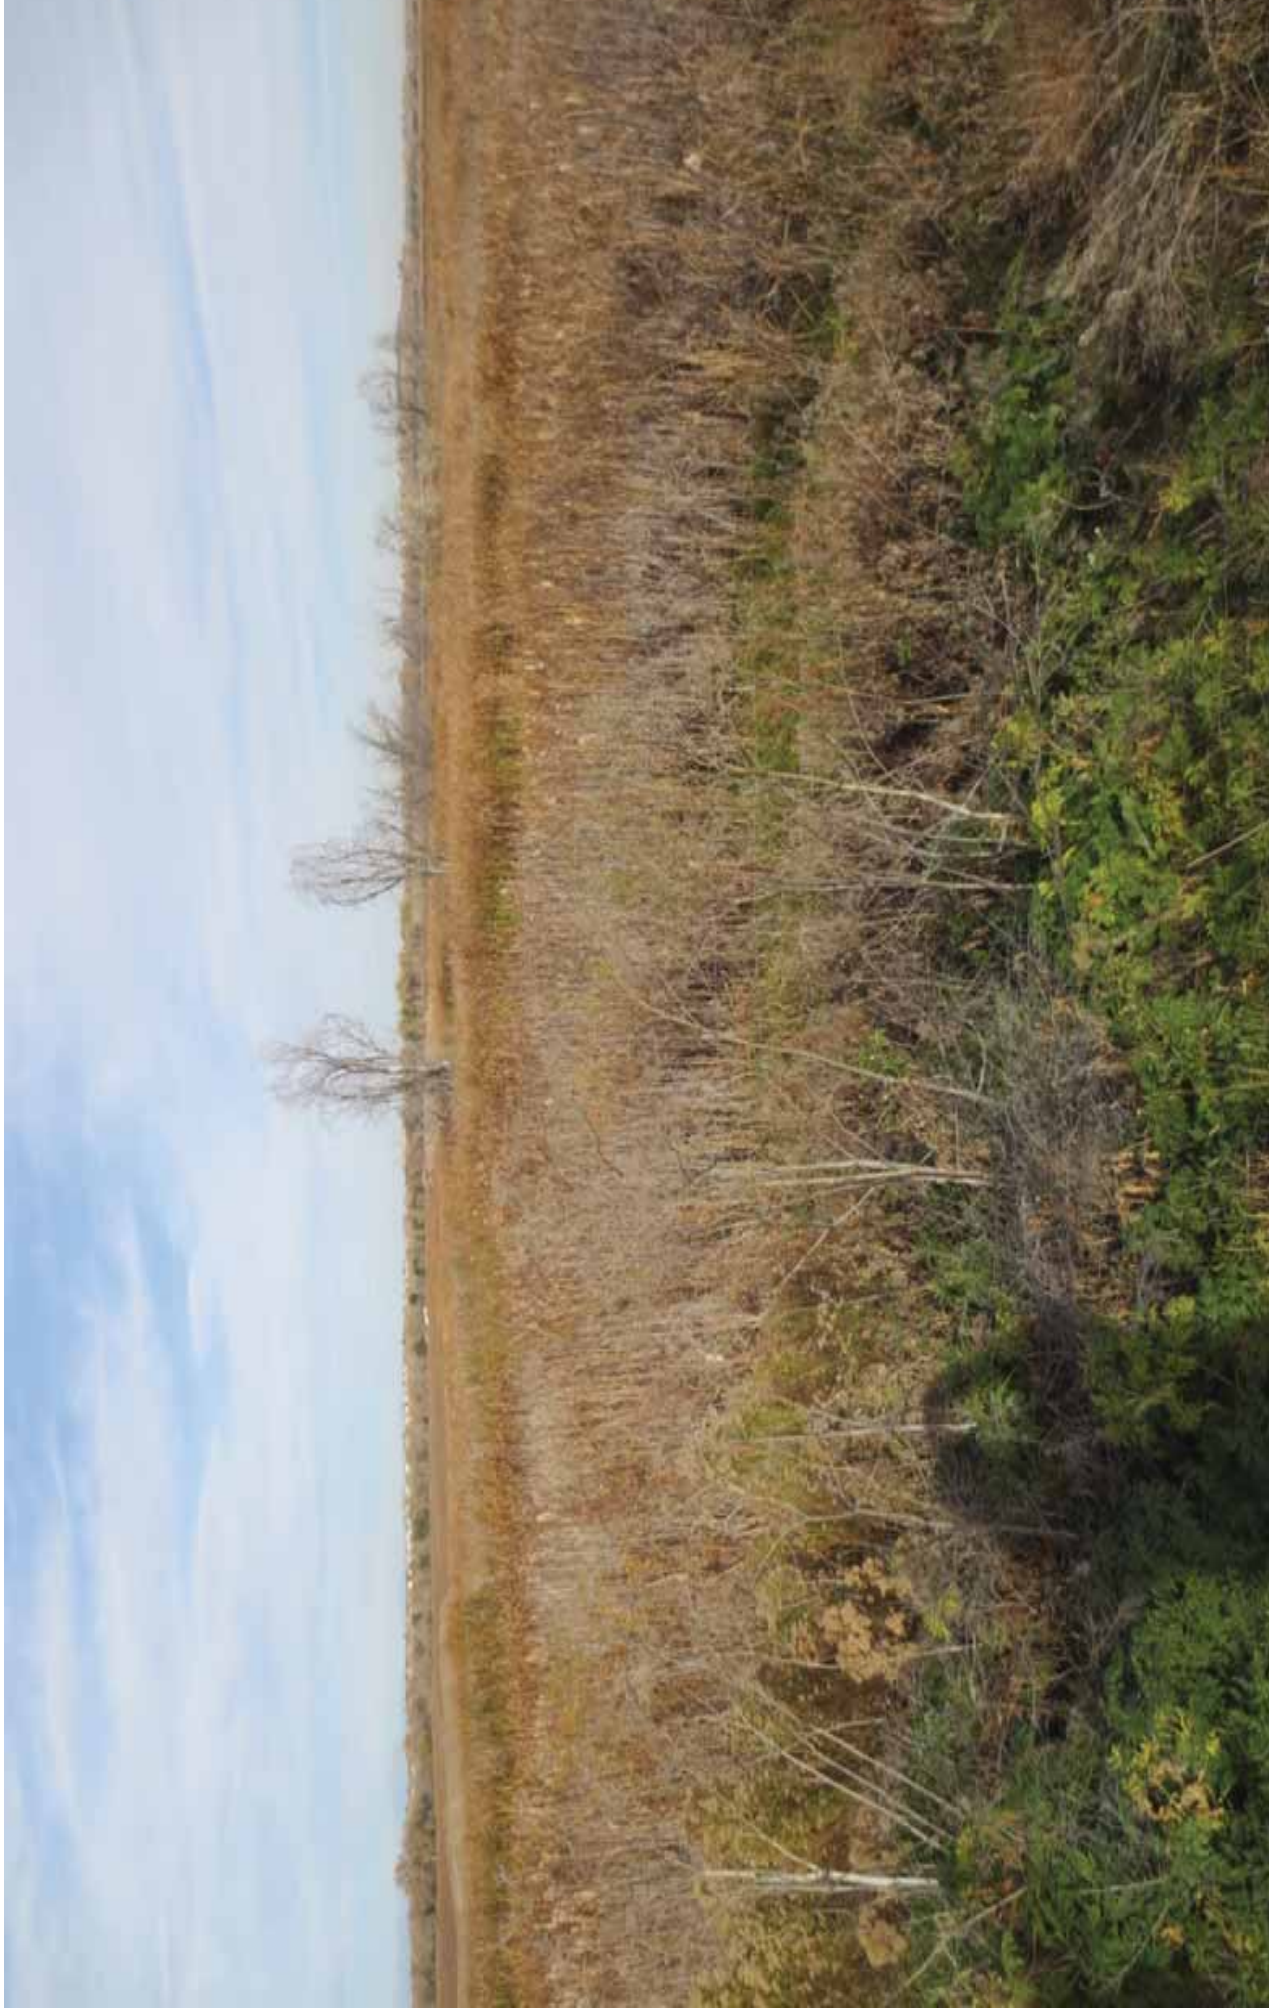
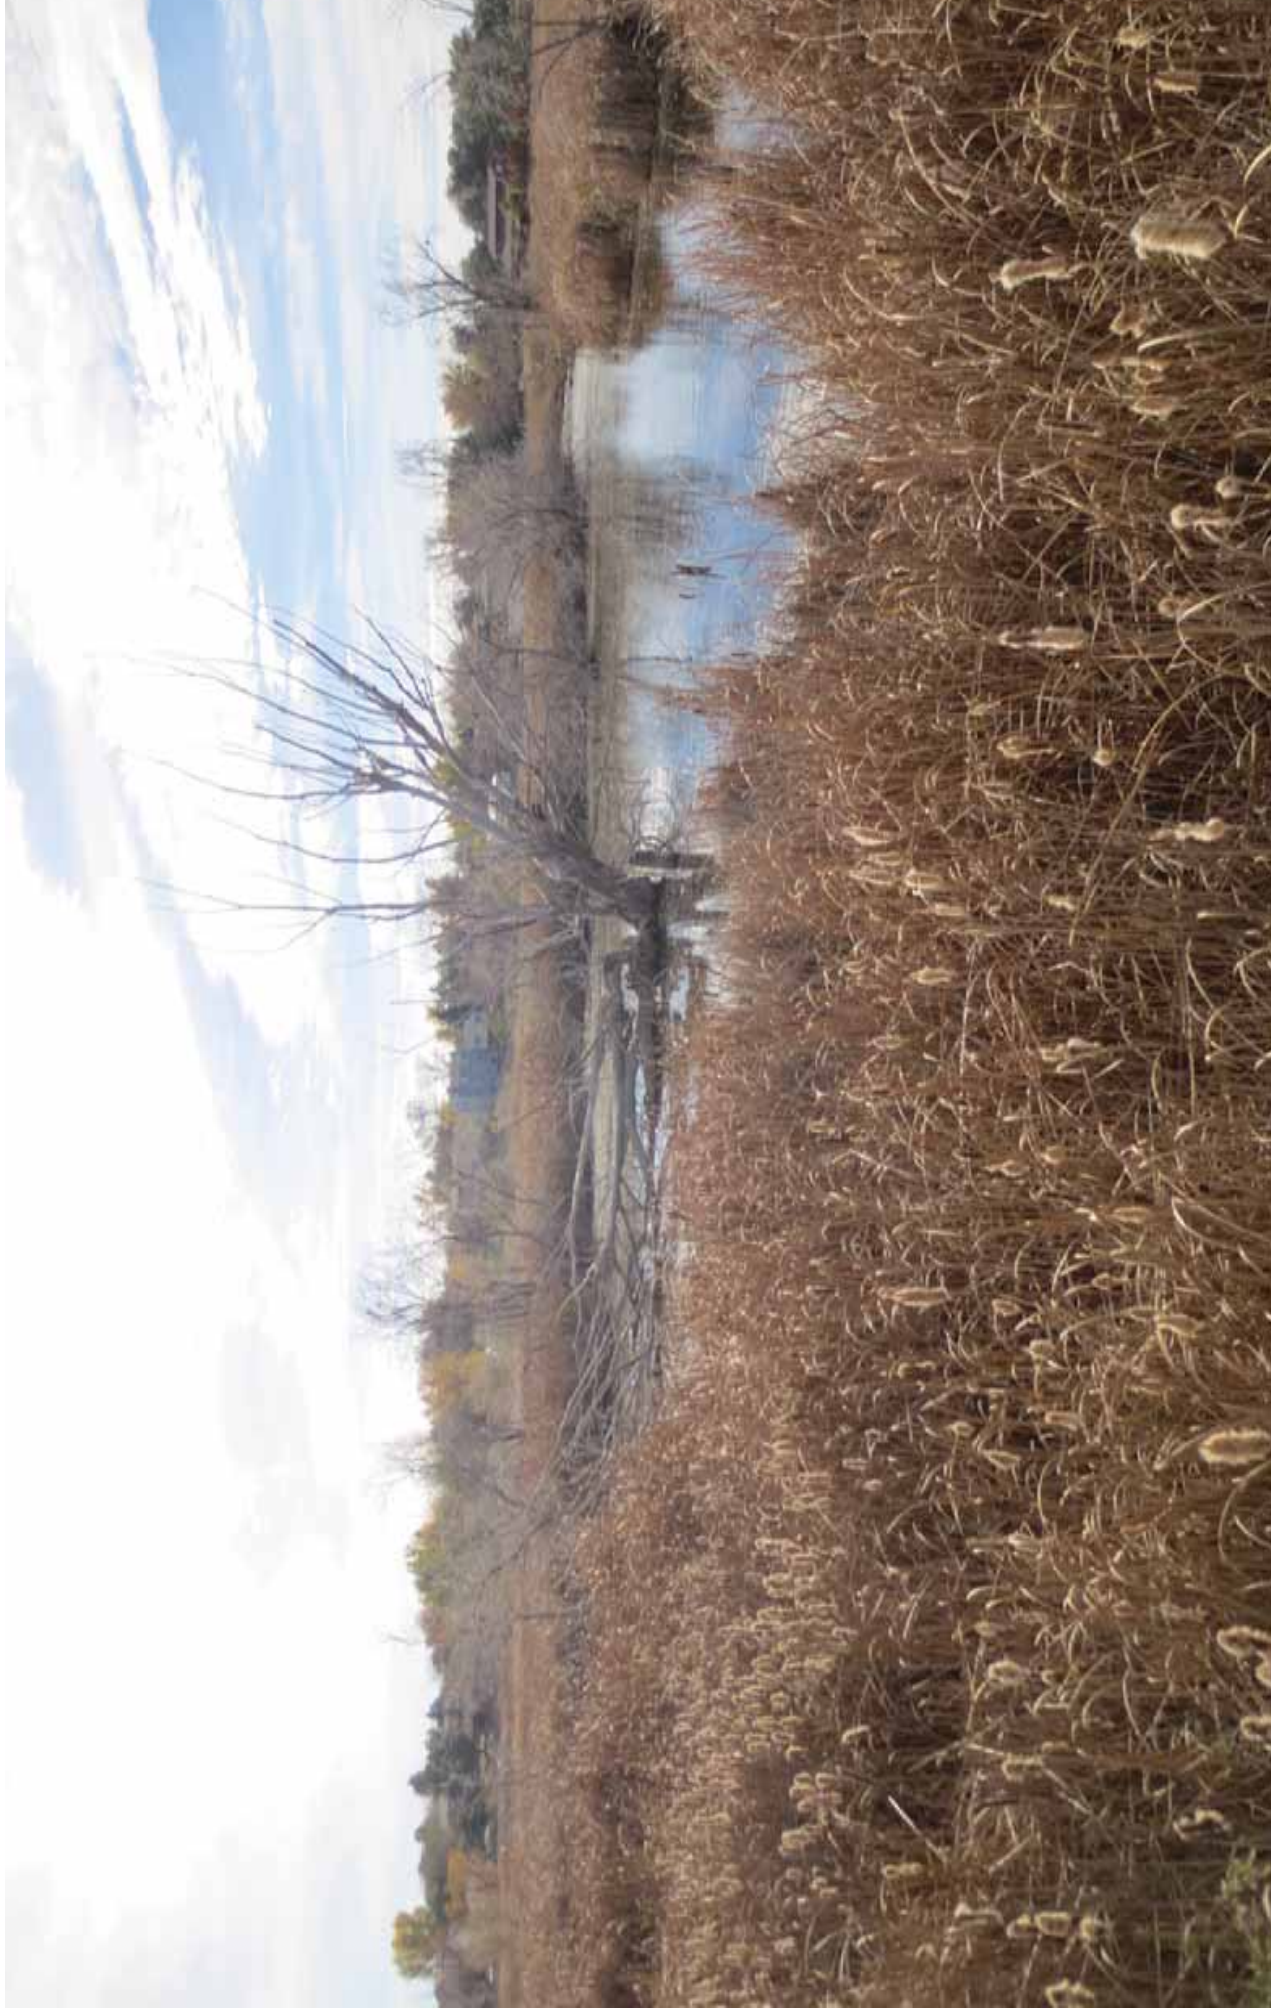
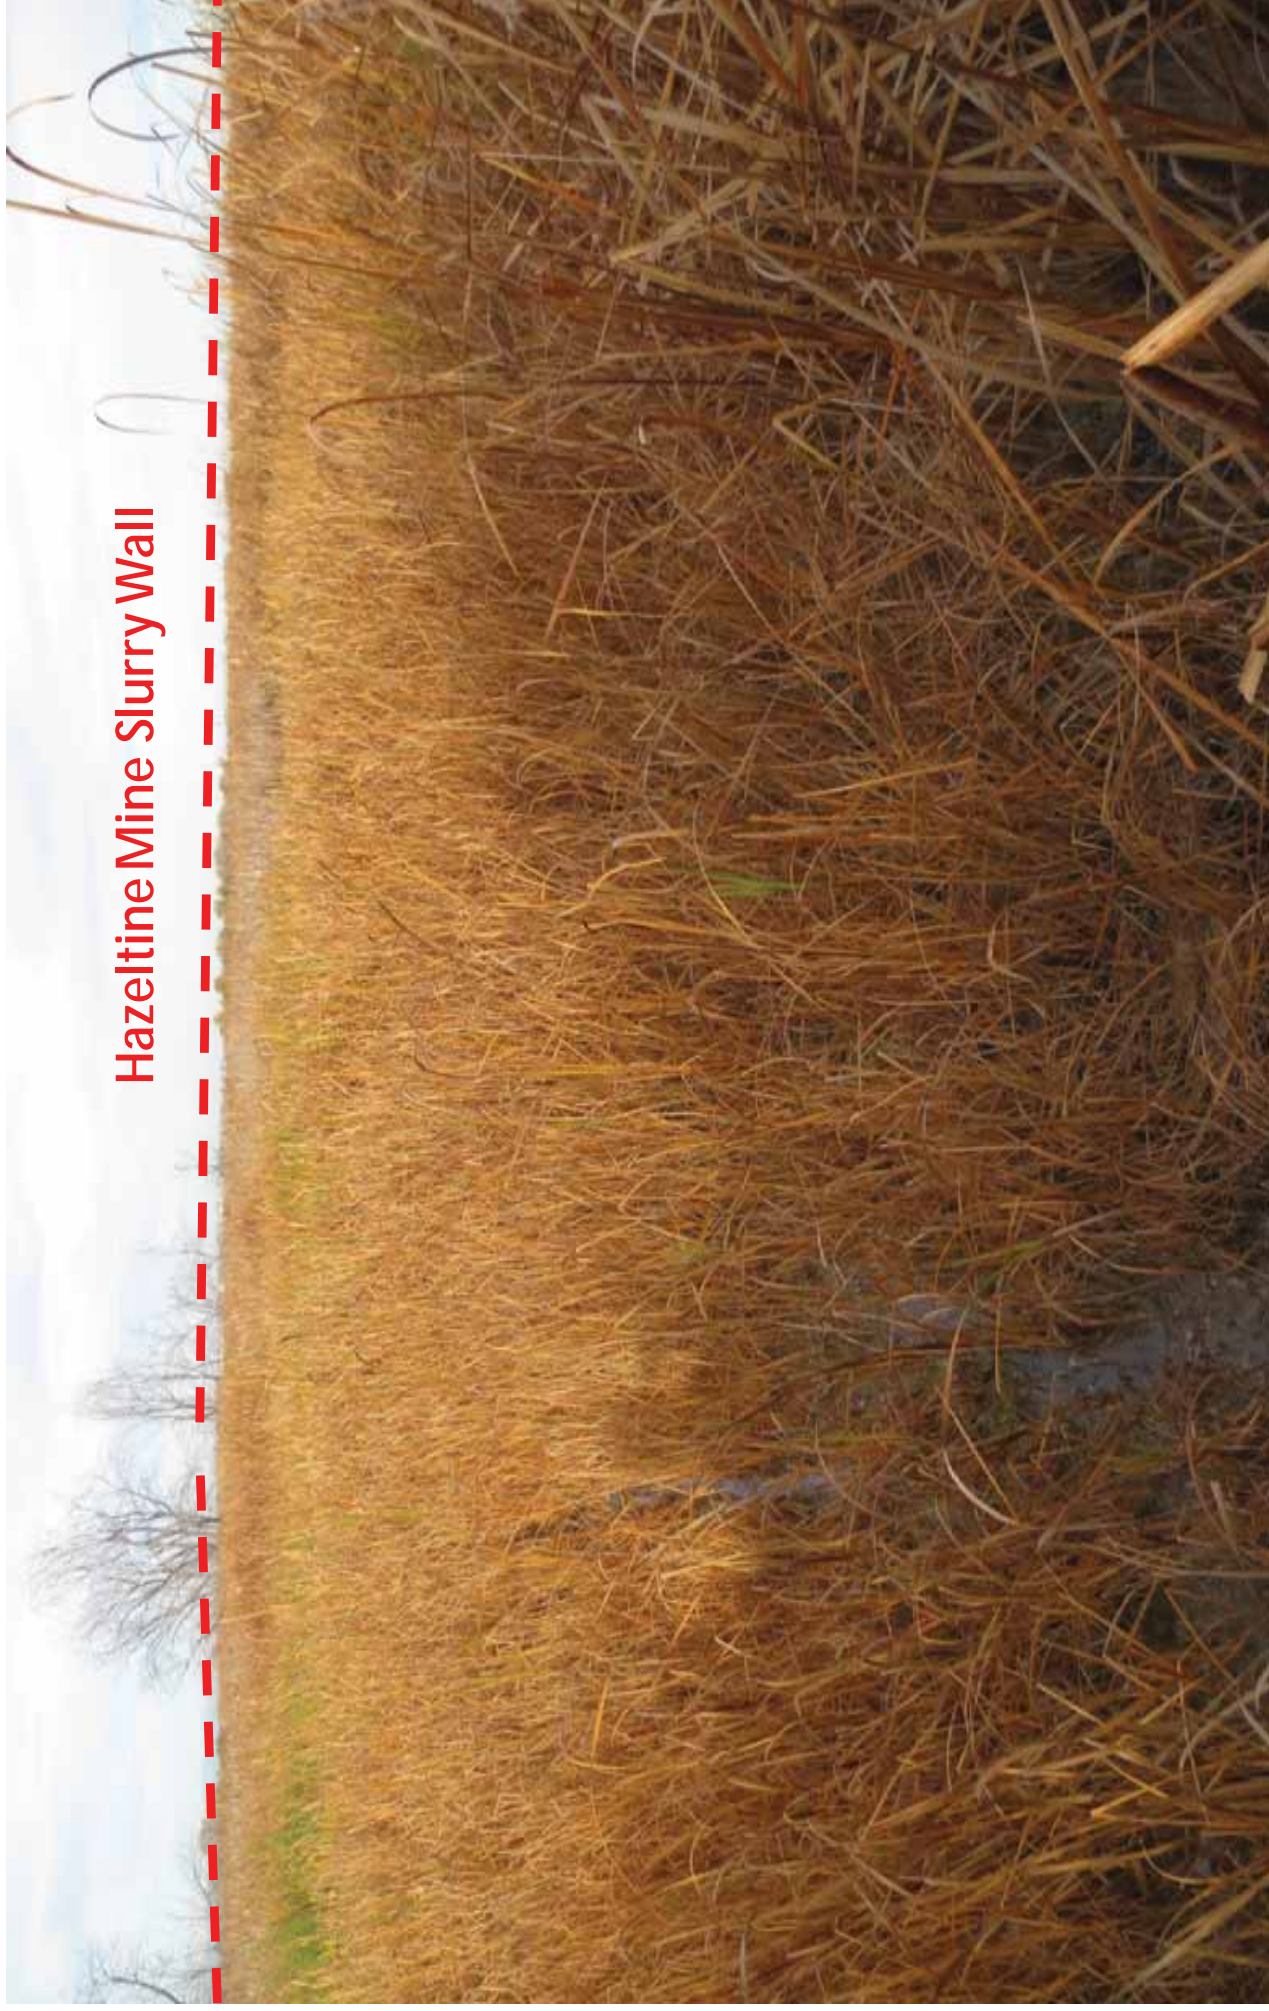
# Inspection October 31, 2014

- October 31, 2014 – DRMS Inspection Report
  - Found groundwater mounding and saturated conditions on the historically dry Orr property.
  - DRMS required submittal of ground water mounding mitigation by Nov. 25, 2014
- February 3, 2015 – RTB letter mailed to Aggregate industries, regarding flooding of Orr property.

- B. The Temporary Plan shall eliminate flooded conditions on the adjacent Orr property within 60 days of commencement, by controlling groundwater mounding.
