COLORADO DIVISION OF RECLAMATION, MINING AND SAFETY
MINERALS PROGRAM INSPECTION REPORT
PHONE: (303) 866-3567

MINE NAME: LBC Bentonite Pit	MINE/PROSPECTING ID#: M-1977-231	MINERAL: Clay (general)	COUNTY: Fremont
INSPECTION TYPE: Monitoring	INSPECTOR(S): Timothy A. Cazier	INSP. DATE: April 28, 2015	INSP. TIME: 16:15
OPERATOR: First Bentonite Company Colorado	OPERATOR REPRESENTATIVE: Pam Wedge	TYPE OF OPERATION: 110c - Construction Limited Impact

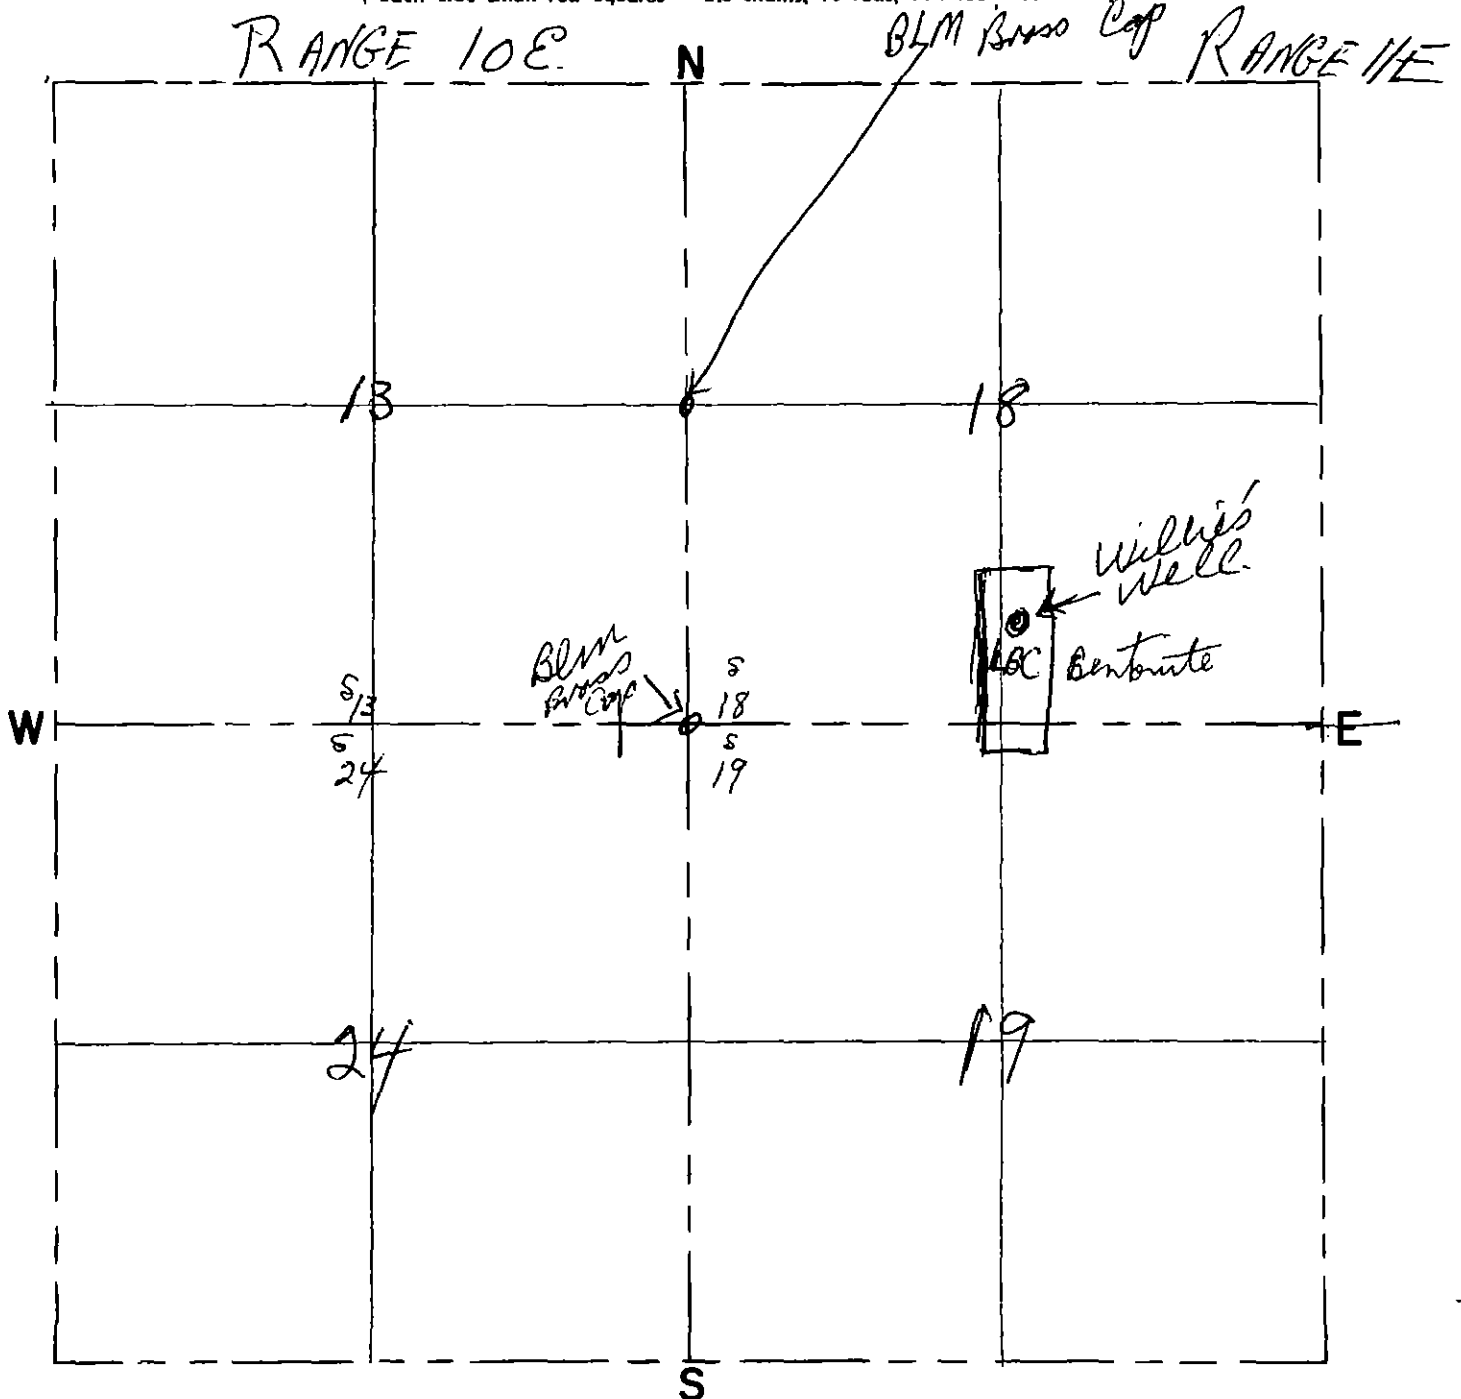
Figure 1. M-1977-231 Inspection Map

Markers & Boundary – A permit sign was displayed at the site entrance (see **Photo 1**). Permit boundaries were marked by corner posts and recorded using a hand held GPS unit (Trimble Juno 3B). The attached inspection map shows the location of the boundary markers and the disturbed area based on the September 24, 2013 Google Earth satellite image (see **Figure 1**).

- **Revisions:** **Surety Increase** (SI-01) in 1993; the permit was transferred (HR-01) from First Land Co of Howard to First Bentonite Company of Colorado in 1984.
- **Commitments/Stipulations:** No open commitments or stipulations.
- **Other Records**
 - a) The total permitted area is 8.0 acres. The Division's disturbed area estimate is approximately 3 acres (including the ~0.14 area associated with the sediment ponds). The original permit describes creating water ponds as part of the reclamation plan. It is unclear if these are the ponds outlined in green on **Figure 1**.
 - b) The previous inspection was performed on 6/13/2010. No problems were cited.

1. If the Operator wishes to begin final reclamation, the reclamation plan outlined in **Attachment A** needs to be followed for final reclamation approval by the Division. The narrow area outlined in yellow near GPS Boundary Marker-2 on **Figure 1** that starts to the southwest, then turns south may be either be a natural gulley or pre-law disturbance and therefore not required to be reclaimed by the Division.
2. No problems were observed.
