COLORADO DIVISION OF RECLAMATION, MINING AND SAFETY
MINERALS PROGRAM INSPECTION REPORT
PHONE: (303) 866-3567

MINE NAME: Rough Cut Pit	MINE/PROSPECTING ID#: M-2001-033	MINERAL: Sand and gravel	COUNTY: Otero
INSPECTION TYPE: Monitoring	INSPECTOR(S): Amy Eschberger	INSP. DATE: January 13, 2016	INSP. TIME: 13:00
OPERATOR: Rough Cut, L.L.C.	OPERATOR REPRESENTATIVE: Keith Tucker	TYPE OF OPERATION: 112c - Construction Regular Operation

INSPECTION TOPIC: Gen. Compliance With Mine Plan

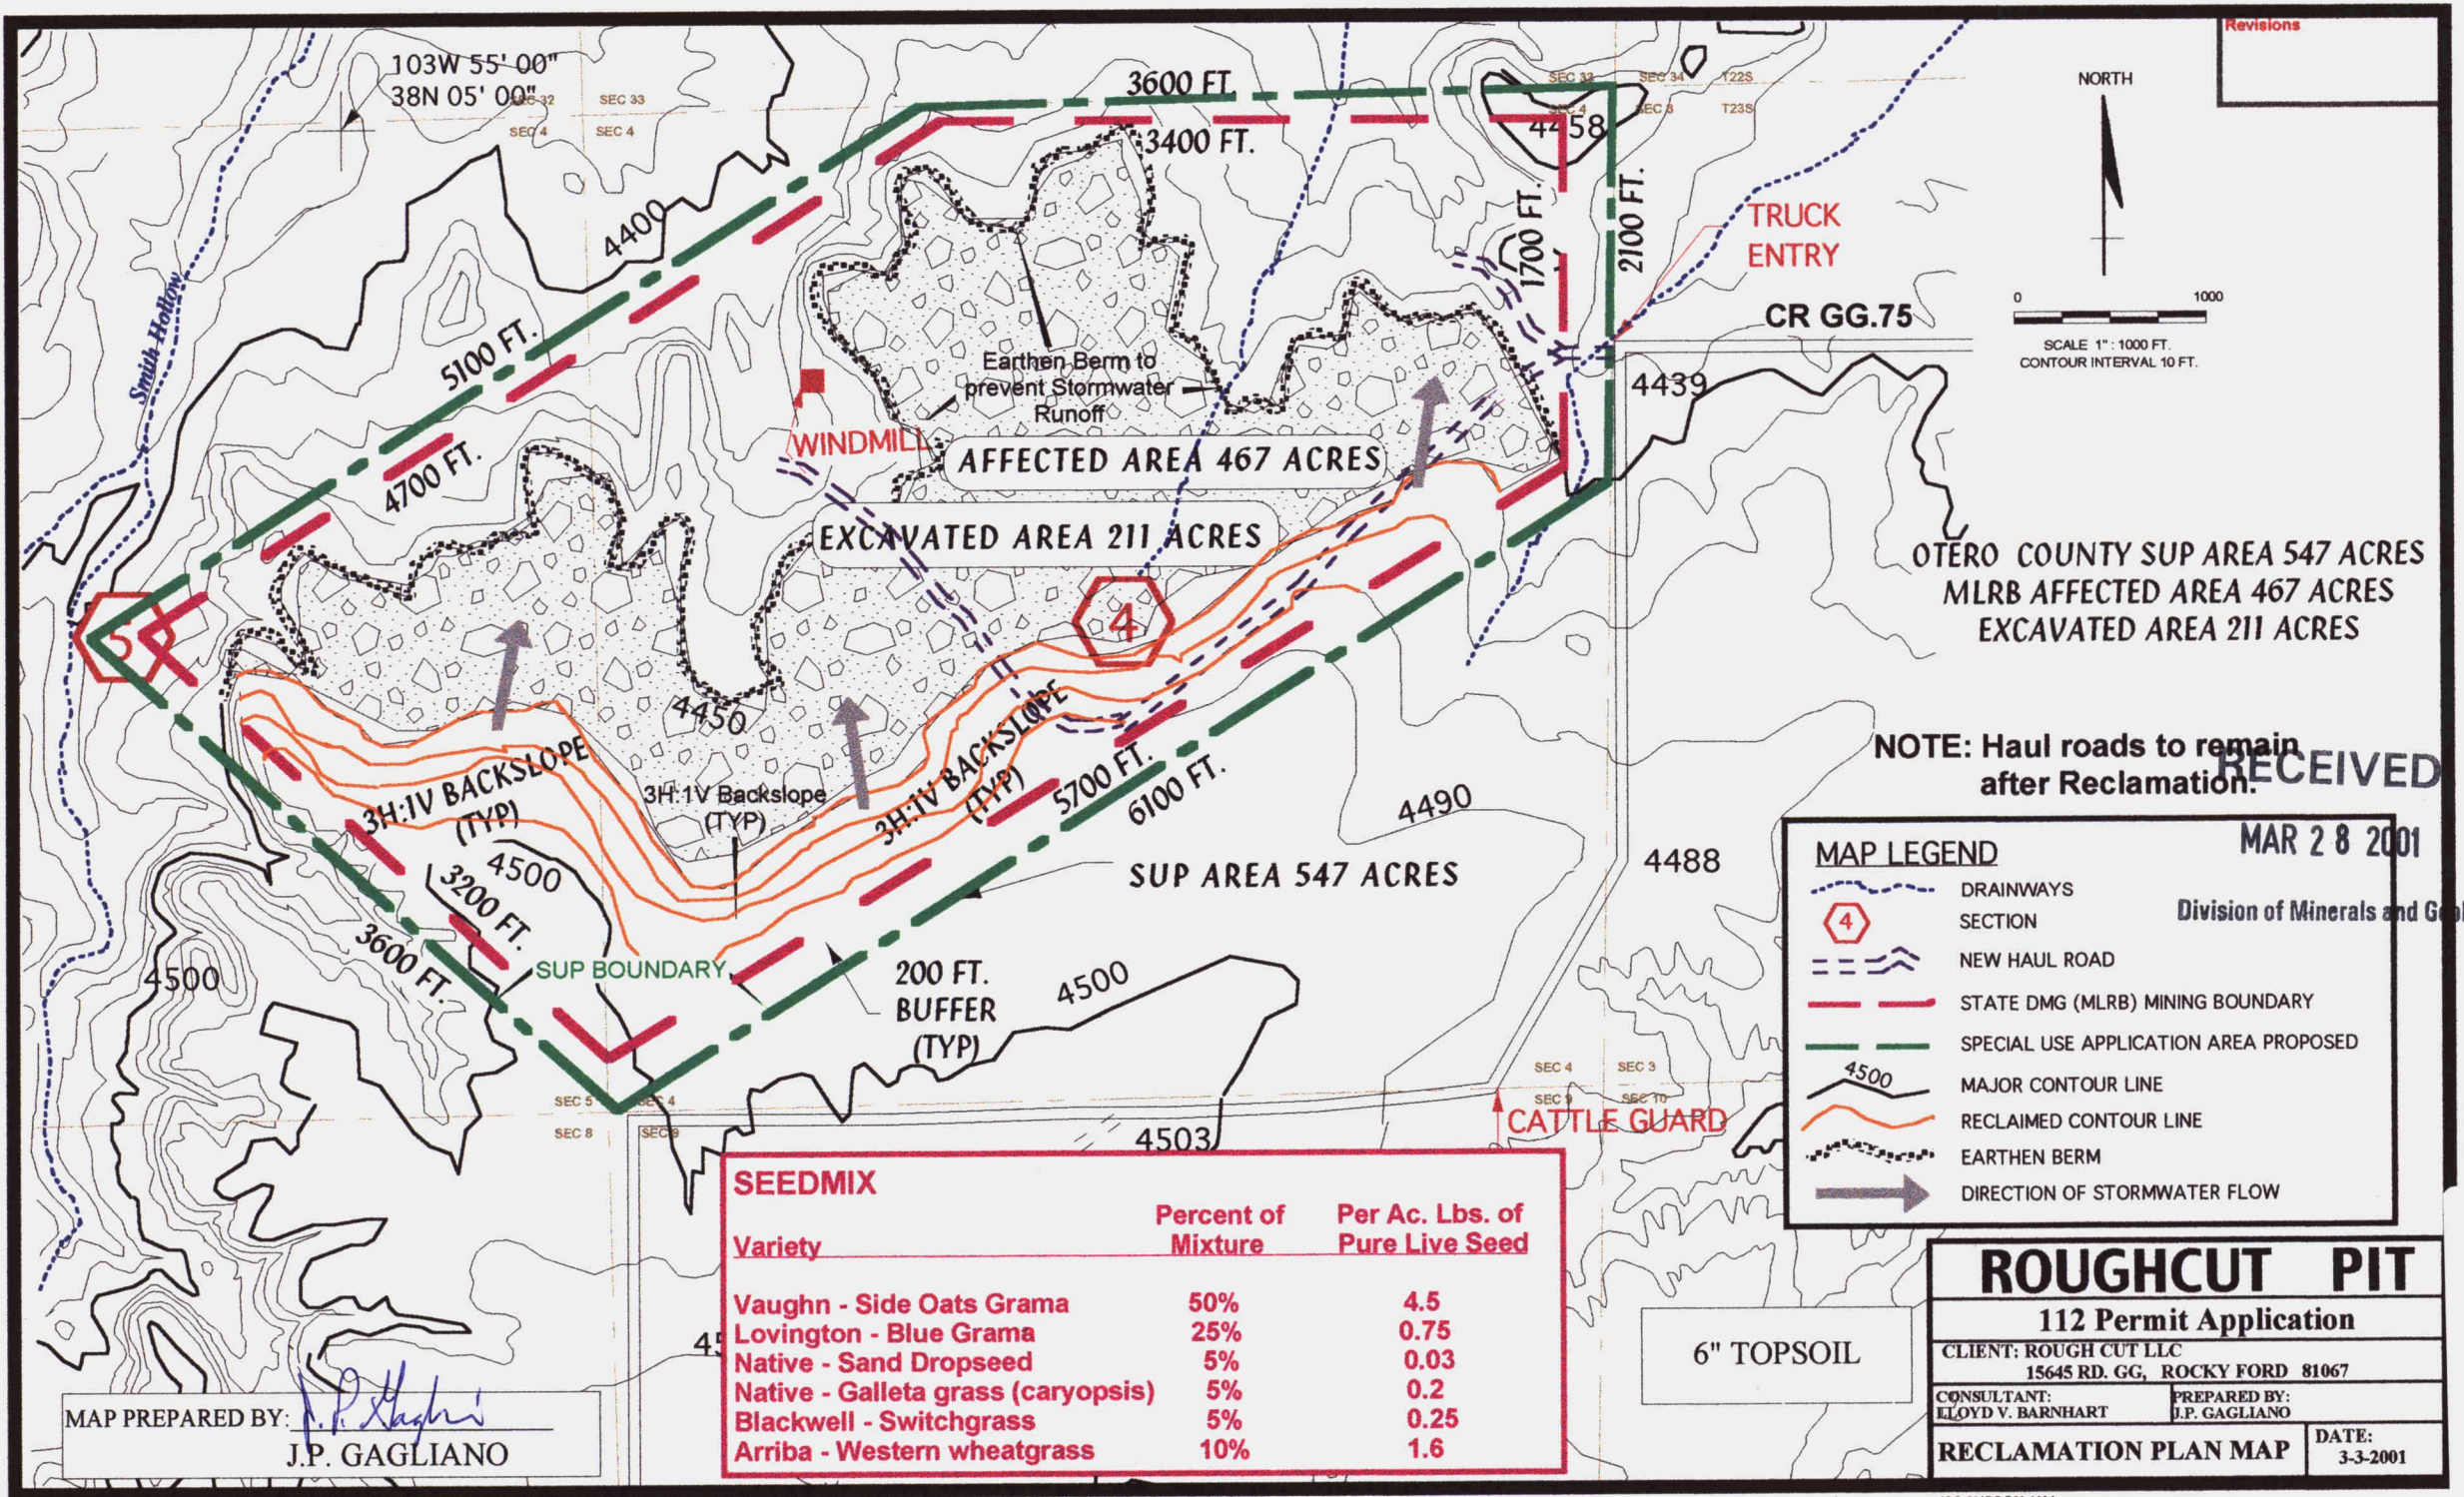
M2001-033 / Rough Cut Pit / Rough Cut L.L.C

Red Outline = 467 acres = Approved Permit Area

Yellow Outline = 23.25 acres = Total Reclaimed Area (15 acres Phase 1 + 8.25 acres Phase 2)

Purple Line = 4,141 feet = Approximate Total Length of Highwalls (1,647 feet Phase 1 + 1,974 feet Phase 2 + 520 feet Phase 3)

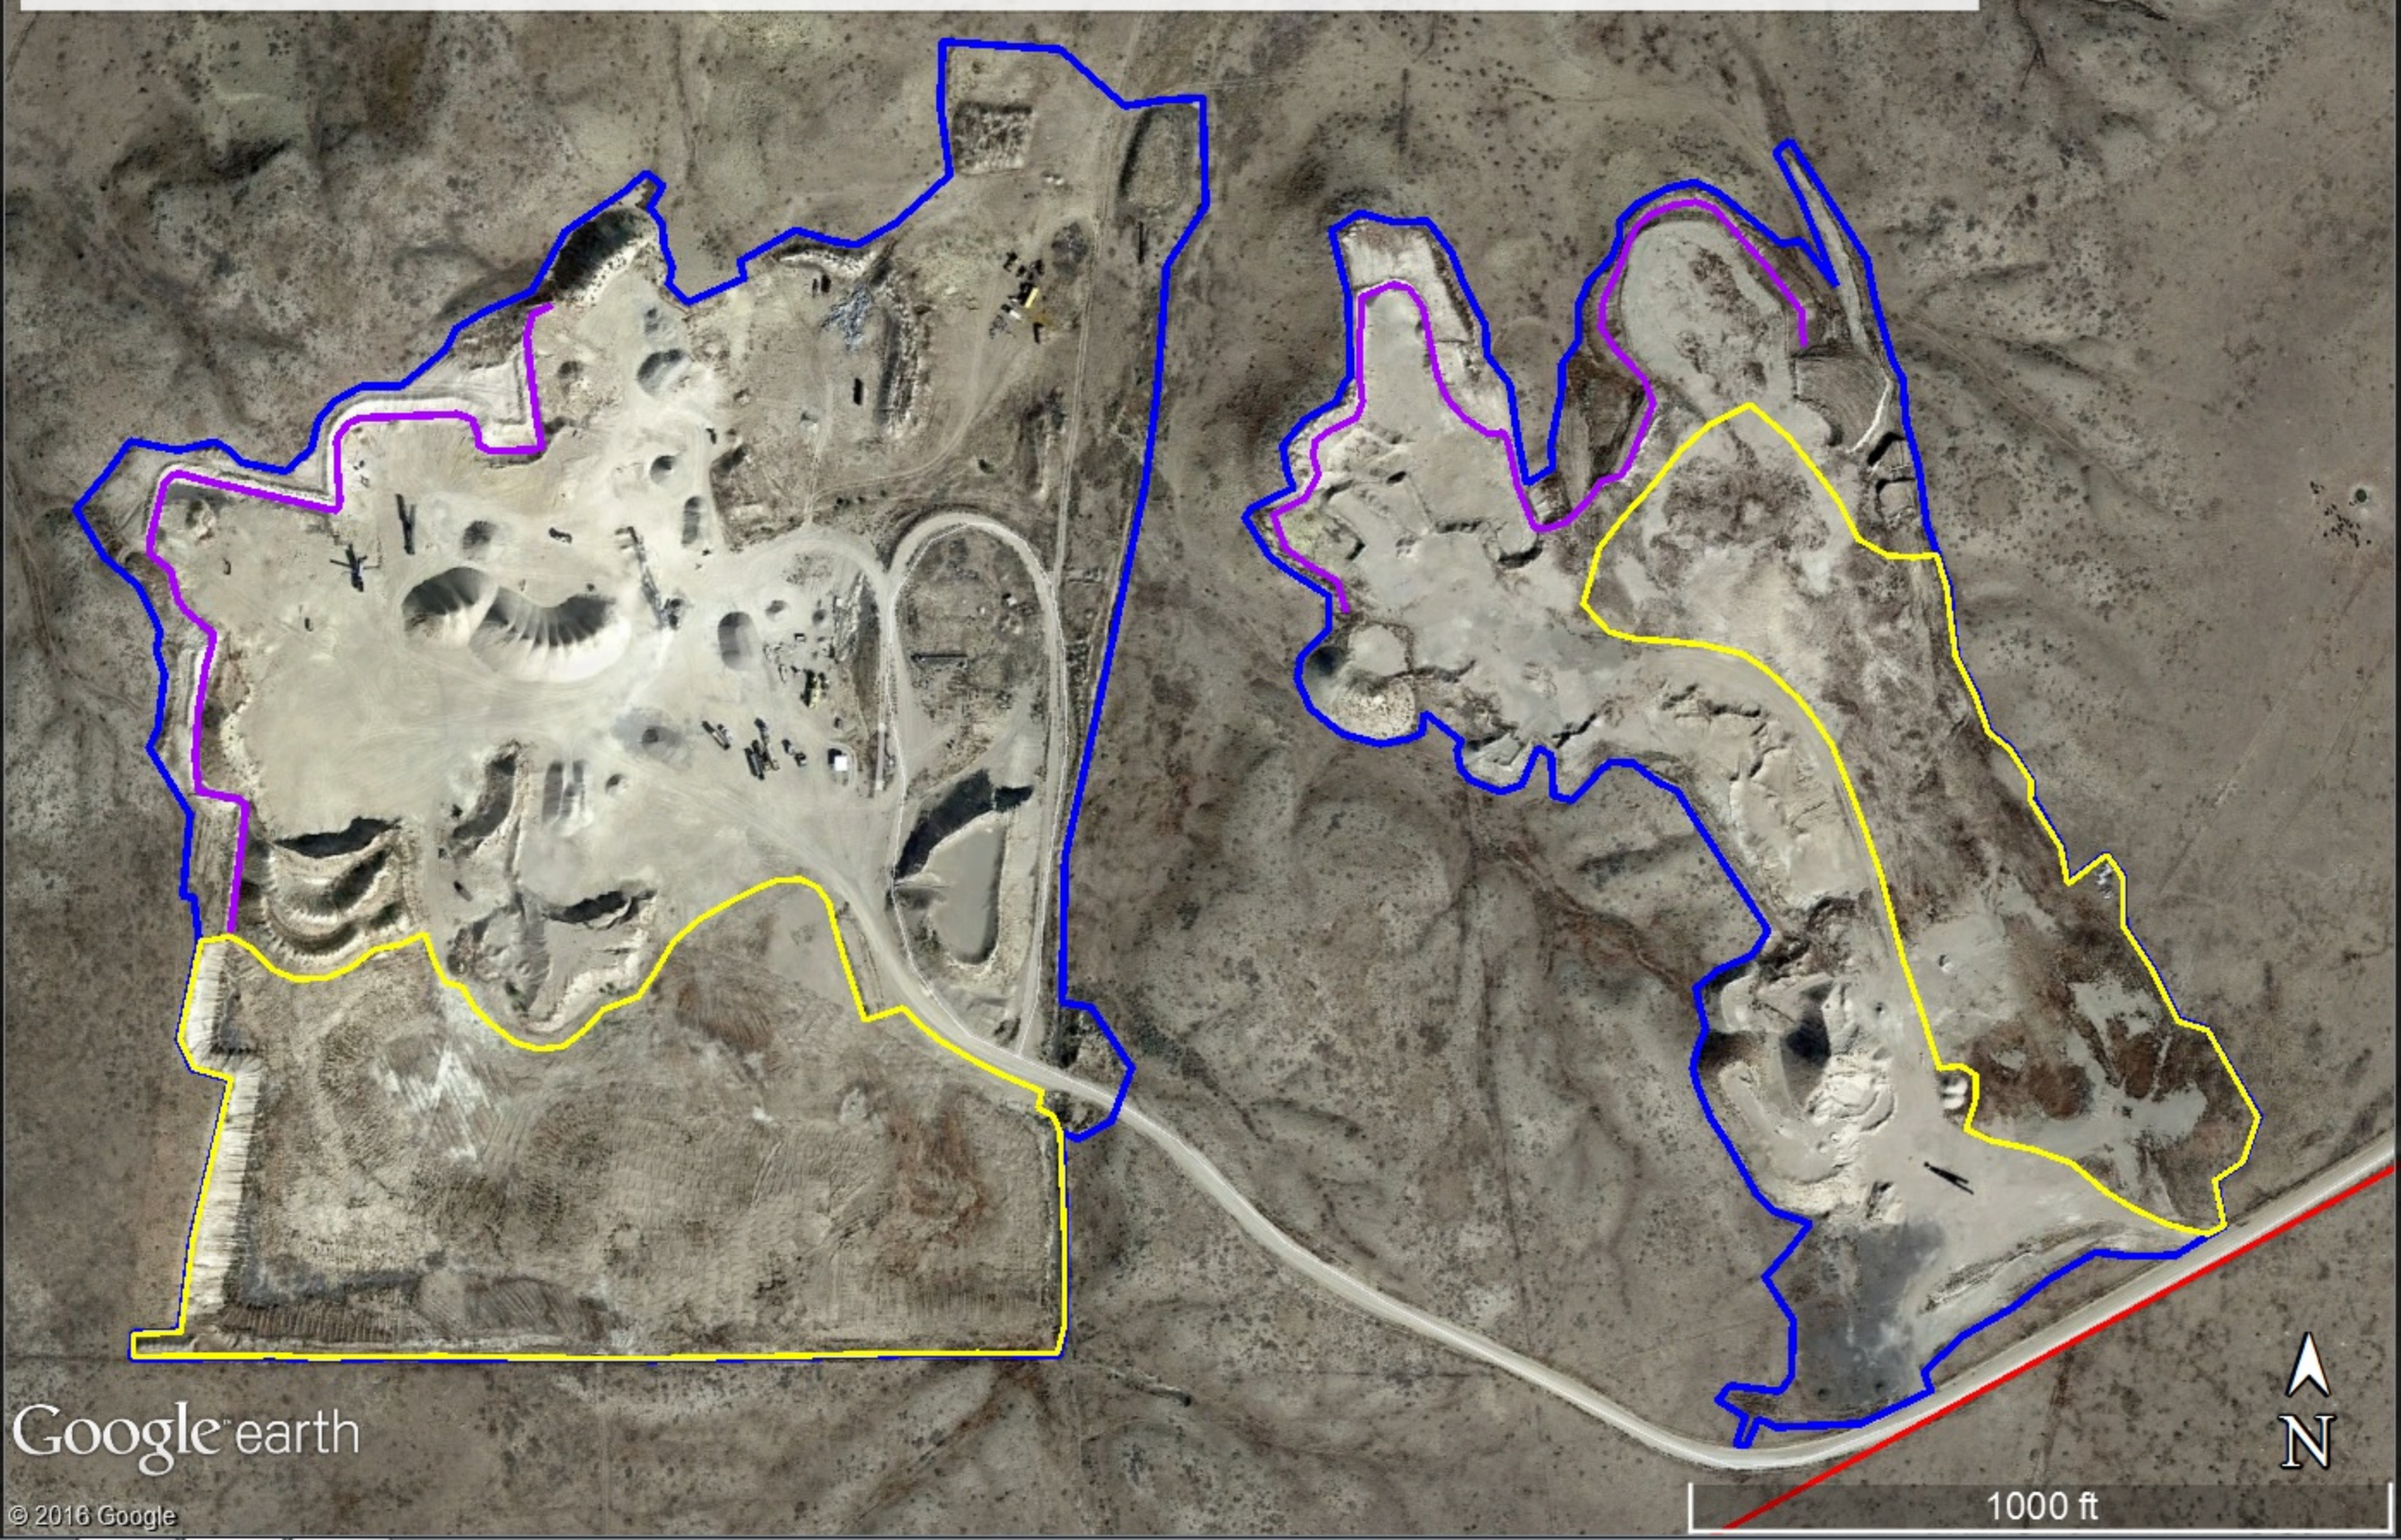
M2001-033 / Rough Cut Pit / Rough Cut L.L.C

Red Outline = 467 acres = Approved Permit Area

Yellow Outline = 23.25 acres = Total Reclaimed Area (15 acres Phase 1 + 8.25 acres Phase 2)

Purple Line = 4,141 feet = Approximate Total Length of Highwalls (1,647 feet Phase 1 + 1,974 feet Phase 2 + 520 feet Phase 3)
