**COLORADO DIVISION OF RECLAMATION, MINING AND SAFETY**  
**MINERALS PROGRAM INSPECTION REPORT**  
**PHONE: (303) 866-3567**

<b>MINE NAME:</b> E 8 <sup>th</sup> Street Operation	<b>MINE/PROSPECTING ID#:</b> M-2000-082	<b>MINERAL:</b> Sand and Gravel	<b>COUNTY:</b> Weld
<b>INSPECTION TYPE:</b> Monitoring	<b>INSPECTOR(S):</b> Peter S. Hays	<b>INSP. DATE:</b> March 11, 2016	<b>INSP. TIME:</b> 12:00
<b>OPERATOR:</b> Superior Oilfield Services Co., LTD	<b>OPERATOR REPRESENTATIVE:</b> Jack Miller	<b>TYPE OF OPERATION:</b> 112c - Construction Regular Operation

<b>REASON FOR INSPECTION:</b> Citizen Complaint	<b>BOND CALCULATION TYPE:</b> None	<b>BOND AMOUNT:</b> \$270,000.00
<b>DATE OF COMPLAINT:</b> March 7, 2016	<b>POST INSP. CONTACTS:</b> None	<b>JOINT INSP. AGENCY:</b> None
<b>WEATHER:</b> Clear	<b>INSPECTOR'S SIGNATURE:</b>

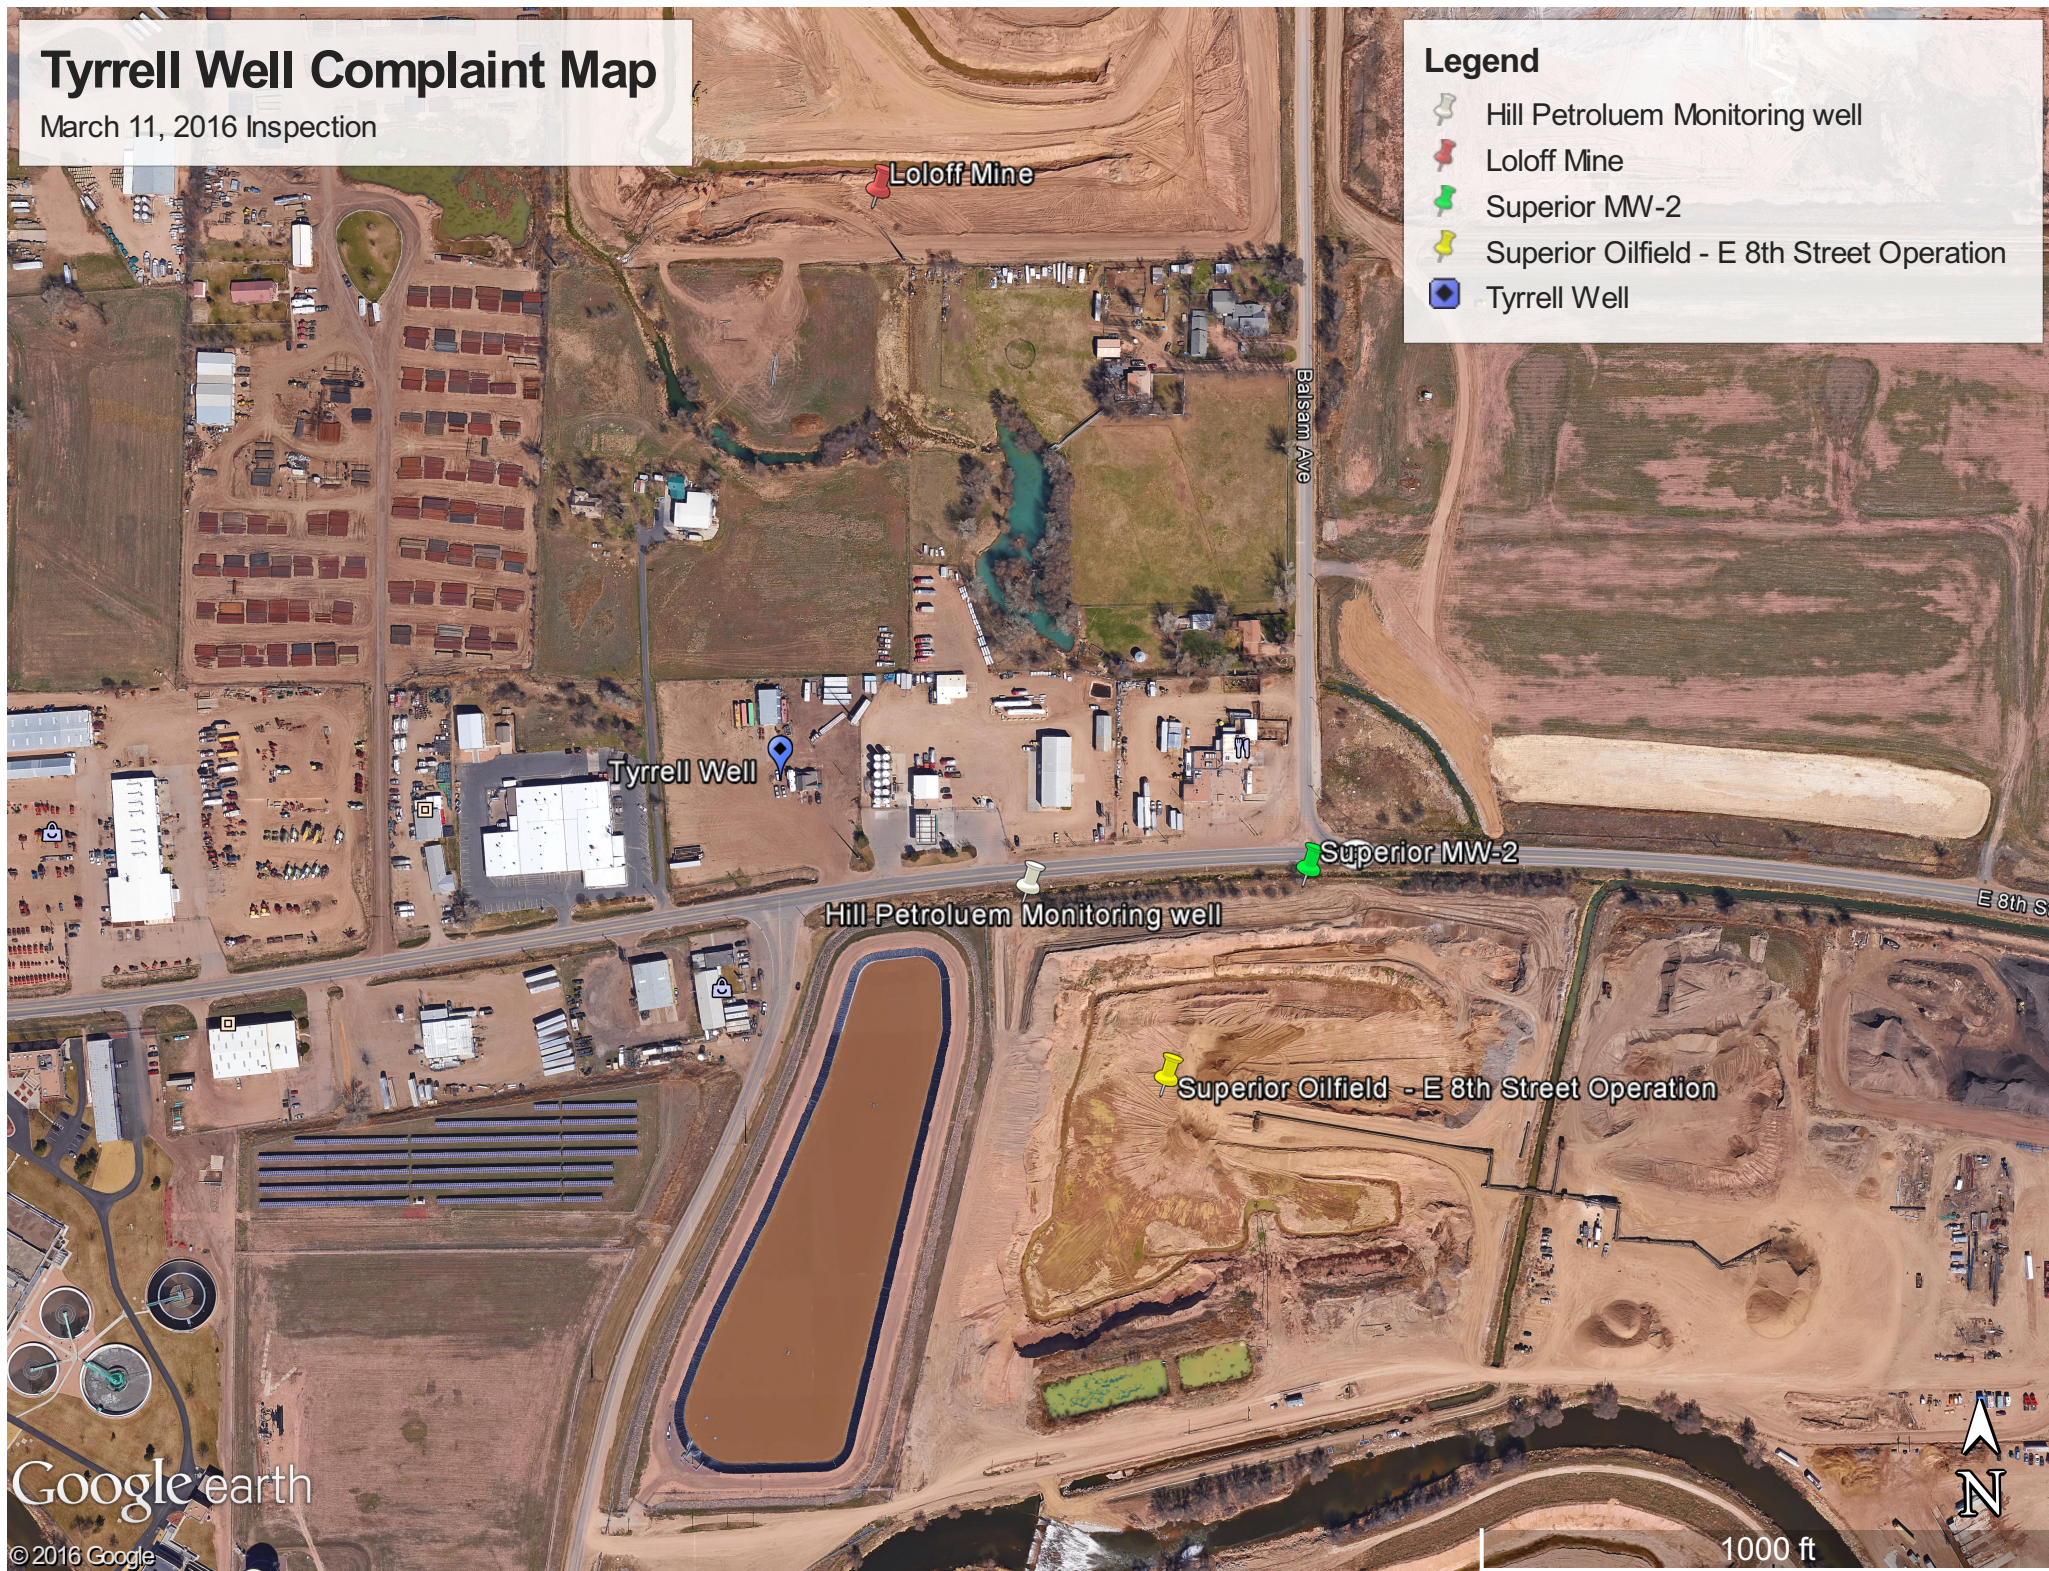
Tyrrell Well

Based on the GPS data and calculations from Google Earth Pro, the Division estimates the Tyrell well is located 430 feet (130 meters) from the northwest corner of Phase 2 of the E 8th Street Operation. The pit radius of Phase 2 was estimated at 400 feet (122.5 meters). Using the USGS Analytical and Numerical Simulation of Steady-State Hydrologic Effects of Mining Aggregate in Hypothetical Sand-and-Gravel and Fractured Crystalline-Rock Aquifers, Report 02-4267, the Division calculated a drawdown of 10.5 feet (3.2 meters) for the Tyrell well due to the dewatering of Phase 2 at the E 8th Street Operation.

Overall, based on the observations from this inspection, the lack of groundwater monitoring data from the Operator and the calculated drawdown, the Division believes the E 8<sup>th</sup> Street Operation has caused disturbances to the prevailing hydrologic balance of the surrounding area and to the quantity of water in the groundwater system.

- Modify the existing well to operate under lower groundwater conditions. This could include re-drilling the existing well to deeper depths or lowering the pump. All work would be done at the expense of the Operator with the exception of replacing equipment that was non-functional prior to mining.
- If the existing well cannot be repaired, the Operator will drill a new well within 200 feet of the existing well for the owner to replace the damaged well. The new well will produce water of the same quantity and quality to support the historic use.
- Provide an alternative source of water to support the historic well water use.
