COLORADO DIVISION OF RECLAMATION, MINING AND SAFETY
MINERALS PROGRAM INSPECTION REPORT
PHONE: (303) 866-3567

MINE NAME: Loloff Mine	MINE/PROSPECTING ID#: M-1985-112	MINERAL: Sand and gravel	COUNTY: Weld
INSPECTION TYPE: Monitoring	INSPECTOR(S): Peter S. Hays	INSP. DATE: March 11, 2016	INSP. TIME: 11:15
OPERATOR: Loloff Construction, Inc.	OPERATOR REPRESENTATIVE: Kelly Hodge	TYPE OF OPERATION: 112c - Construction Regular Operation	
REASON FOR INSPECTION: Citizen Complaint	BOND CALCULATION TYPE: None	BOND AMOUNT: \$689,552.00	
DATE OF COMPLAINT: NA	POST INSP. CONTACTS: None	JOINT INSP. AGENCY: None	
WEATHER: Clear	INSPECTOR'S SIGNATURE:

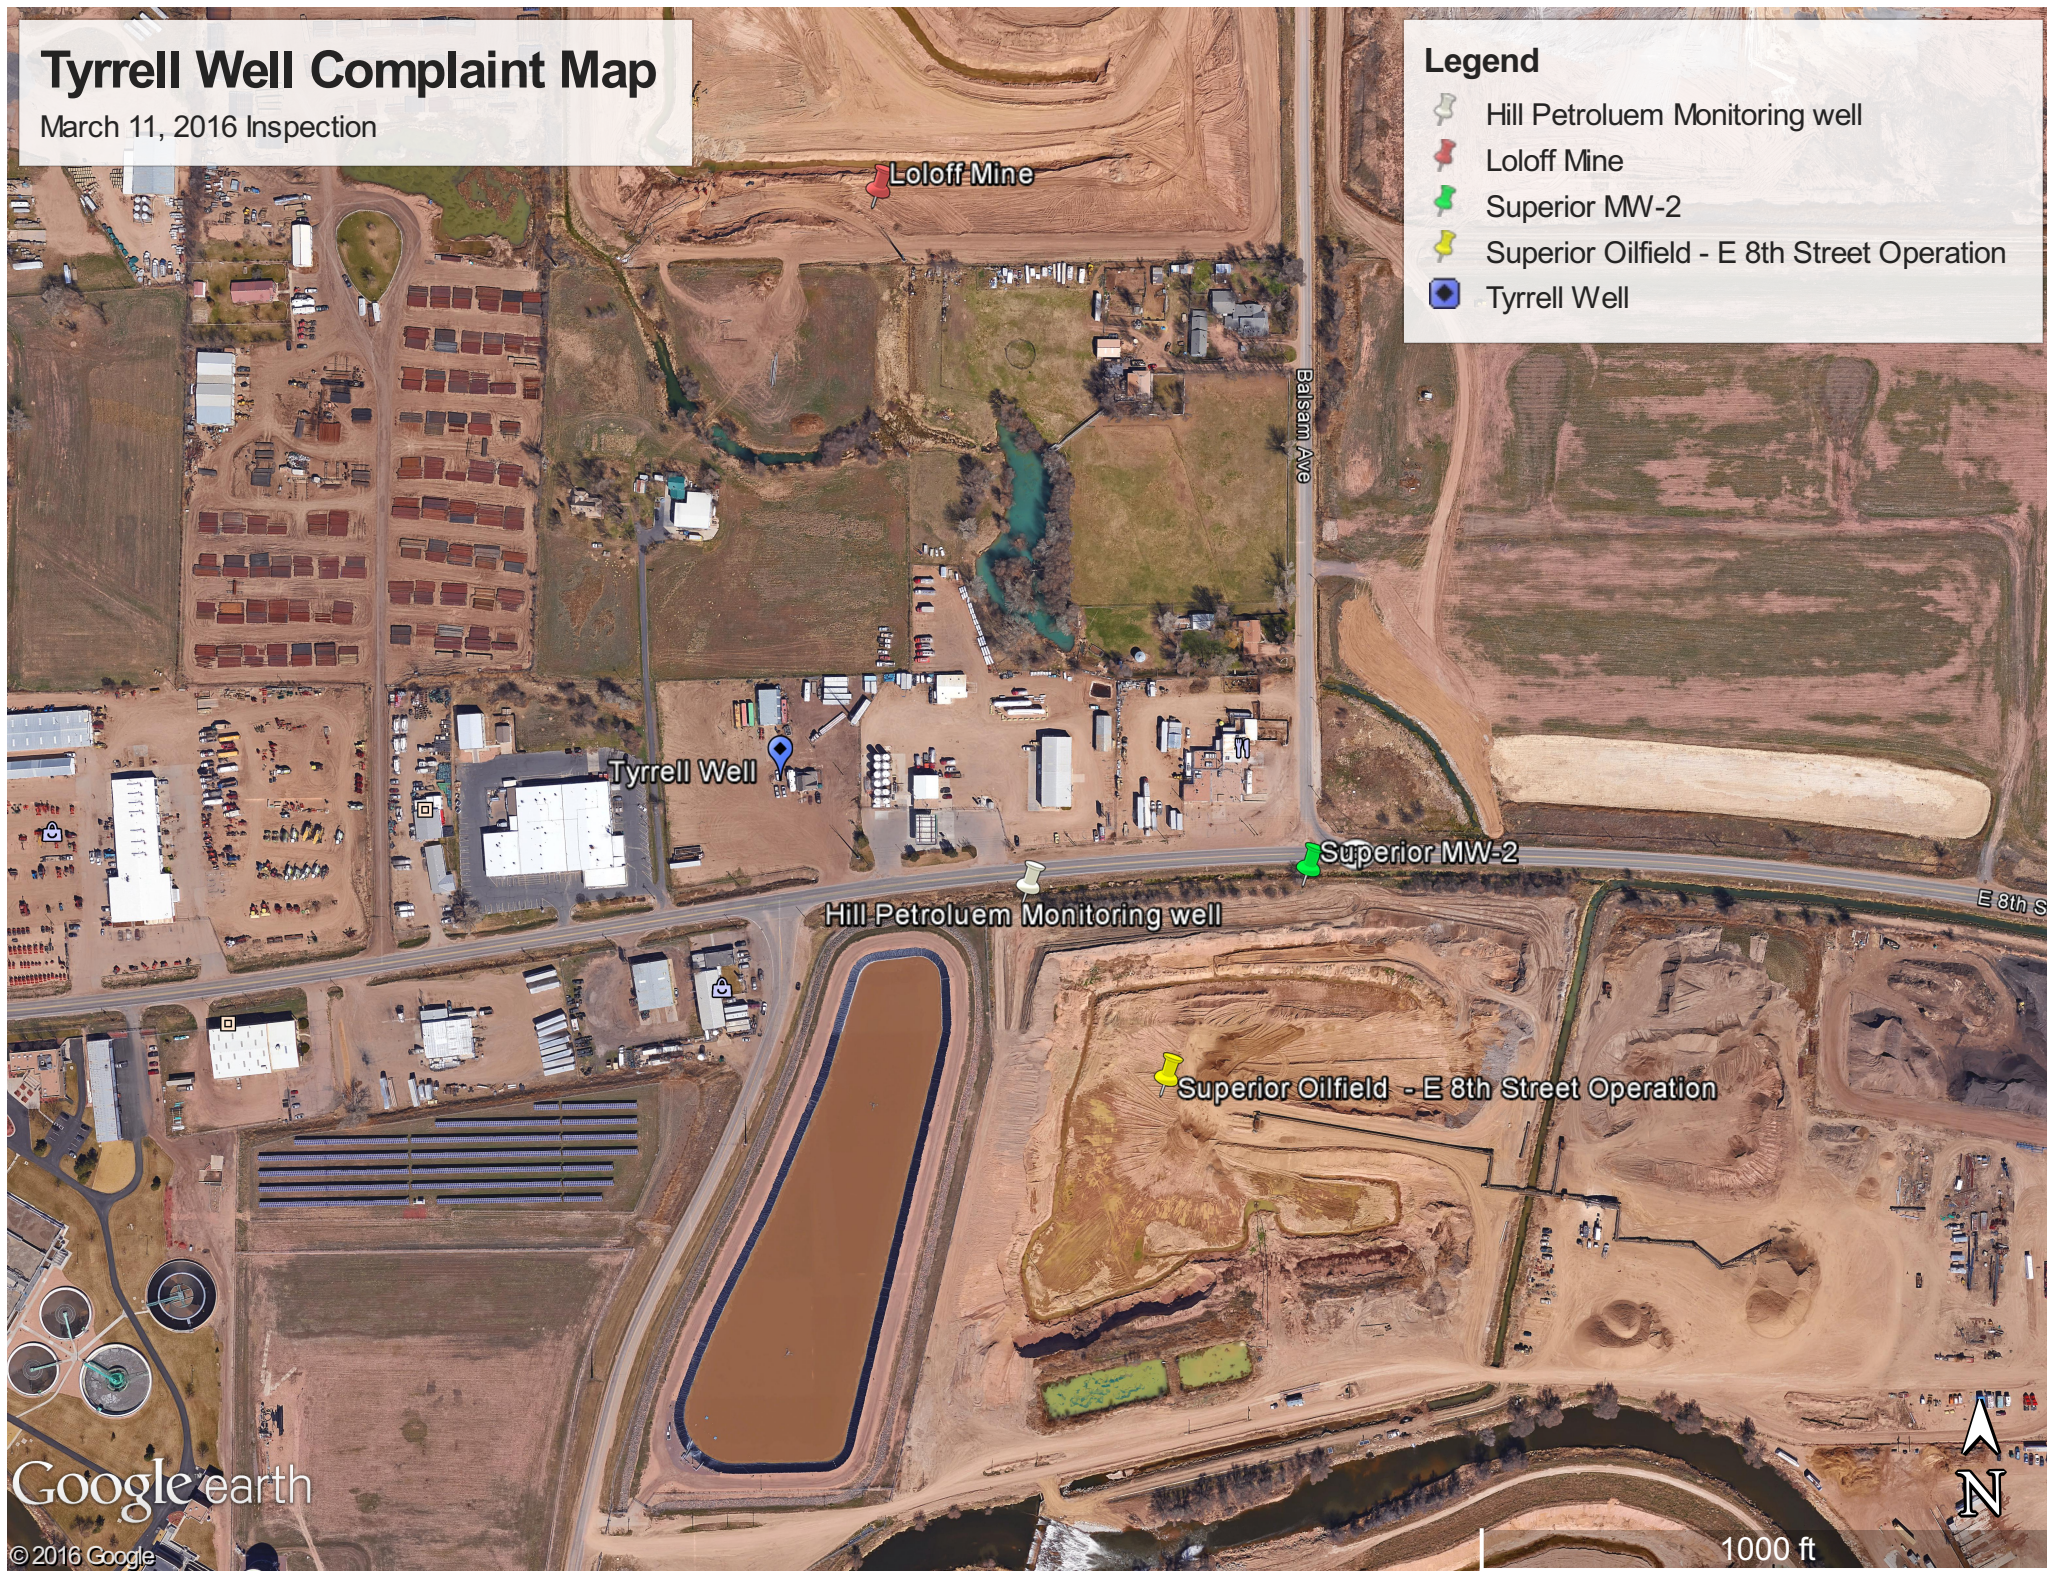
Tyrrell Well

PROBLEM/POSSIBLE VIOLATION: Problem: The dewatering activity at the Loloff Mine has caused disturbances to the prevailing hydrologic balance and is affecting the groundwater well located at 417 East 8th Street, Greeley, CO 80631 owned by Mr. Tyrrell. This is a problem related to Rule 3.1.6 of the Mineral Rules and Regulations of the Colorado Mined Land Reclamation Board for the Extraction of Construction Materials and CRS 34-32.5-116(4)(h) of the Colorado Land Reclamation Act for the Extraction of Construction Materials.

The upper well casing and wellhead were observed during the inspection. The groundwater and pump elevations could not be determined during the inspection, due to the lack of an access port in the well. The well location was GPS surveyed using a Trimble Juno 3B by the Division.

As cited as a problem, Loloff Construction, Inc. must implement the approved mitigation plan for the site and work with Mr. Tyrrell to investigate and rehabilitate the well on this property within 30 days of the mailing date of this inspection report. Failure to comply with the corrective action may result in the problem escalating to possible violation and an enforcement hearing being scheduled in front of the Mined Land Reclamation Board.
