**COLORADO DIVISION OF RECLAMATION, MINING AND SAFETY**  
**MINERALS PROGRAM INSPECTION REPORT**  
**PHONE: (303) 866-3567**

<b>MINE NAME:</b> Arkins Park Quarries	<b>MINE/PROSPECTING ID#:</b> M-1985-212	<b>MINERAL:</b> Sandstone	<b>COUNTY:</b> Larimer
<b>INSPECTION TYPE:</b> Monitoring	<b>INSPECTOR(S):</b> Michael A. Cunningham	<b>INSP. DATE:</b> December 10, 2015	<b>INSP. TIME:</b> 09:00
<b>OPERATOR:</b> ARKINS PARK STONE CORPORATION	<b>OPERATOR REPRESENTATIVE:</b> Chantea Honer	<b>TYPE OF OPERATION:</b> 112c - Construction Regular Operation

# Arkins Park Quarries

M-1985-212

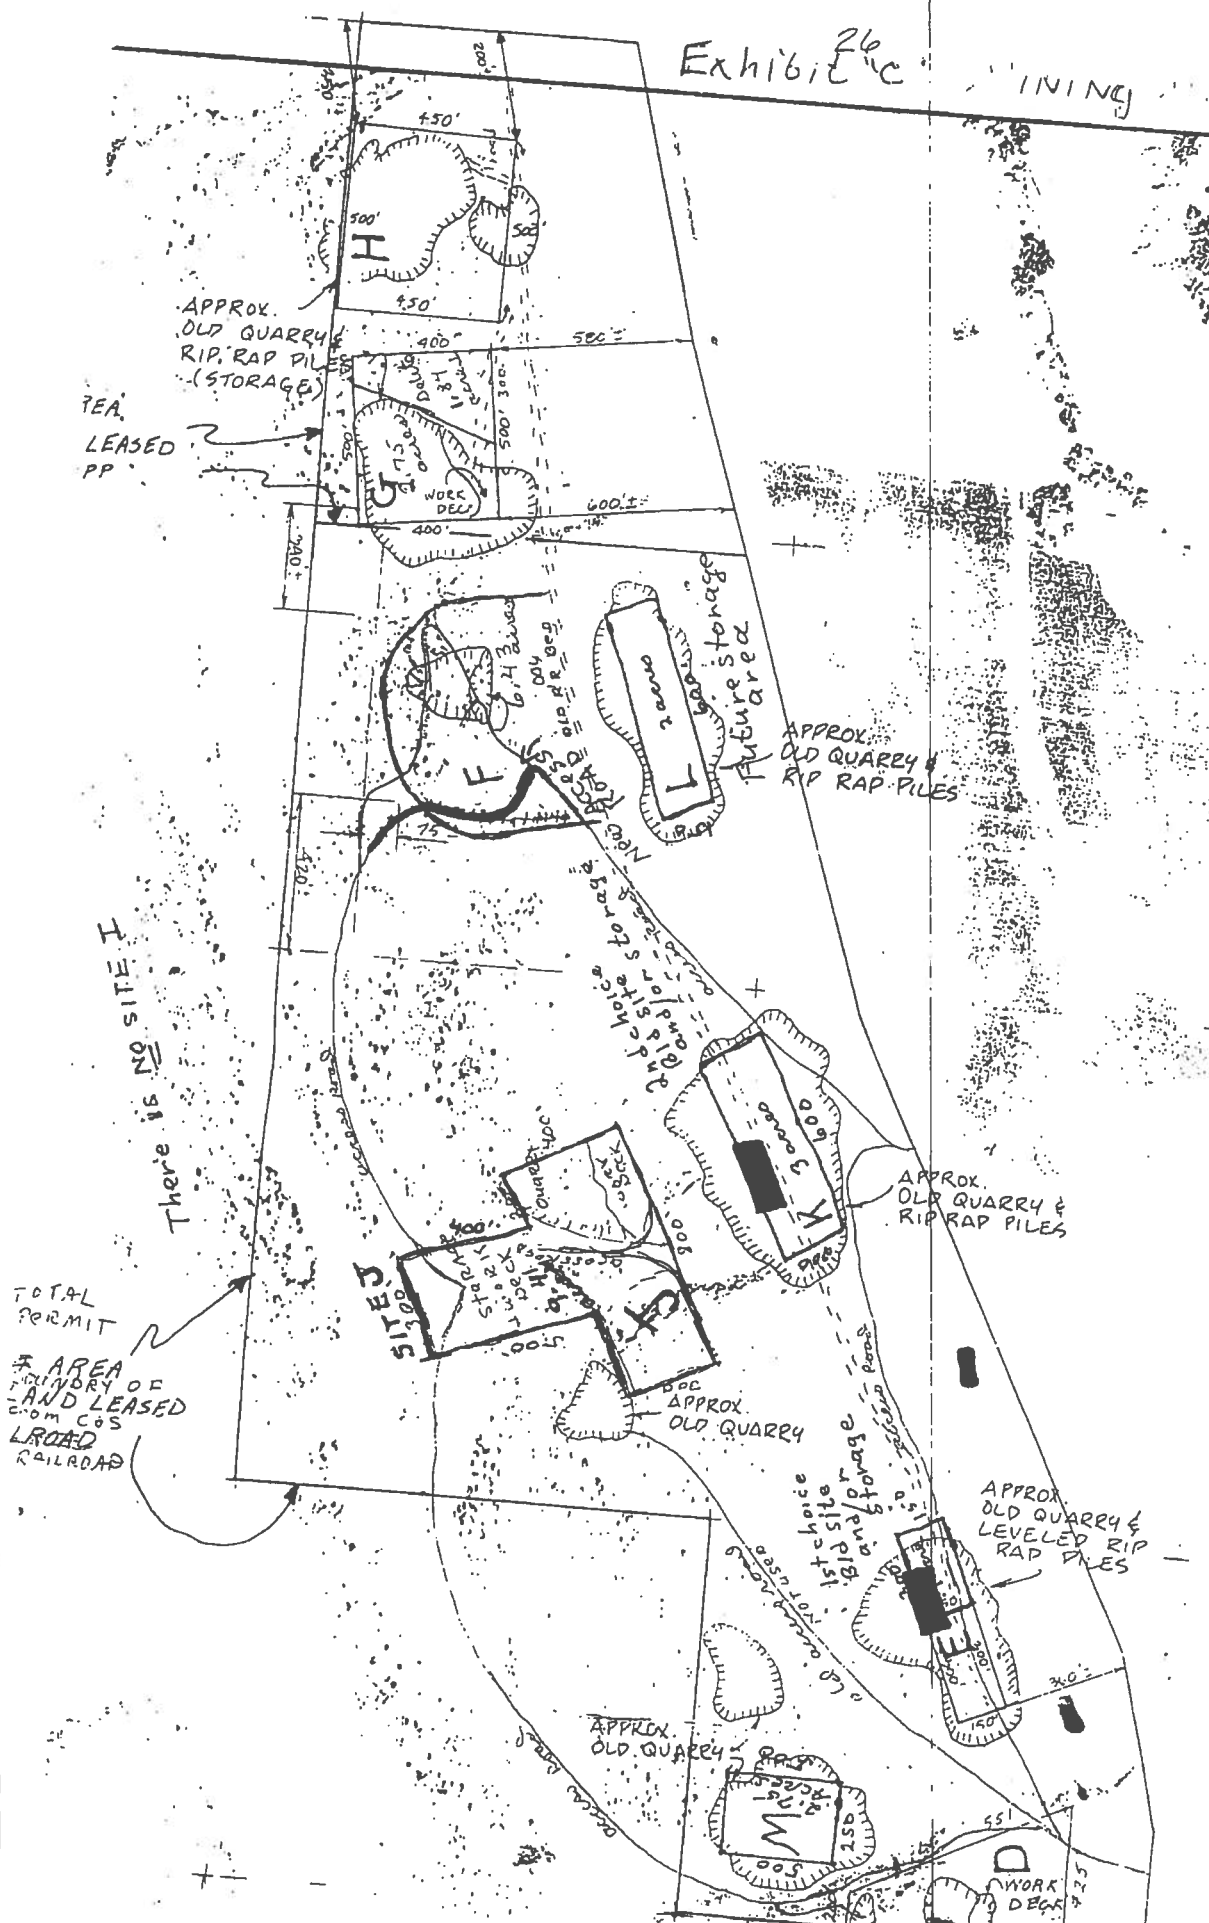
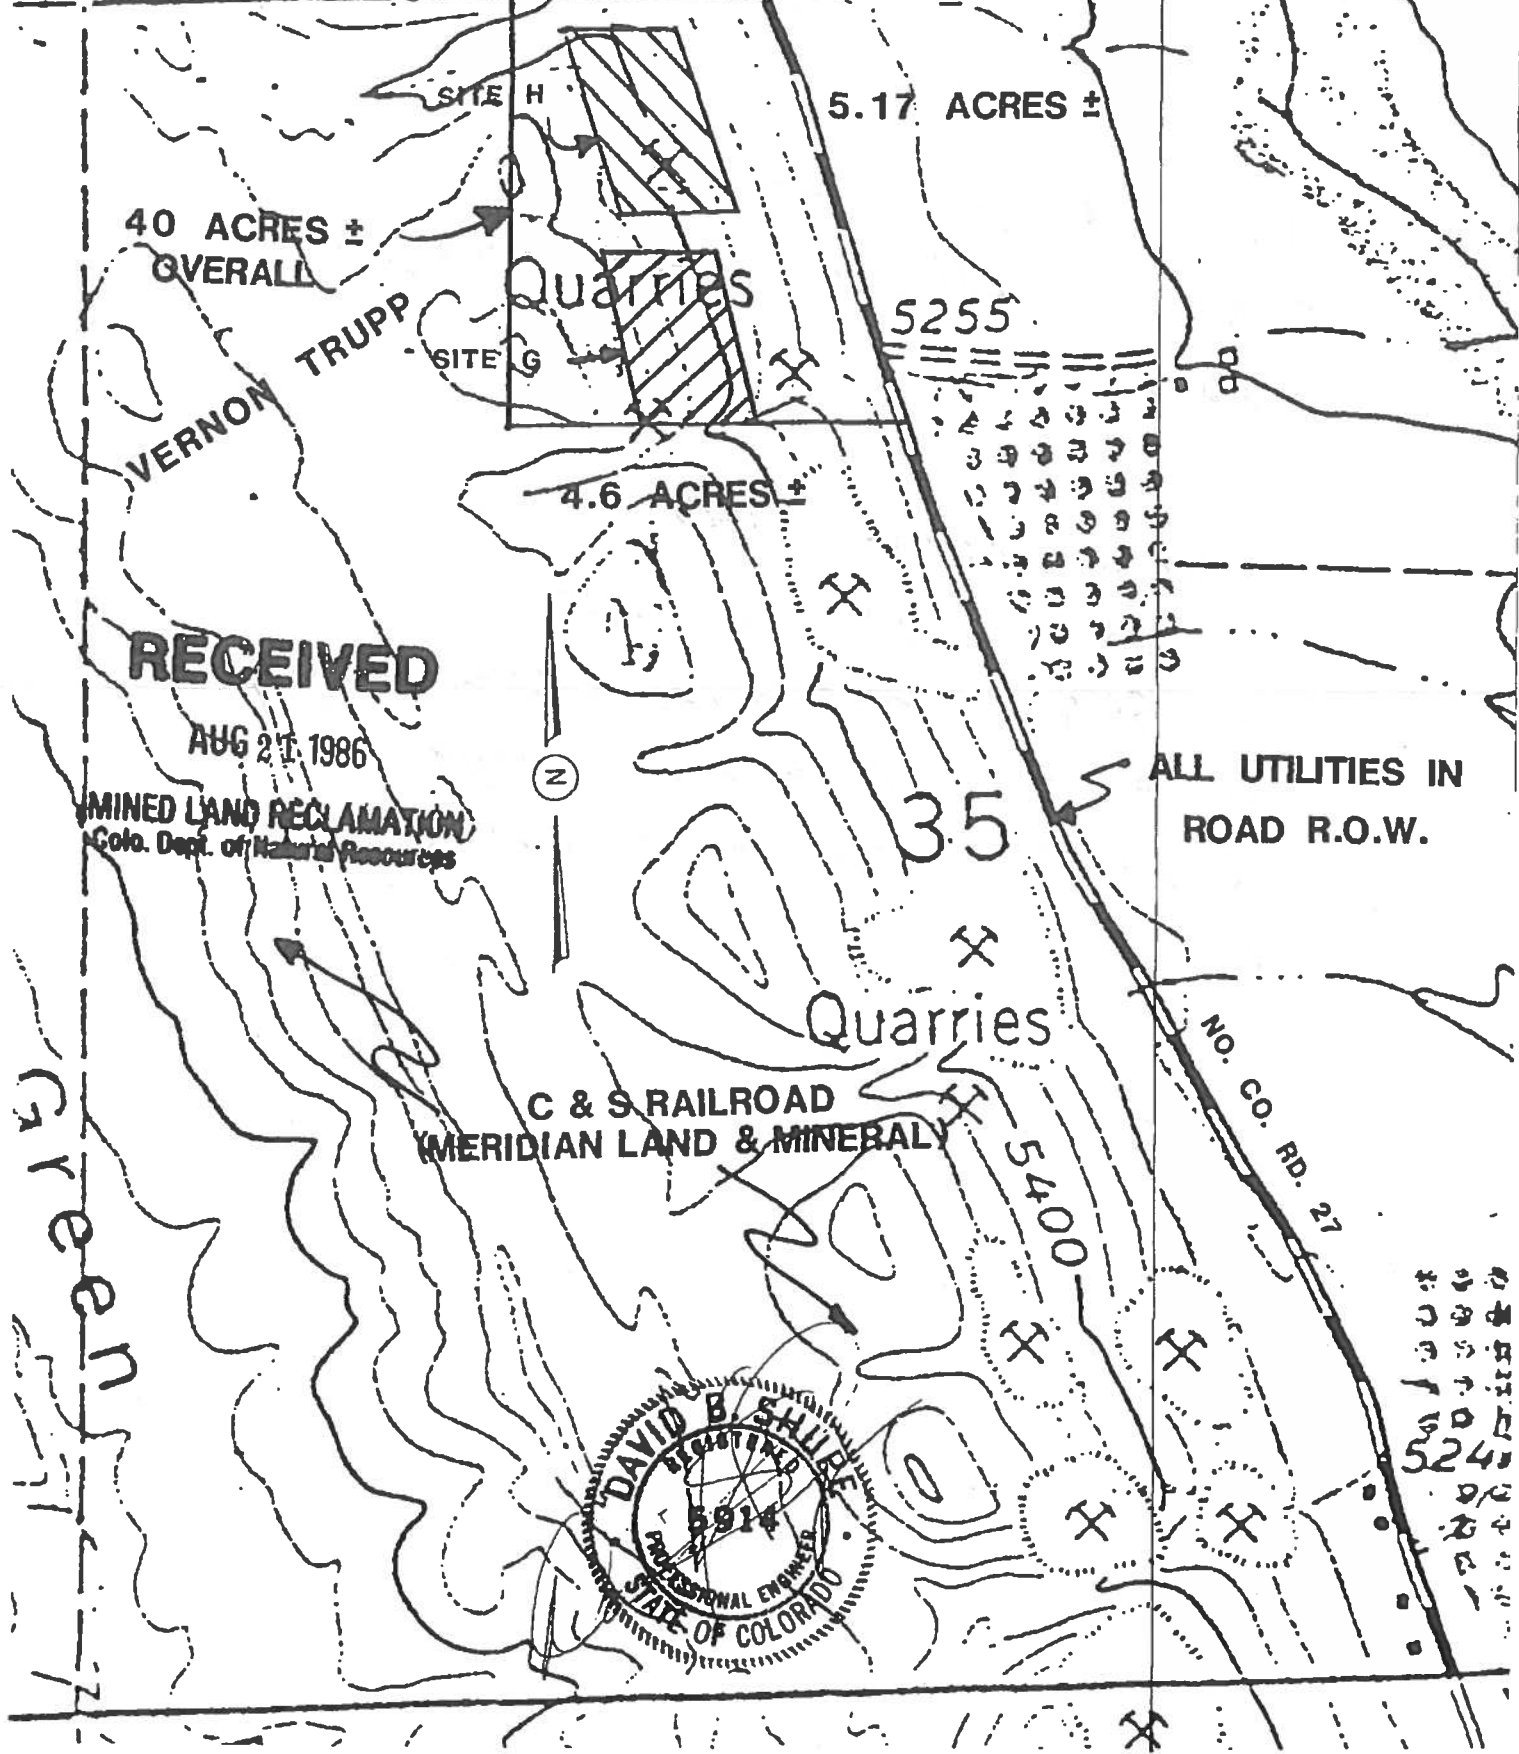
**MINING PLAN MAP**

**PROBLEM/POSSIBLE VIOLATION:** Problem: The Division has reason to believe, based on a review of Mining Plan Maps and aerial photographs, that the Operator may have affected land outside of the permit boundary. This is a problem pursuant to C.R.S. 34-32.5-116(4)(i) for failure to protect areas outside of the affected land from slides or damage occurring during the mining operation and reclamation.

Following the inspection, the Division utilized Google Earth Pro to overlay the permit boundary onto an aerial photograph of the Arkins Park Quarry. The aerial photograph was taken on June 19, 2014 and is considered to be representative of current site conditions. The permit boundary was recreated by referencing Exhibit C - Mining Plan Map which was submitted under Conversion No. 2 (approved August 28, 1986) as well as Exhibit C - Mining Plan Map submitted under Amendment No. 2 (approved April 21, 1994). The approved Mining Plan Maps depict the permit boundary on a USGS 7.5 minute topographic map. Utilizing historical topographic maps in Google Earth Pro, the Division was able to draw the permit boundary using the contour lines as reference points. Upon review of the completed maps, the Division believes a portion of the western permit boundary is incorrectly delineated in the field. As a result, the Division has reason to believe that approximately 16.3 acres of land have been affected outside of the approved permit boundary. Failure to protect areas outside of the affected land may result in a possible violation. However, the Division will afford the Operator an opportunity to demonstrate that the currently delineated permit boundary accurately encompasses the 177 acre permit area.
