COLORADO DIVISION OF RECLAMATION, MINING AND SAFETY
MINERALS PROGRAM INSPECTION REPORT
PHONE: (303) 866-3567

| MINE NAME: North Clear Creek Construction Materials Mi | MINE/PROSPECTING ID#: M-2006-039 | MINERAL: Sand & Gravel | COUNTY: Garfield |
| INSPECTION TYPE: Monitoring | INSPECTOR(S): Amy C. Yeldell | INSP. DATE: April 13, 2016 | INSP. TIME: 14:00 |

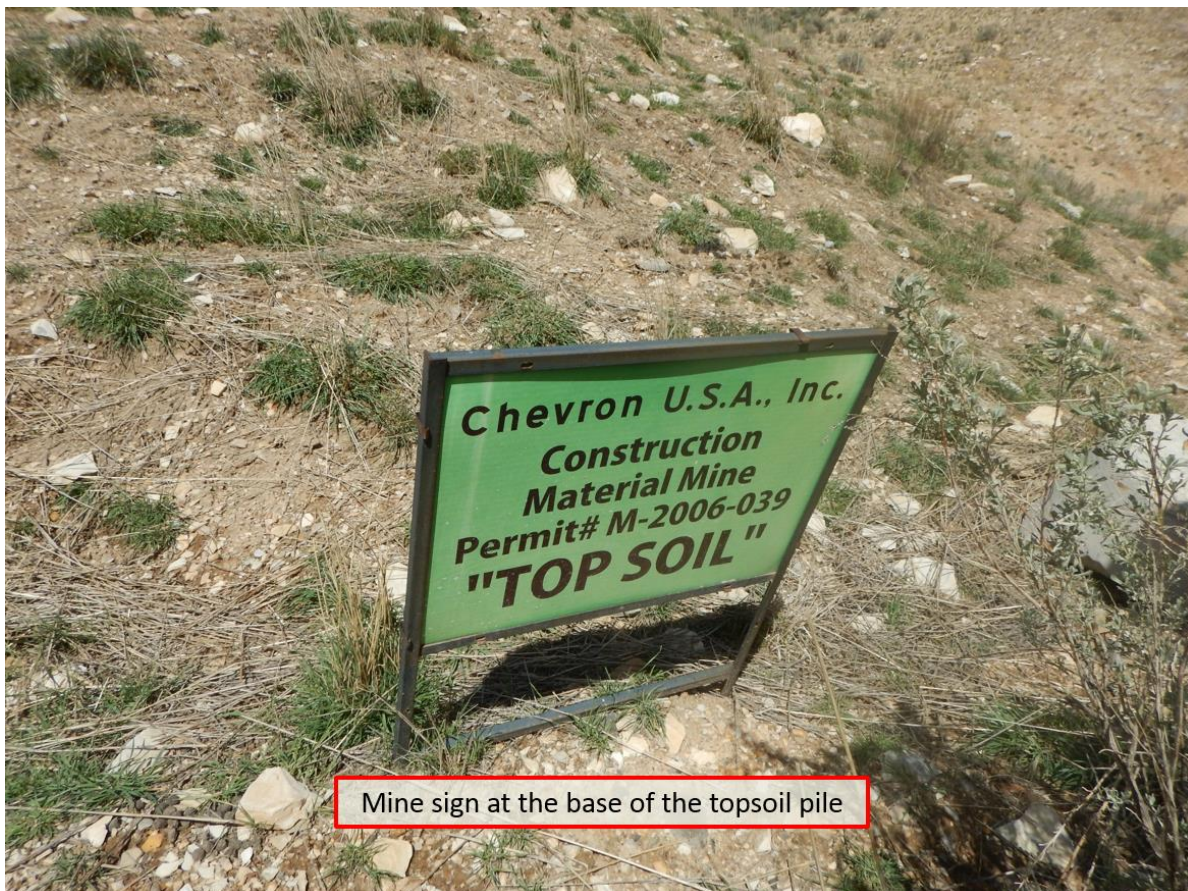
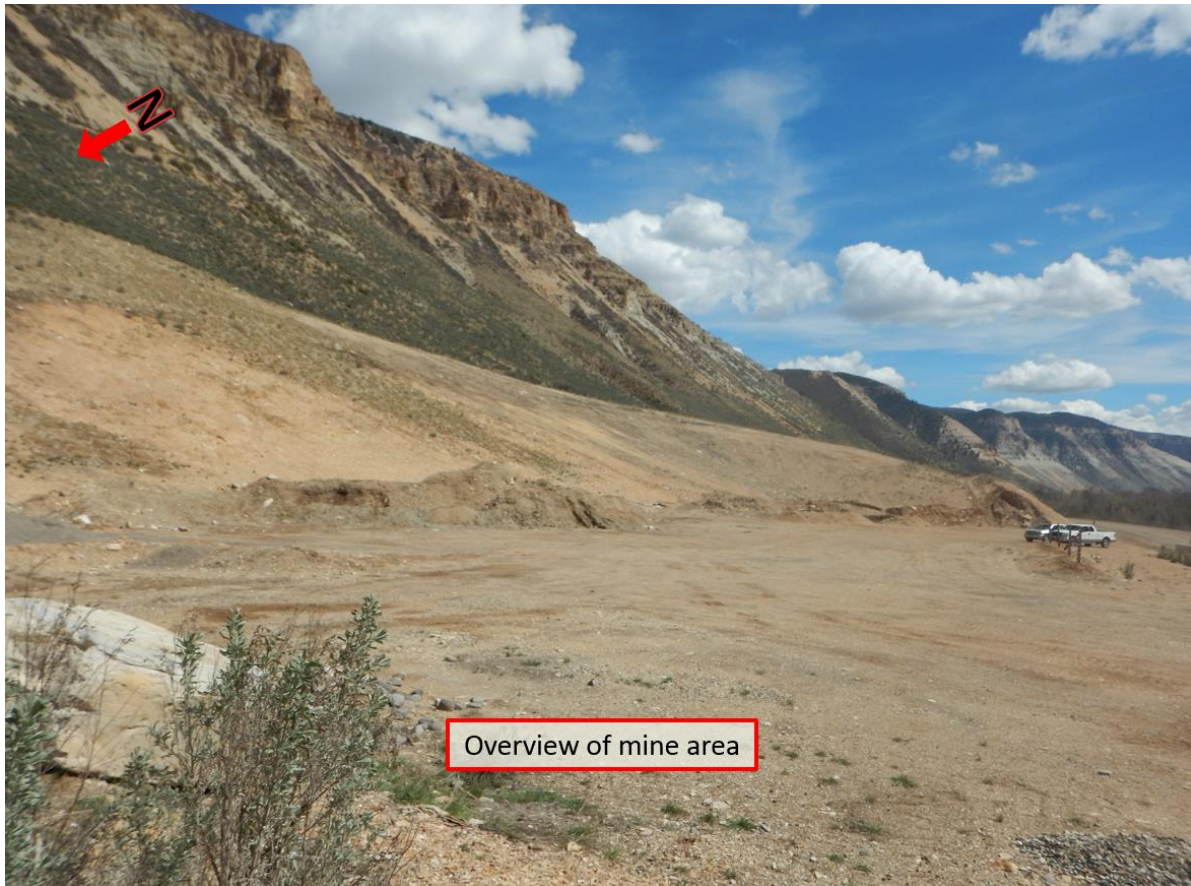
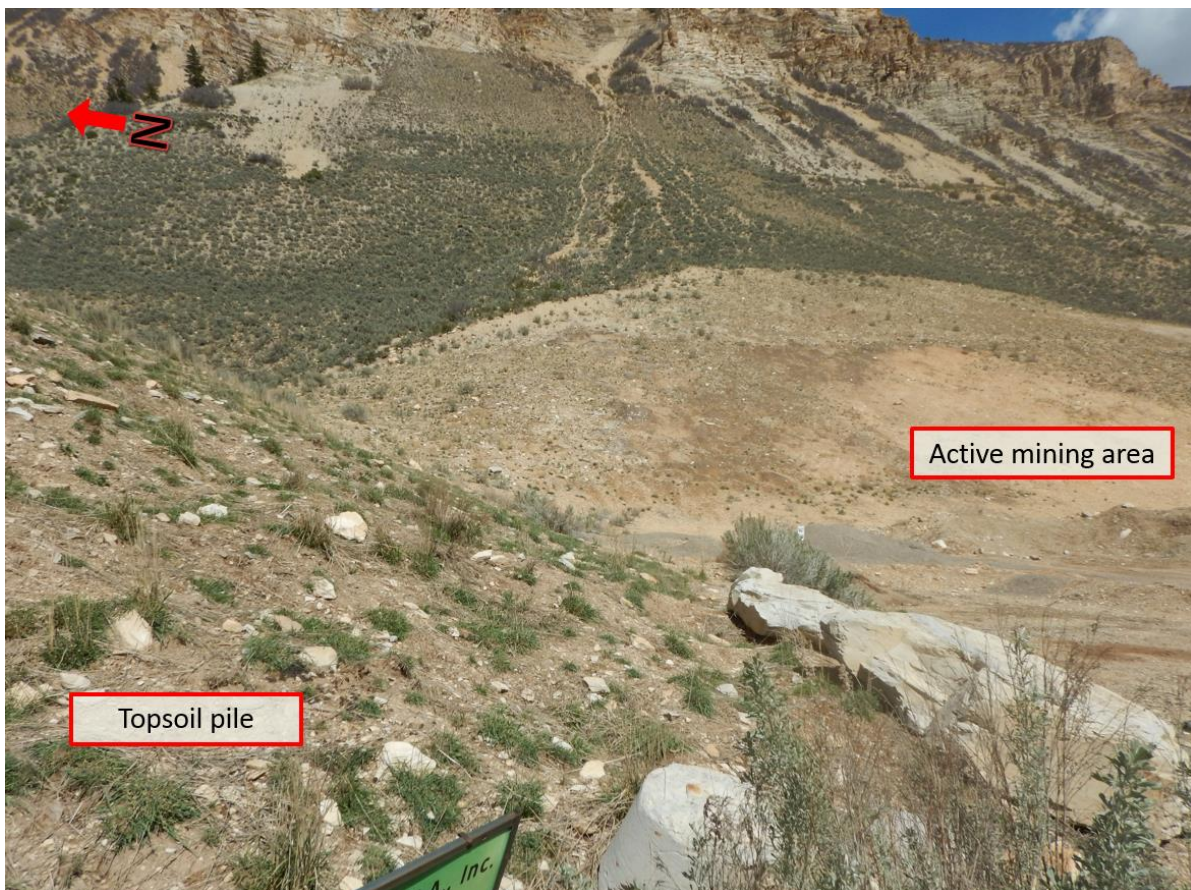
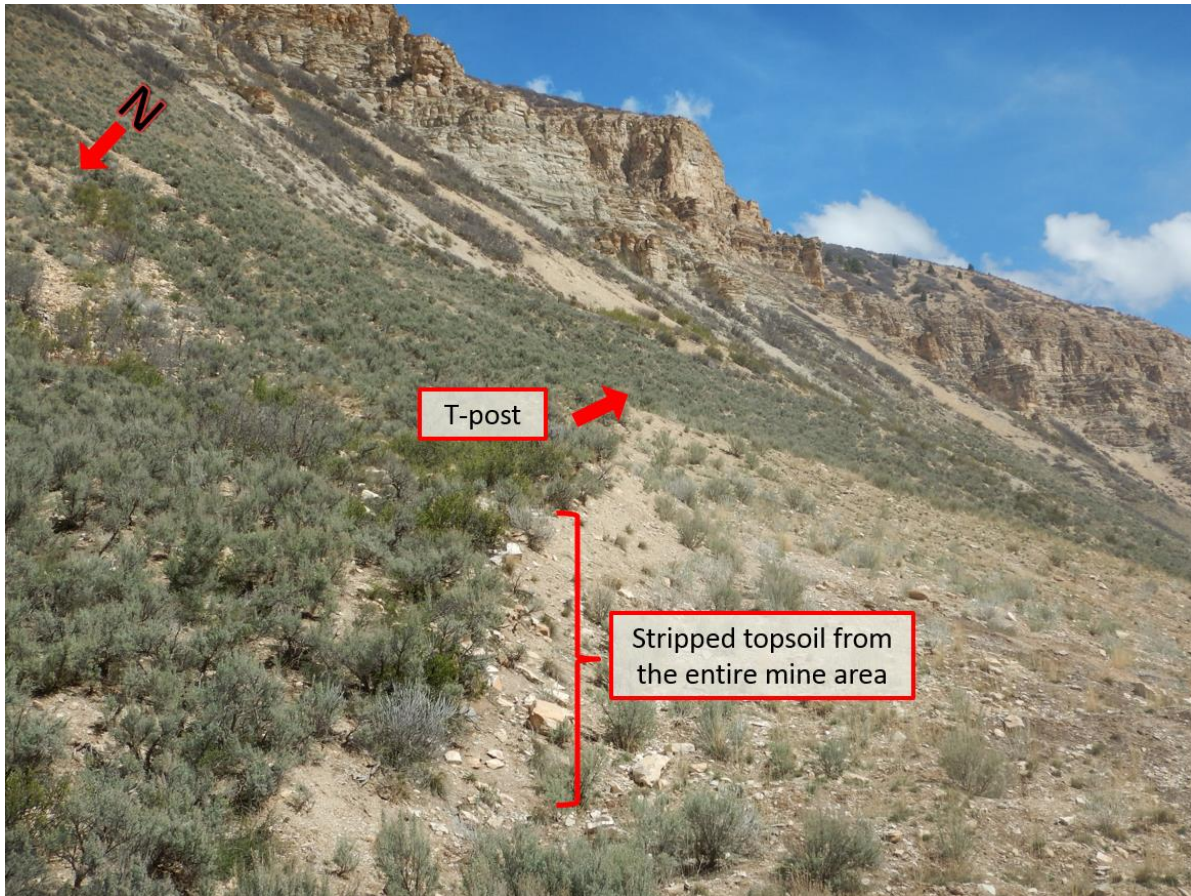
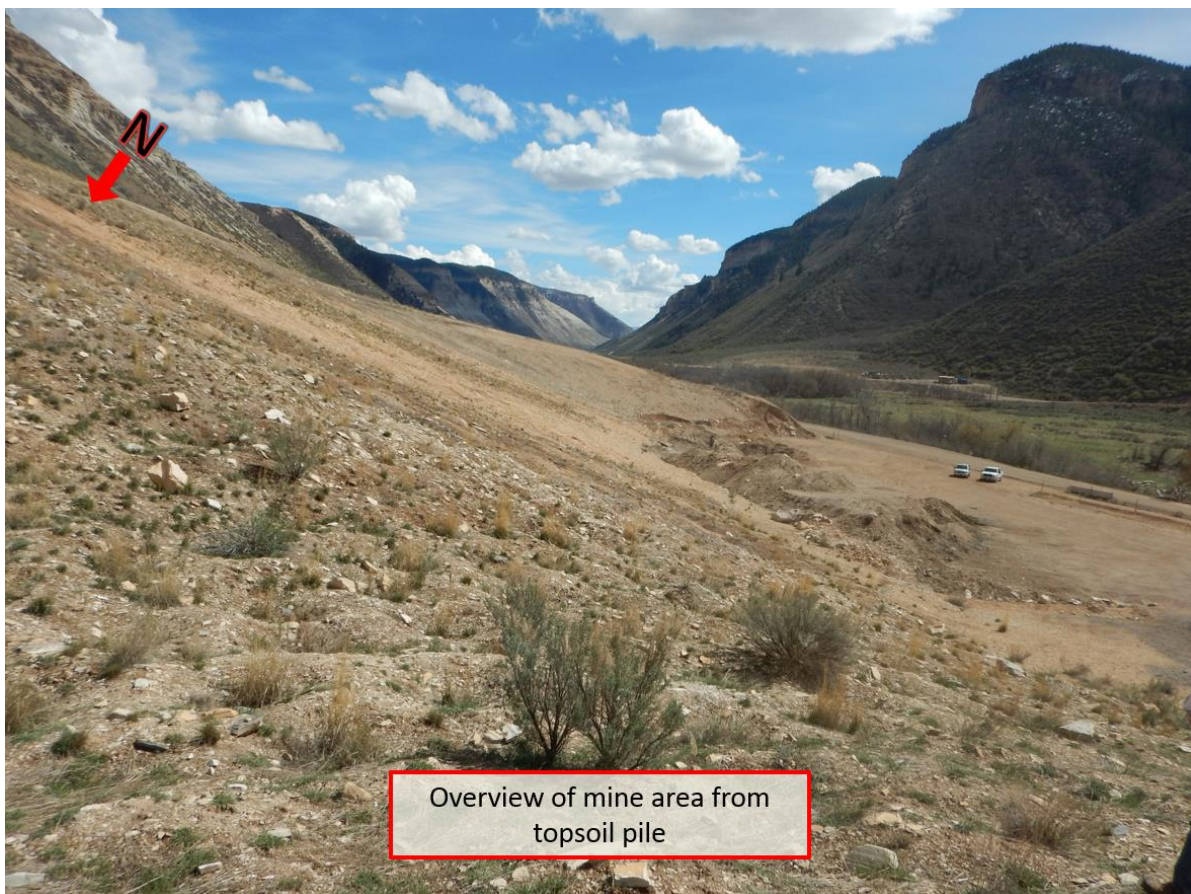
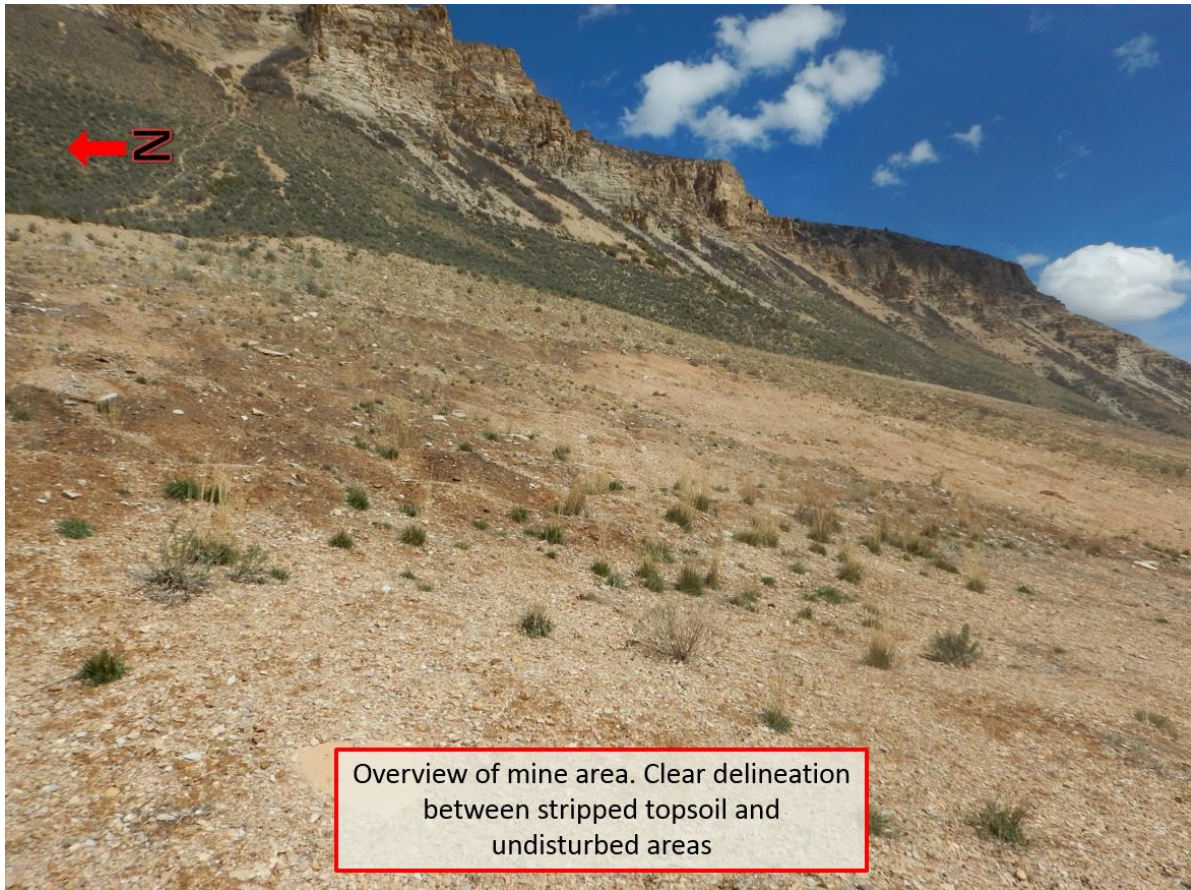
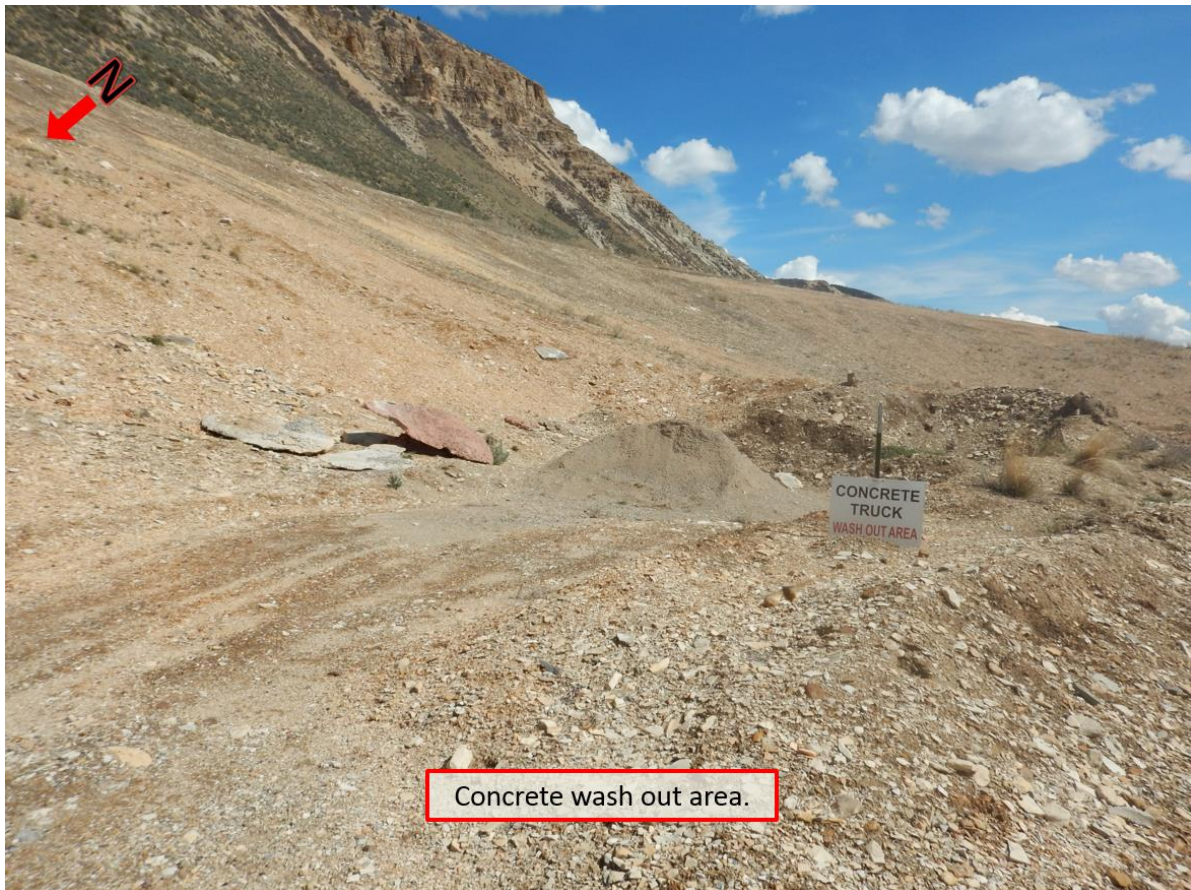
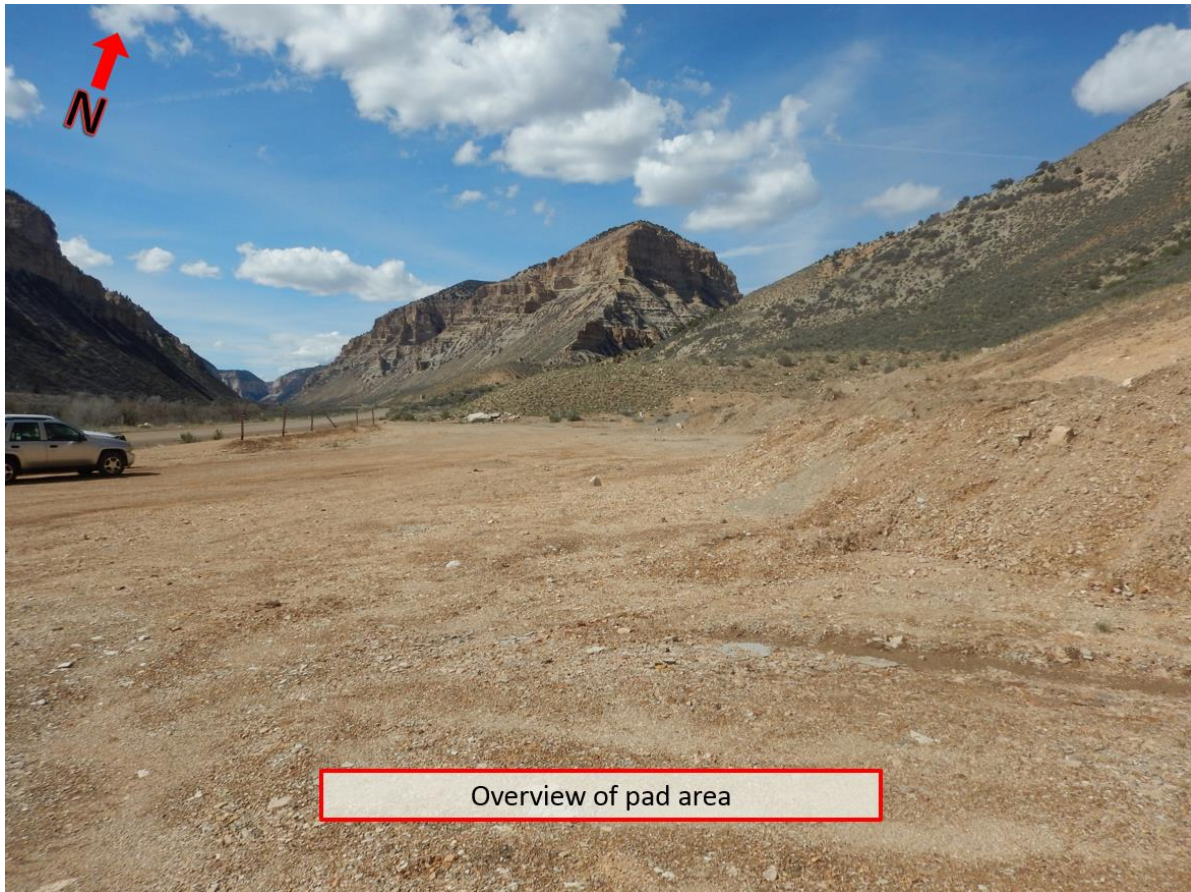
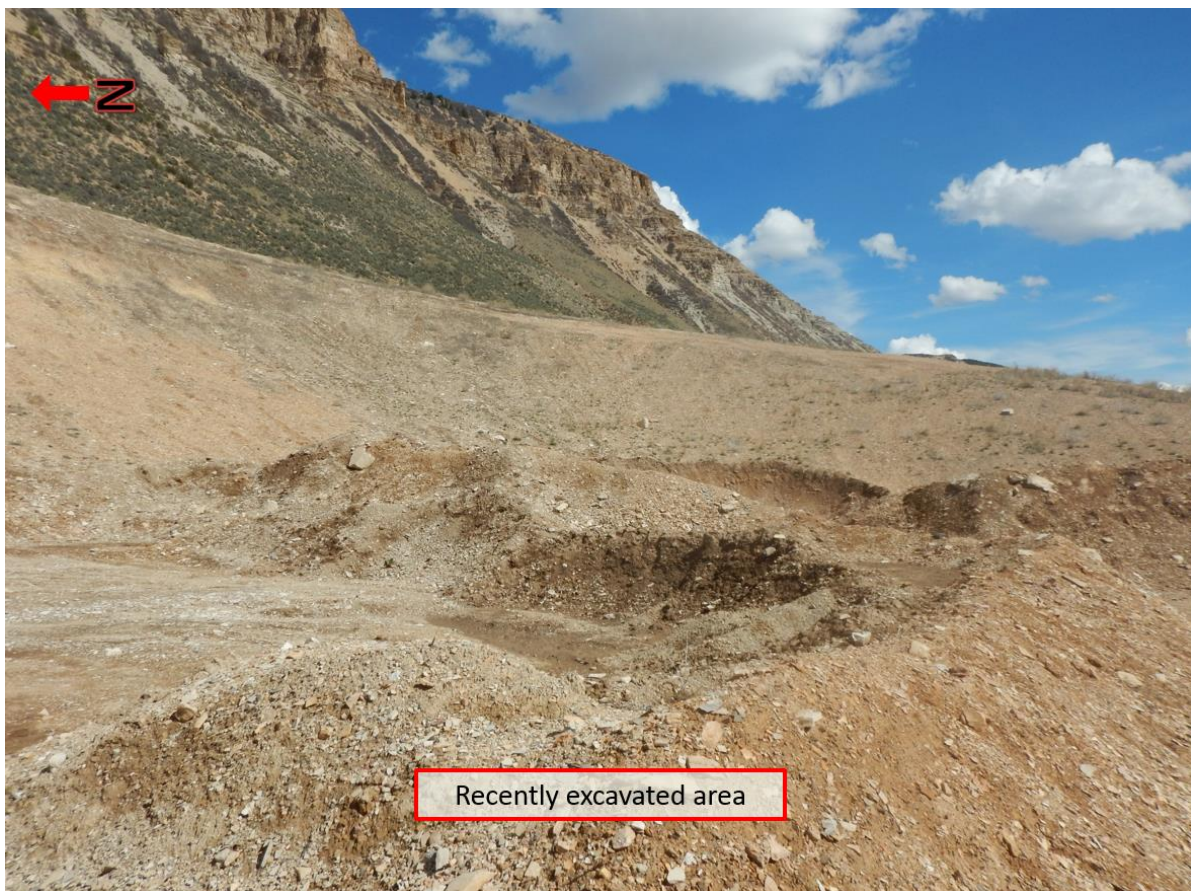
PHOTOGRAPHS

The mine identification sign and affected area boundary markers are in place. The mine sign is posted at the base of the topsoil pile in the northwest corner of the mine. The permit boundary is delineated by t-posts. It is noted that the green t-posts blend into the natural landscape and were very difficult spot. The operator would benefit from painting the t-post a bright color or perhaps adding a tall stick of white PVC to make the permit boundary easier to delineate at a distance.

The topsoil pile is seeded and stable. Pocketing has been used well and there is little to no evidence of erosion. The entire site has been stripped of topsoil. Along the northeastern slopes, natural vegetation has volunteered. The site is stable with no erosion and no weeds were observed.

Several piles of sediment pond/culvert clean out material was observed. This material may prove beneficial for reclamation given its high quality of nutrients and fine texture as compared to the native material of this site. In order to import material the operator must provide the office with notice per Rule 3.1.5 (9). "The notice shall include but is not limited to: a narrative that describes the approximate location of the proposed activity; the approximate volume of inert material to be backfilled; a signed affidavit certifying that the material is clean and inert, as defined in Rule 1.1(20); the approximate dates the proposed activity will commence and end, however, such dates shall not be an enforceable condition; an explanation of how the backfilled site will result in a post-mining configuration that is compatible with the approved post-mining land use; and a general engineering plan stat how the material will be place and stabilized in a manner to avoid unacceptable settling and voids." Please submit this notice in the form of a technical revision.

A cement wash out area was also observed. The operator is reminded that per Rule 1.1(20) concrete must be in a hardened state for at least 60 days prior to burial and notice given per Rule 3.1.5(9). Based on discussions with the operator the Division recommends they file for intermittent status. Active status requires mining annually more than 180 days which this operation does not do. Intermittent status requires that a site be active annually however does not operate more than 180 days a year. If the mine ceases production for more than a year it shall go into temporary cessation. Mining activities include not only excavation but the moving of stockpiled materials as well.

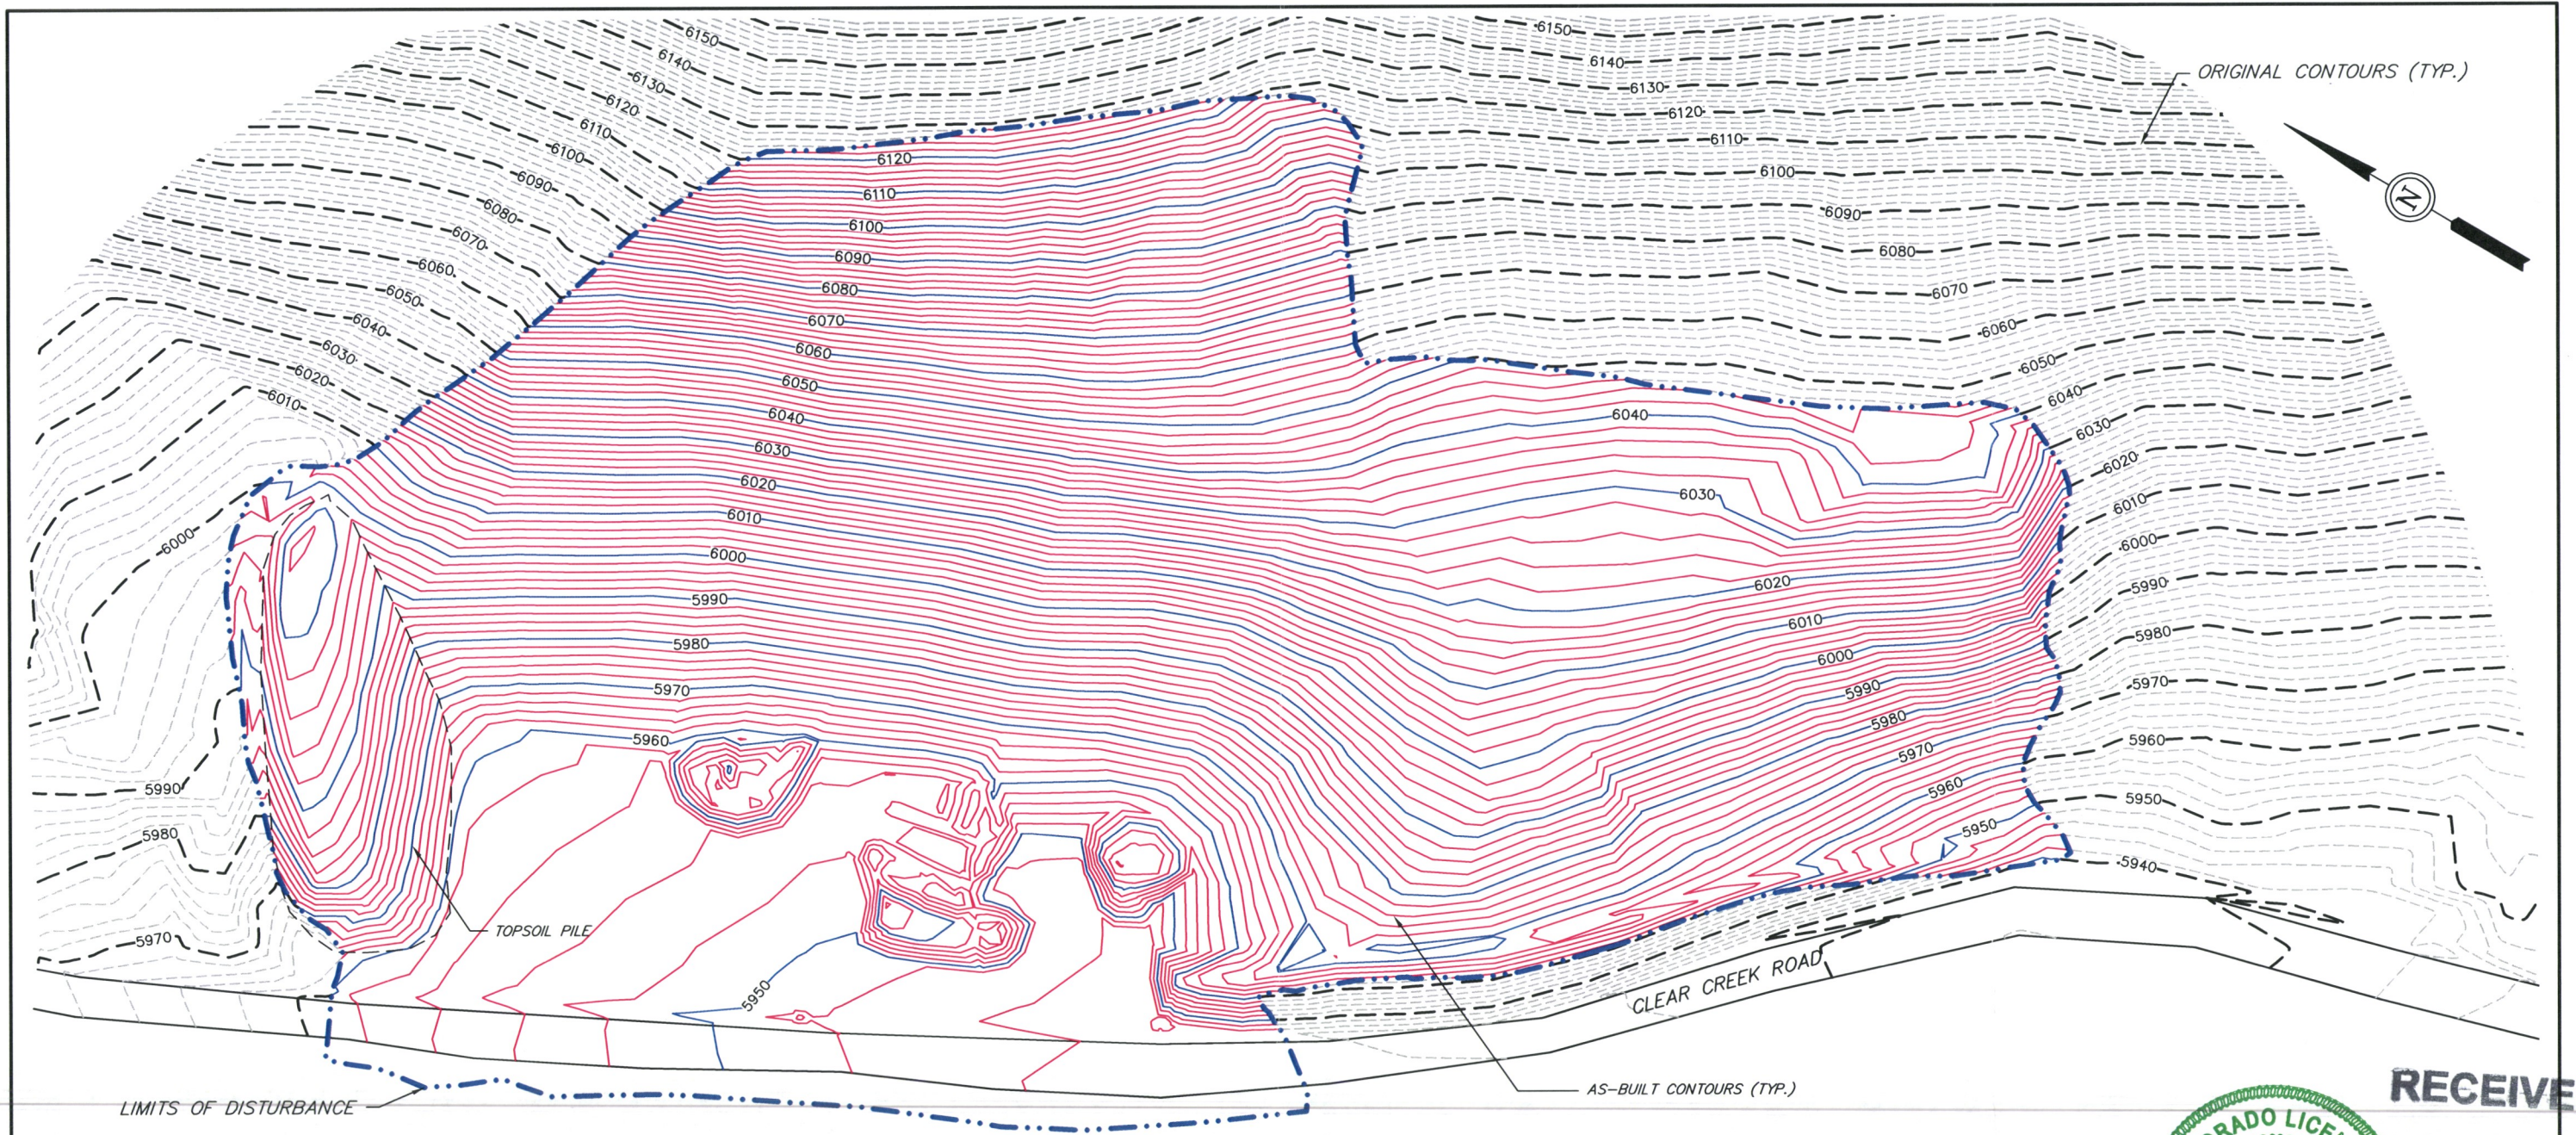
coincides to the striped land. This permit boundary does not match the boundary delineated in the permit application (map attached). The site appears to be approximately 11 acres which is larger than the approved 8 acres. Depending on the extent in which land has been affected outside of the permit boundary this could be a possible violation of mining without a permit or failure to protect lands from off-site damages. The Division is requesting that the operator survey the current disturbance to clarify the total affected acreage to date. Then the operator shall provide the Division with documentation of their findings within 90 days of this inspection report including an updated map. Upon receipt of this information the Division will make its determination of how to proceed forward and rectify the situation.
