COLORADO DIVISION OF RECLAMATION, MINING AND SAFETY
MINERALS PROGRAM INSPECTION REPORT
PHONE: (303) 866-3567

MINE NAME: Highway 50 Borrow Area No. 2	MINE/PROSPECTING ID#: M-1999-076	MINERAL: Borrow material for	COUNTY: Mesa
INSPECTION TYPE: Monitoring	INSPECTOR(S): Stephanie J. Mitchell	INSP. DATE: March 2, 2016	INSP. TIME: 10:30
OPERATOR: Elam Construction, Inc.	OPERATOR REPRESENTATIVE: Jon Mueller	TYPE OF OPERATION: 111 - Construction by Government Agency

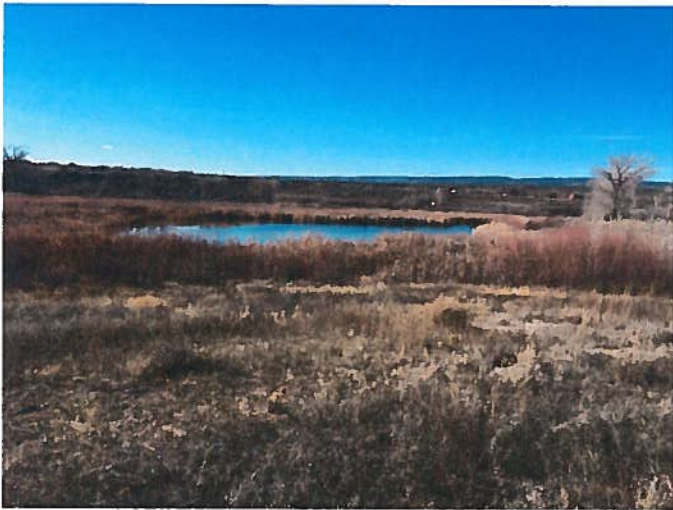
As noted in the previous two inspection reports, the site is impounding water. This is considered a problem at the beginning of the inspection report. A well permit to account for the evaporative losses is required by the Division of Water Resources. Enforcement action will be initiated if an evaporative loss permit or another form of compliance is not received by the Division on or before August 17, 2016. In July of 2013, Elam wrote a letter to the Division ensuring that an approval for augmentation will be filed with the Water Court or plans would be completed to otherwise mitigate the hydrologic balance problem by March 31, 2014. This issue has still not been resolved.

Water Impounded

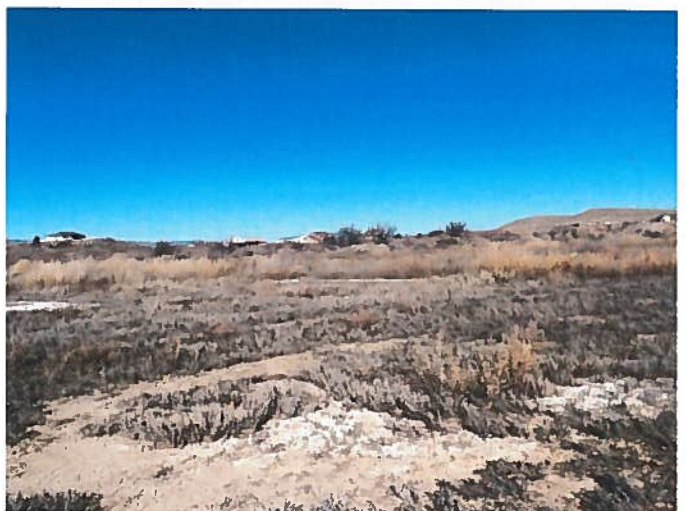
Overall, the site appears to have been graded to match the surrounding topography. No stockpiles are in place at the site. The amount of vegetation is adequate at the site. However, Tamarisk, Russian Olive and Russian Knapweed were all observed. Elam submitted a weed management plan as technical revision in 2005. The Operator ensures that they will be spraying the site in the spring. The Division will be closely monitoring the progress of the weed (Russian Knapweed) management in the future.

Russian Knapweed
