## Bowie No. 2 2nd Quarter Gob & Pond Reports

Re: Bowie Resources, LLC, Bowie No. 2 Mine  
Coal Mine Waste Banks & Instrumentation Monitoring  
Pond Quarterly Inspections  
Permit C-1996-083

#### Coal Mine Waste Bank Nos. 1, 2, & 3 Inspections - 2nd Quarter 2016

## QUARTERLY POND INSPECTION REPORT

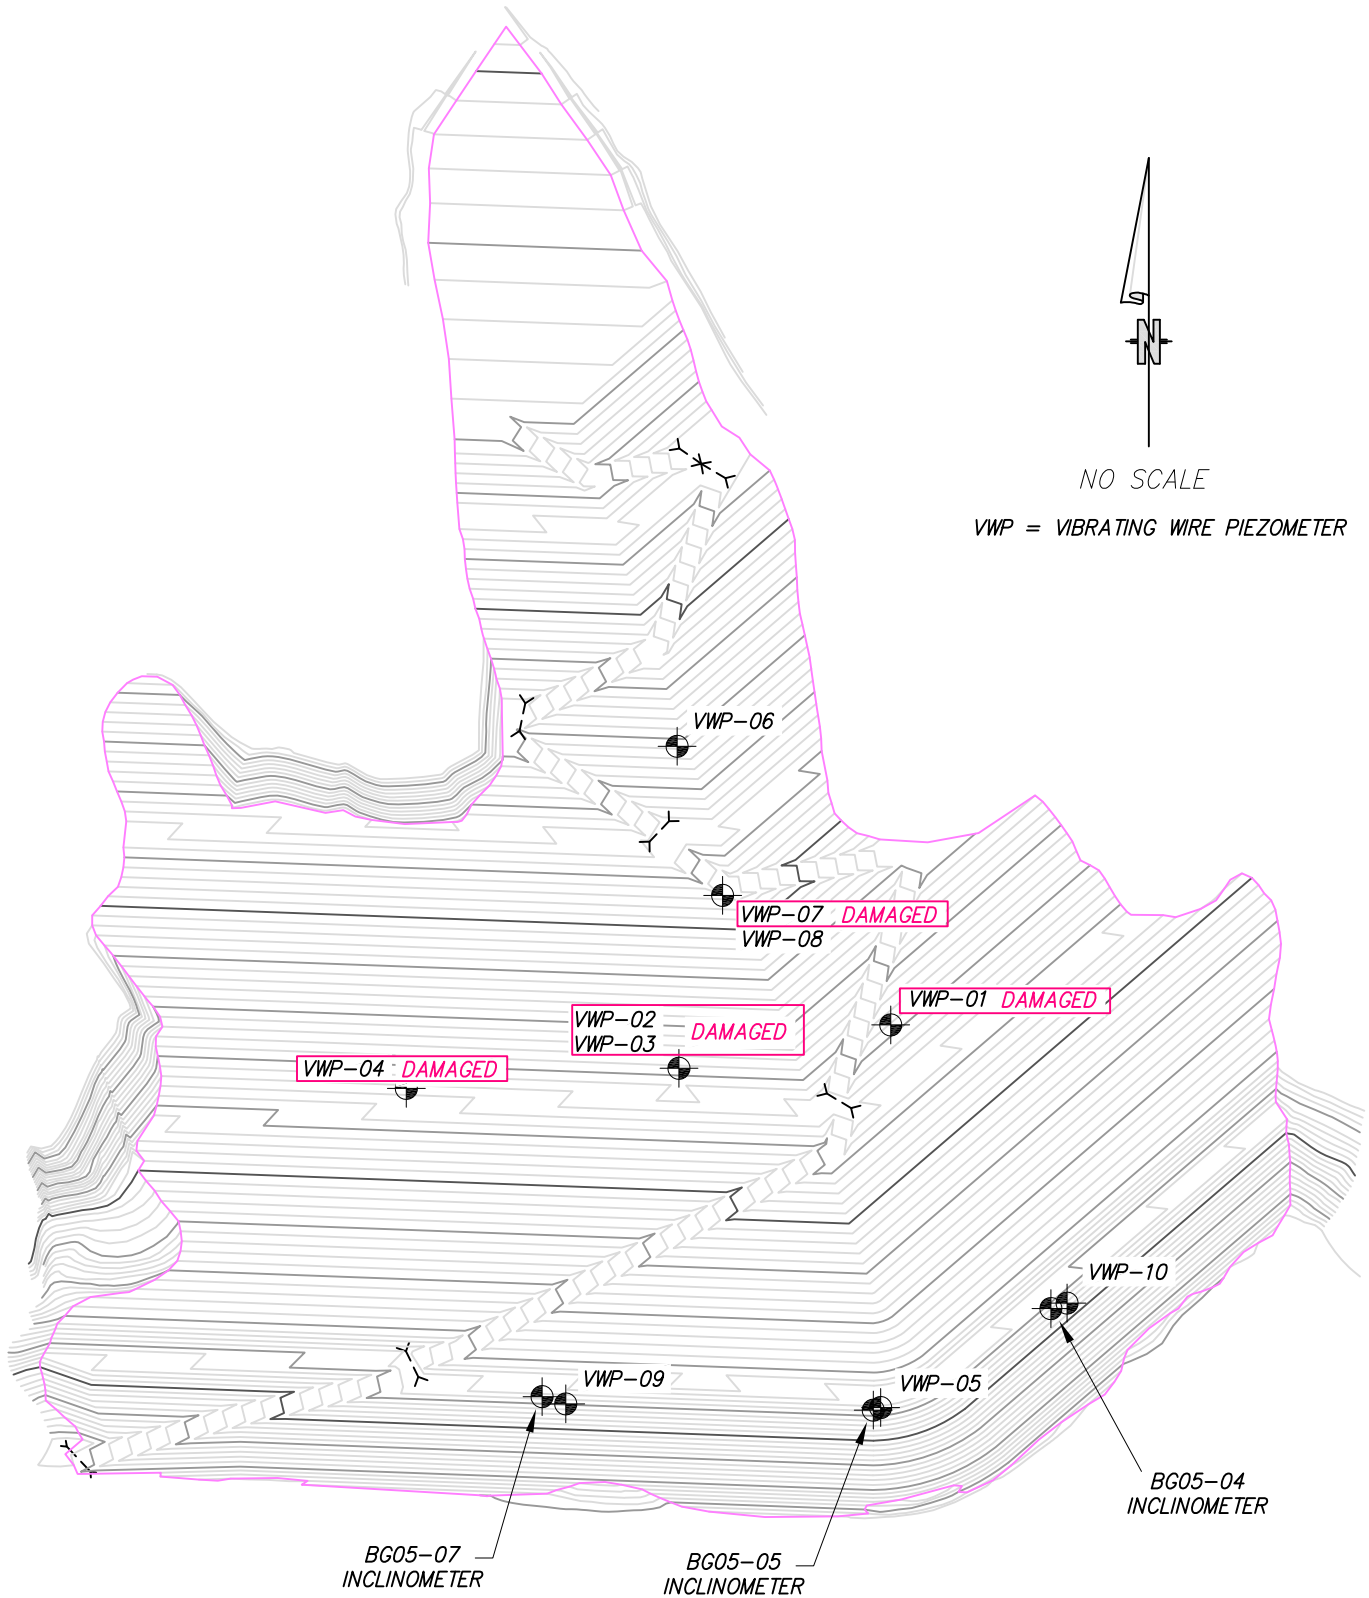
# INSTRUMENTATION SITE PLAN

The physical locations of the piezometers are shown on the attached Instrumentation Site Plan, Drawing 1. The graph of historical data through 5-21-14 is presented for reference as Figure 1. A graph of active piezometers only is presented as Figure 2.

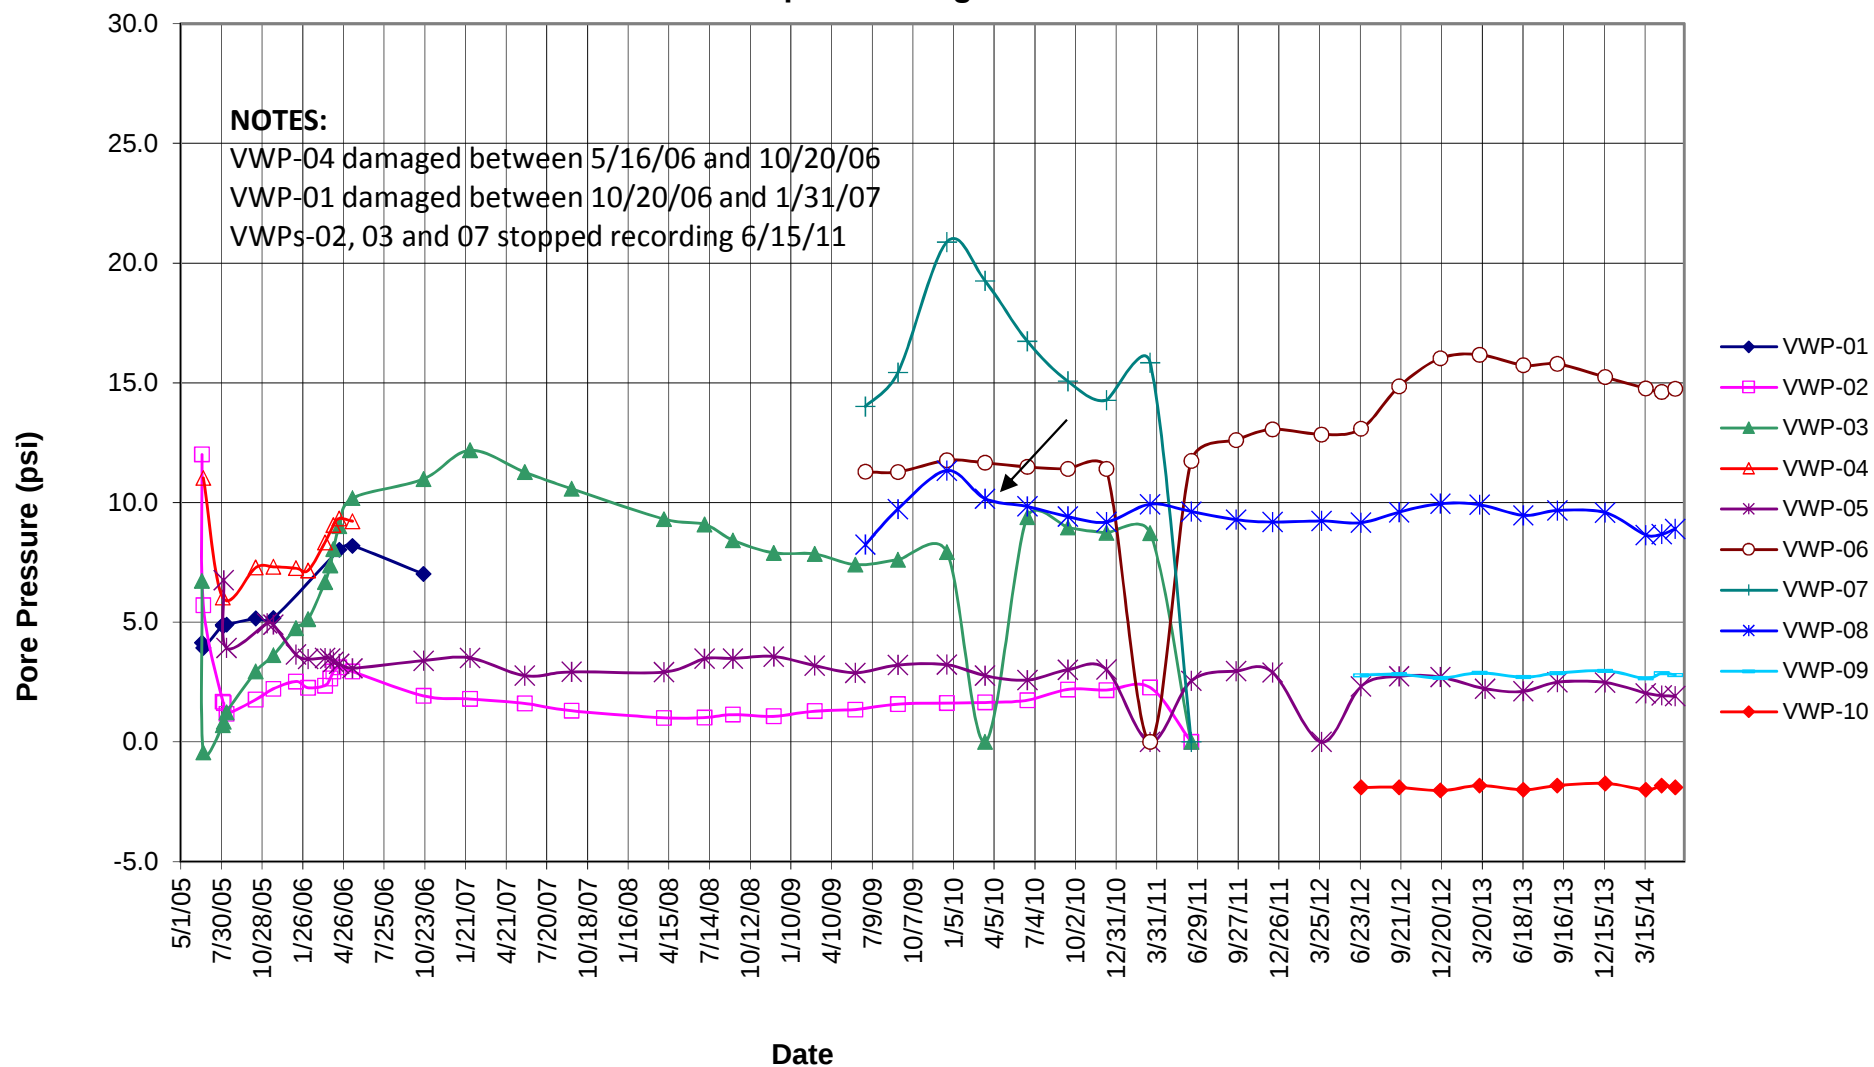
**FIGURE 1**

Between 2005 and 2012, a total of ten vibrating wire piezometers were installed in CWDA No. 2. However, several of the piezometers have been damaged or have otherwise ceased to function. Currently, five of the piezometers are functional.

VWP-05 was installed on August 3, 2005 near the toe of CWDA No. 2 adjacent to the access road/bench. The pore pressures recorded at VWP-05 have shown some seasonal fluctuations; however, the range of pore pressure changes is fairly small. In general, HBET does not believe that the pore pressures in VWP-05 are cause for concern regarding stability of the gob pile.

# **Bowie Mine No. 2 - CWDA No. 2** **Active and Damaged Vibrating Wire Piezometer Data**

**Inception through 5-21-14**

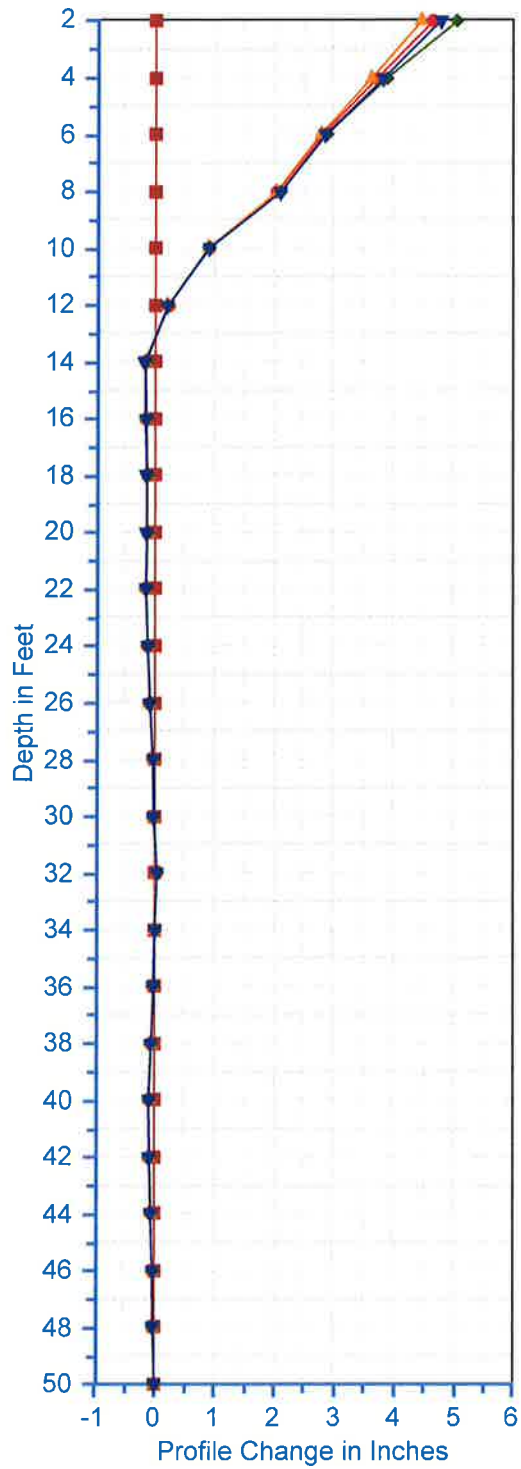
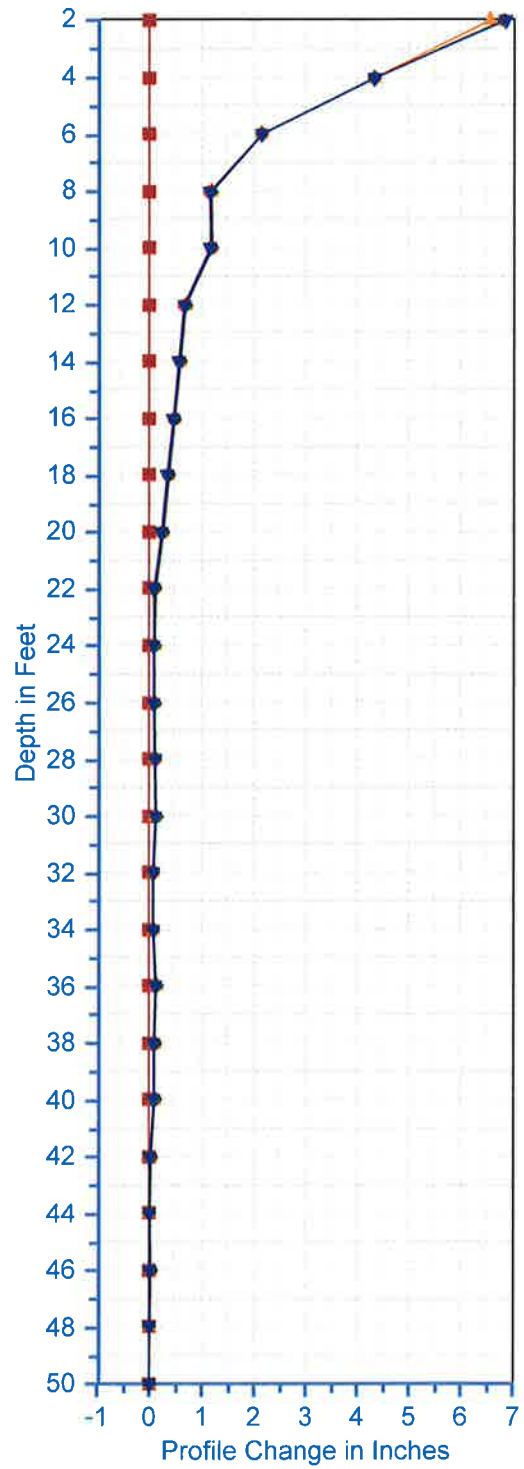
### BOWIE BG05\_7 A

The latest inclinometer readings indicate no major movements since the last quarterly reading. As indicated in the DOWL report, some deflection was observed at BG05-05. However, the movement in the A-axis is zero at the top and bottom with a fairly uniform shift of the data along the length of the instrument. In general, it is unusual to see a fairly uniform shift along the 'middle' of the instrument with no movement at the top along the same axis. In addition, the movement along the B-axis is only in the upper portion of the instrument. Overall, HBET does not believe that the data represents instability in the gob. However, the 3<sup>rd</sup> Quarter 2016 monitoring data may provide additional information regarding the observed deflection.
