MINERALS PROGRAM INSPECTION REPORT

MINE NAME: Incas Mine	MINE/PROSPECTING ID#: M-1986-076	MINERAL: Gold and silver	COUNTY: La Plata
INSPECTION TYPE: Monitoring	INSPECTOR(S): Lucas J. West	INSP. DATE: June 30, 2016	INSP. TIME: 08:42
OPERATOR: Michael McClure	OPERATOR REPRESENTATIVE: None	TYPE OF OPERATION: 110d - Designated Limited Impact

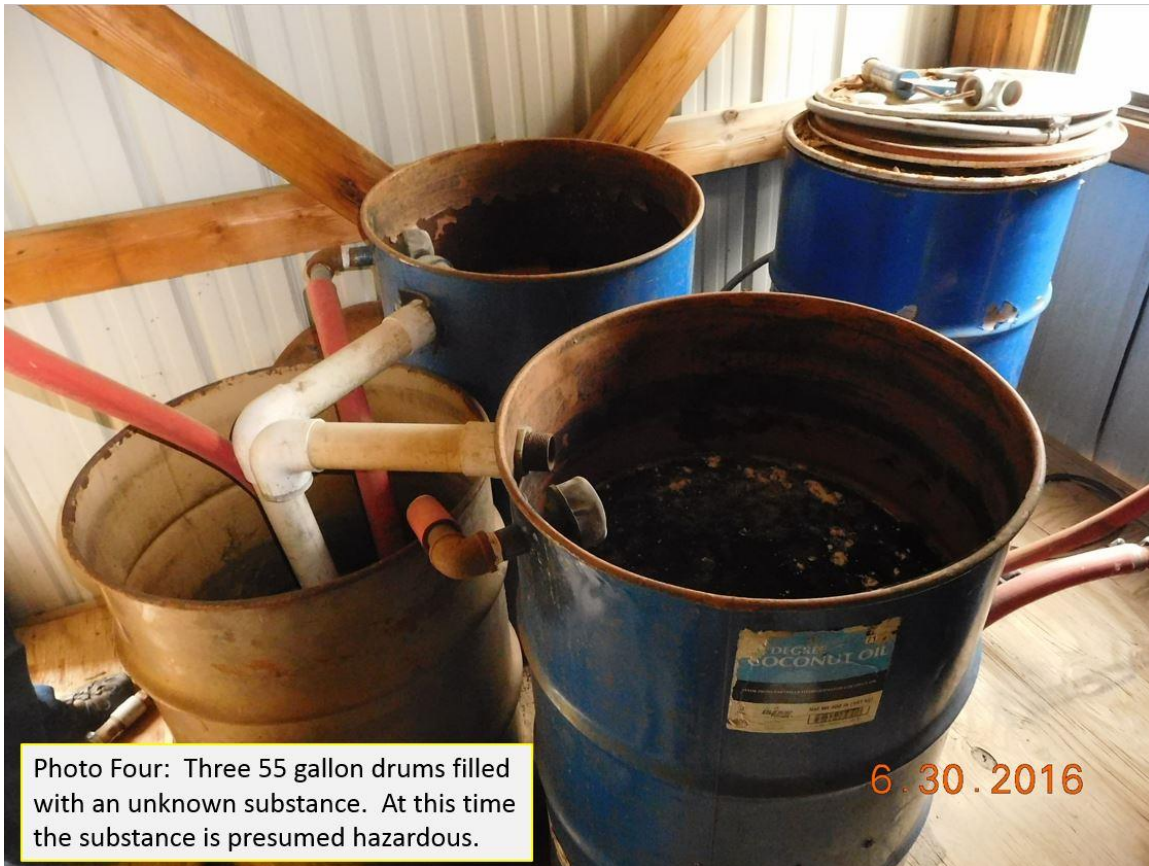
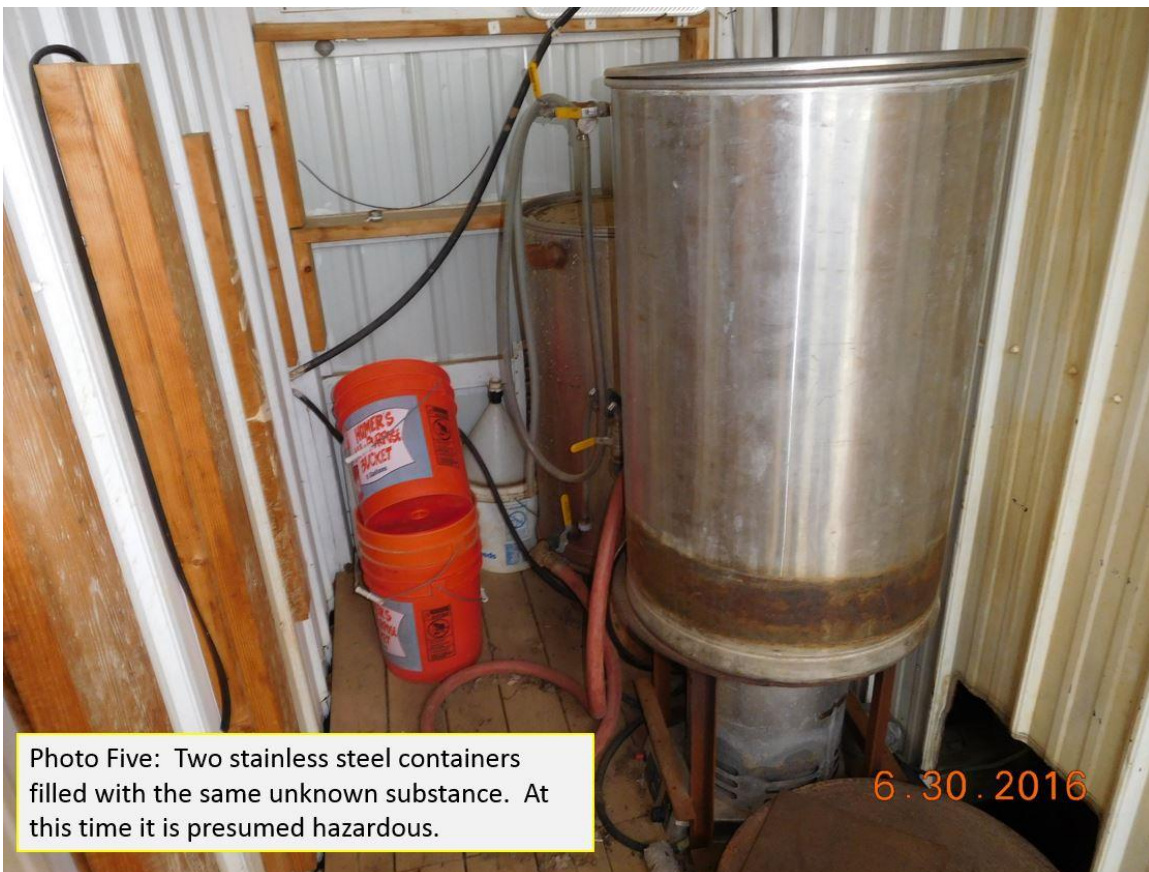
PROBLEM/POSSIBLE VIOLATION: Problem: Several containers of unknown materials are located within the mill building. Due to the fact that the mill used to operate with cyanide, the material is presumed hazardous and should be either neutralized and or removed from the site, or stored in proper hazardous materials containment structures.

Access to the mill building was gained through an unlocked back door. Photos Two and Three show the mill building. The mill equipment, processing and testing equipment were observed throughout the building. Much of the equipment and the mill building itself is in serious disrepair and requires immediate attention. Several containers, including three plastic 55 gallon drums of an unknown substance, as well as two stainless steel drums were observed within the mill. The 55 gallon drums are shown in Photo Four, and the Stainless Steel containers are shown in Photo Five. The containers are filled with an unknown substance, which at this time is being presumed hazardous. The operator shall submit in writing, a report characterizing the materials to the Division. If determined to be hazardous the operator shall take immediate action to neutralize or remove the materials from the site. The report must be received within **90 days** of the date of this letter. All documentation demonstrating compliance must be received by the Division no later than **Friday October 28, 2016**. If compliance is not reached by the date specified above, a reclamation cost estimate will be performed with the inclusion of a hazardous materials characterization and removal task.

CORRECTIVE ACTIONS: The operator shall submit in writing, a report characterizing the materials to the Division. If determined to be hazardous the operator shall take immediate action to neutralize or remove the materials from the site. The report must be received within 90 days of the date of this letter.
