MINERALS PROGRAM INSPECTION REPORT
PHONE: (303) 866-3567

MINE NAME: O'Bannon Pit	MINE/PROSPECTING ID#: M-1980-201	MINERAL: Sand and gravel	COUNTY: Rio Grande
INSPECTION TYPE: Monitoring	INSPECTOR(S): Travis H. Marshall	INSP. DATE: July 14, 2016	INSP. TIME: 15:00
OPERATOR: Mathias Concrete, Inc.	OPERATOR REPRESENTATIVE: Marshall Mathias	TYPE OF OPERATION: 112c - Construction Regular Operation	
REASON FOR INSPECTION: Normal I&E Program	BOND CALCULATION TYPE: Complete Bond	BOND AMOUNT: \$19,400.00	
DATE OF COMPLAINT: NA	POST INSP. CONTACTS: None	JOINT INSP. AGENCY: None	
WEATHER: Clear	INSPECTOR'S SIGNATURE:

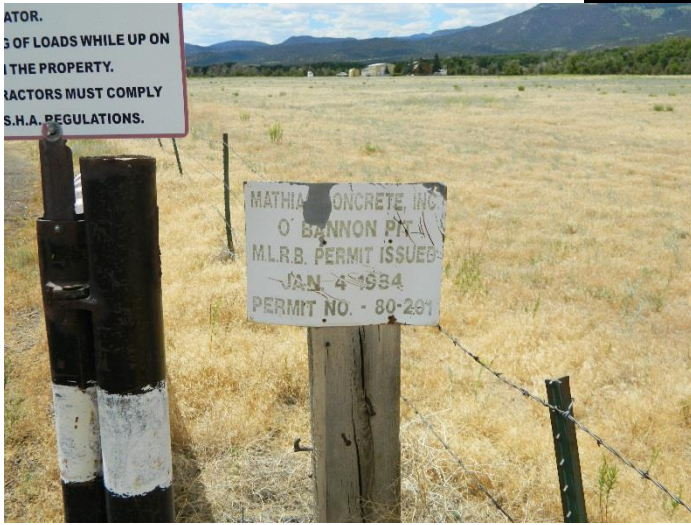
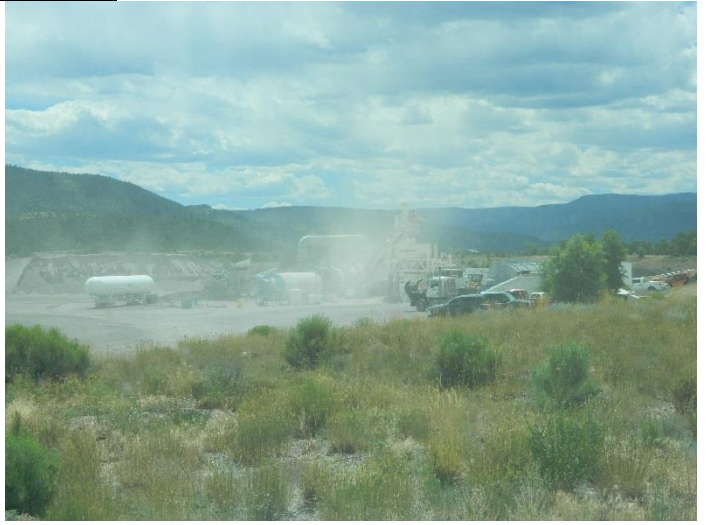
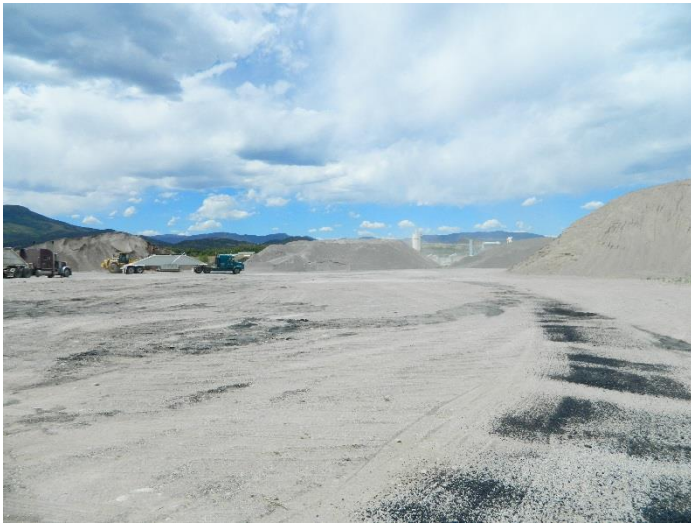
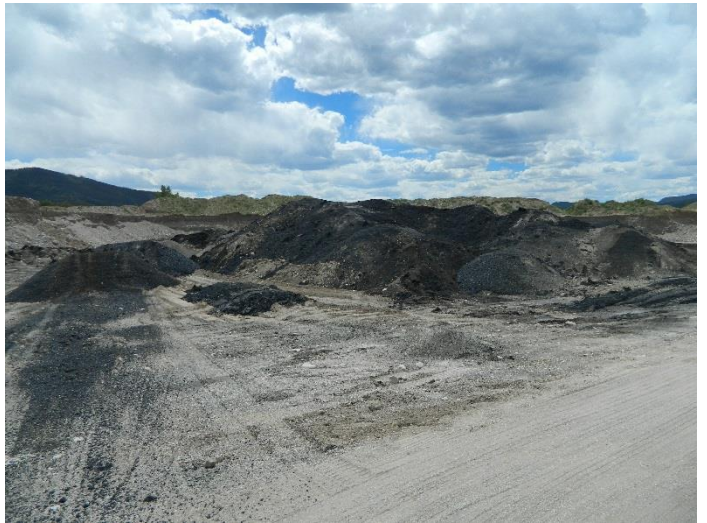
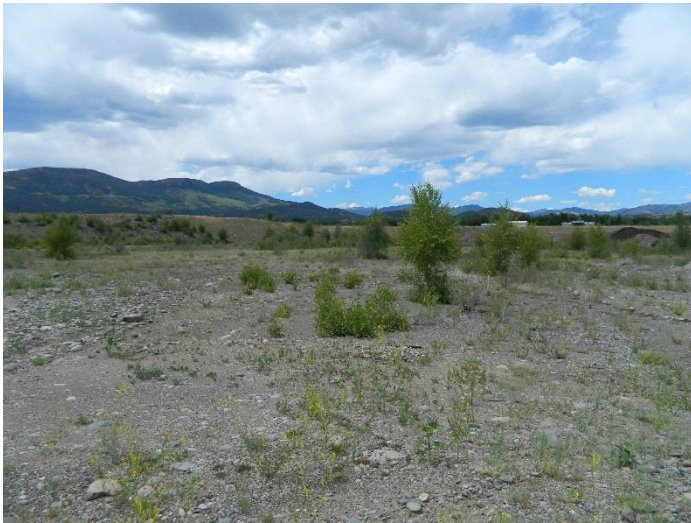
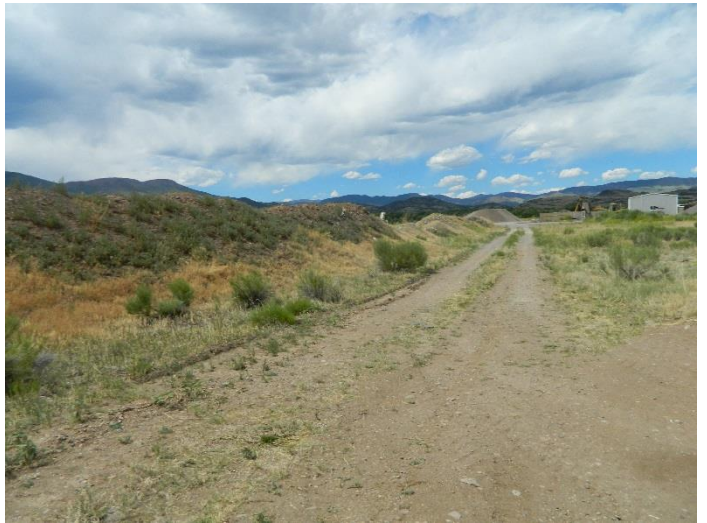
The site was active during the inspection. Four Corners Materials was actively operating a hot plant during the inspection. Various stockpiles of construction material and rip rap were observed around the permit area. A portion of the reclaimed slope located along the northern permit boundary was disturbed to allow for equipment and trucks to access the hot plant. This is not seen as a problem but may increase the surety amount that is required to perform the approved reclamation.

No off-site damage, significant erosional features or unnecessary debris was observed within the permit area. The site was in a very orderly condition during the inspection.
