MINERALS PROGRAM INSPECTION REPORT
PHONE: (303) 866-3567

MINE NAME: Ignacio Pit	MINE/PROSPECTING ID#: M-1977-446	MINERAL: Sand and gravel	COUNTY: La Plata
INSPECTION TYPE: Monitoring	INSPECTOR(S): Lucas J. West	INSP. DATE: September 15, 2016	INSP. TIME: 10:00
OPERATOR: Hocker Construction, LLP	OPERATOR REPRESENTATIVE: Roy Hocker	TYPE OF OPERATION: 112c - Construction Regular Operation	
REASON FOR INSPECTION: Normal I&E Program	BOND CALCULATION TYPE: Complete Bond	BOND AMOUNT: \$115,646.00	
DATE OF COMPLAINT: NA	POST INSP. CONTACTS: None	JOINT INSP. AGENCY: None	
WEATHER: Clear	INSPECTOR'S SIGNATURE:

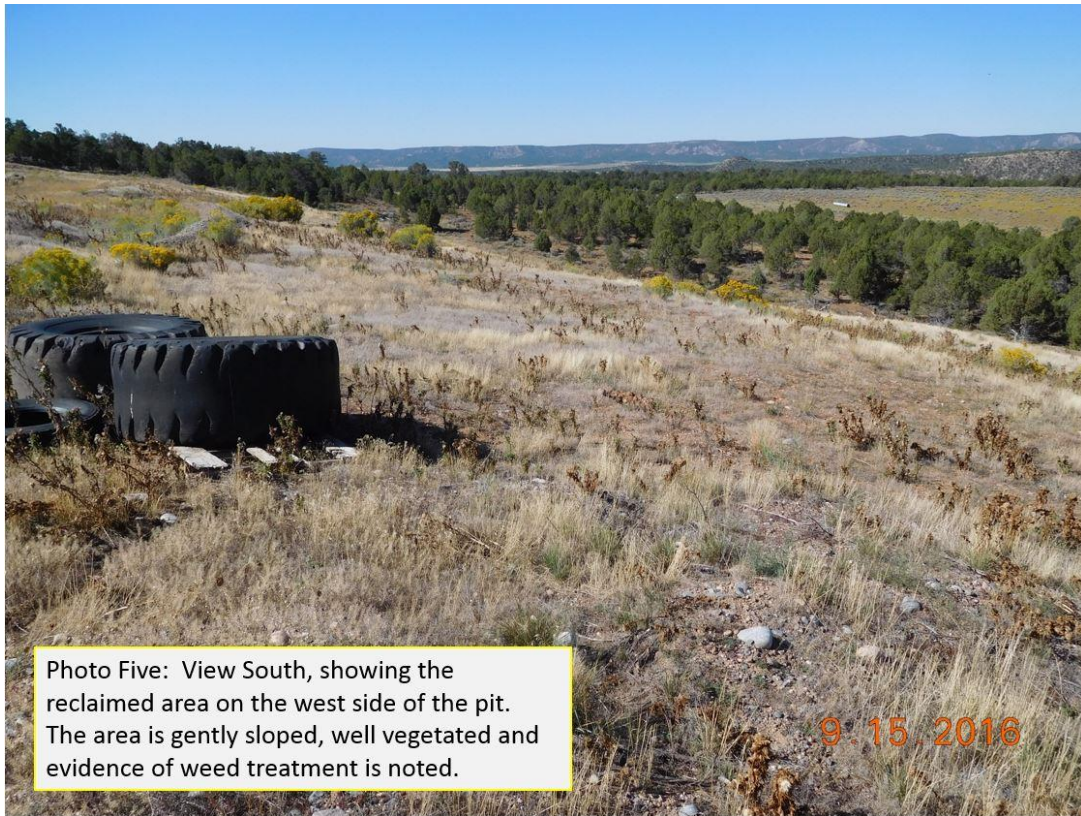
A large area on the west side of the site, approximately 10 acres, has undergone reclamation. The grading of the area appears to be stable and no erosional features were noted. The area has also been vegetated, which is adequate in both density and diversity. The vegetation also shows signs of self-propagation with multiple years growth observed. Photos Four and Five show the reclaimed area. Evidence of chemical treatment of noxious weeds was observed, and conversations with the operator indicate that the weed management plan is active and on-going.

Photo Four: View north, showing the reclaimed area on the west side of the pit. The area is gently sloped, well vegetated and evidence of weed treatment is noted.
