**MINERALS PROGRAM INSPECTION REPORT**  
**PHONE: (303) 866-3567**

<b>MINE NAME:</b> Sunday Mine	<b>MINE/PROSPECTING ID#:</b> M-1977-285	<b>MINERAL:</b> Uranium and vanadium	<b>COUNTY:</b> San Miguel
<b>INSPECTION TYPE:</b> Monitoring	<b>INSPECTOR(S):</b> Lucas J. West	<b>INSP. DATE:</b> September 20, 2016	<b>INSP. TIME:</b> 09:46
<b>OPERATOR:</b> Pinon Ridge Mining LLC	<b>OPERATOR REPRESENTATIVE:</b> Patrick Siglin, Michael Rutter	<b>TYPE OF OPERATION:</b> 112d-2 - Designated Mining Operation	
<b>REASON FOR INSPECTION:</b> Normal I&E Program	<b>BOND CALCULATION TYPE:</b> None	<b>BOND AMOUNT:</b> \$297,926.00	
<b>DATE OF COMPLAINT:</b> NA	<b>POST INSP. CONTACTS:</b> None	<b>JOINT INSP. AGENCY:</b> None	
<b>WEATHER:</b> Clear	<b>INSPECTOR'S SIGNATURE:</b>

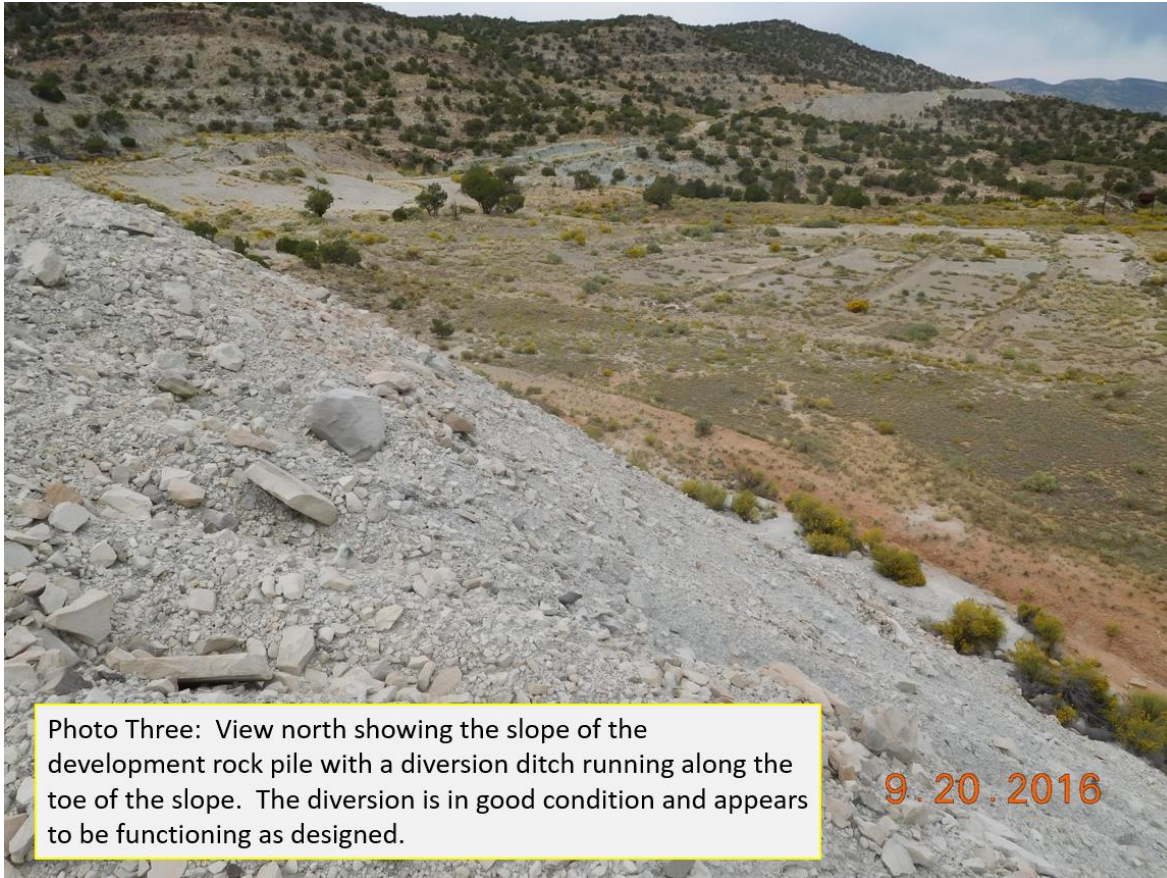
As seen in Photo One, the permit ID sign was observed at the entrance to the site. The permit boundary markers were also observed. Photo Two show the Sediment catchments that are in good condition and appear to be functioning as designed. All diversion ditches appear to be functioning as designed and no significant erosion was observed throughout most of the site. An example of one of the diversion ditches located on site can be seen in Photo Three. The low grade ore pile located on site appears to be stable and in good condition. A large pile of development rock exists on site which appears to be stable and in good condition.

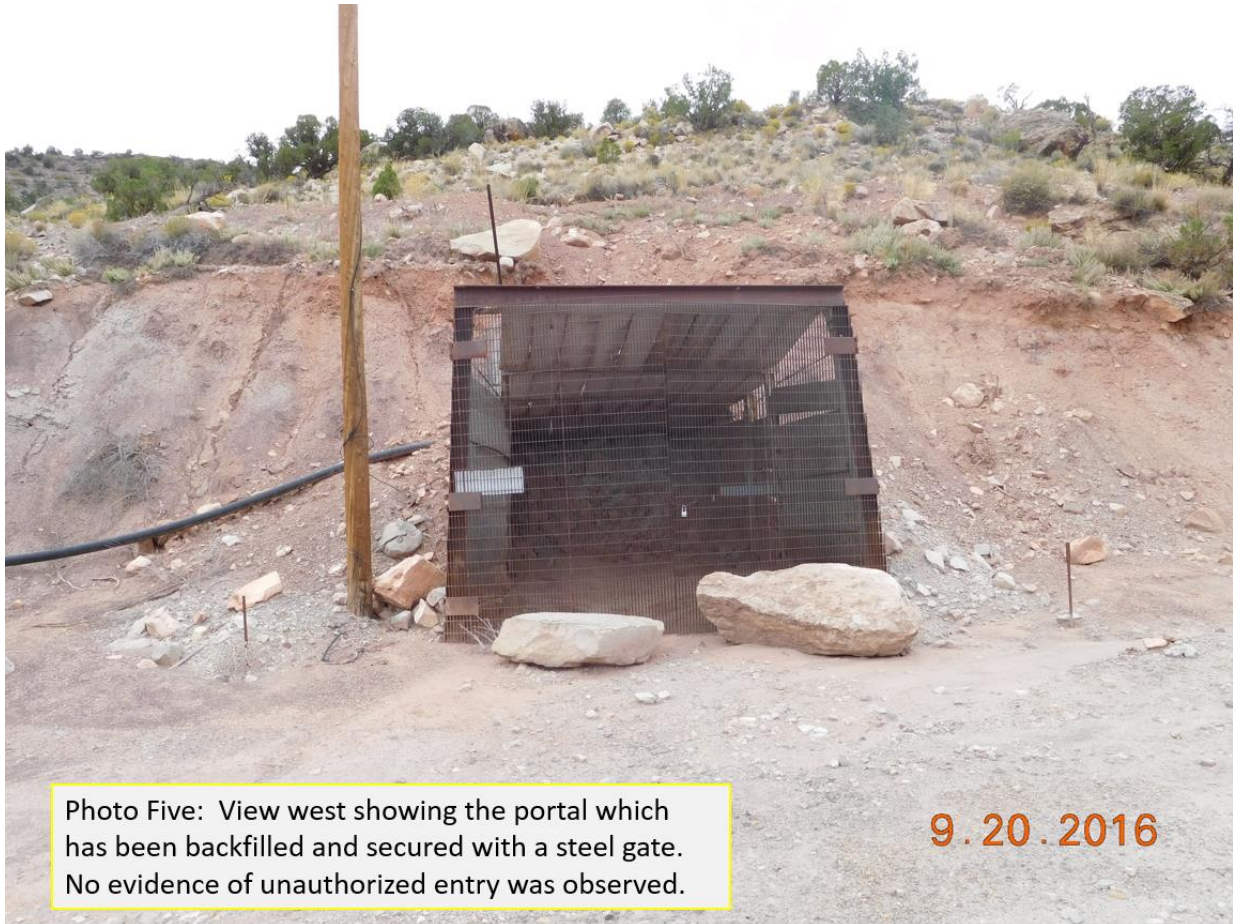
All work facilities were secure and seemed to be in good condition during the time of the inspection. No signs of vandalism or general site degradation were noted. Examples of the work facilities can be seen in Photo Four. The portal located on site was also secured, it has been backfilled and closed off with steel grates that are in good condition as seen in Photo Five. Vent shaft S-2, located to the Northwest of the shop facilities is covered with a steel grate and has been secured in response to the previous Inspection Report. All loadouts, roads and pad areas that exist on site were observed and in good condition. Evidence of chemical weed treatment was observed and the operator expressed that weed management is ongoing throughout the whole Sunday Mine Complex. The site exhibits positive drainage and no erosional features were observed.
