MINERALS PROGRAM INSPECTION REPORT
PHONE: (303) 866-3567

MINE NAME: St Jude Mine	MINE/PROSPECTING ID#: M-1978-039-HR	MINERAL: Uranium and vanadium	COUNTY: San Miguel
INSPECTION TYPE: Monitoring	INSPECTOR(S): Lucas J. West	INSP. DATE: September 20, 2016	INSP. TIME: 16:05
OPERATOR: Pinon Ridge Mining LLC	OPERATOR REPRESENTATIVE: None	TYPE OF OPERATION: 110d - Designated Limited Impact	
REASON FOR INSPECTION: Normal I&E Program	BOND CALCULATION TYPE: None	BOND AMOUNT: \$47,700.00	
DATE OF COMPLAINT: NA	POST INSP. CONTACTS: None	JOINT INSP. AGENCY: None	
WEATHER: Clear	INSPECTOR'S SIGNATURE:

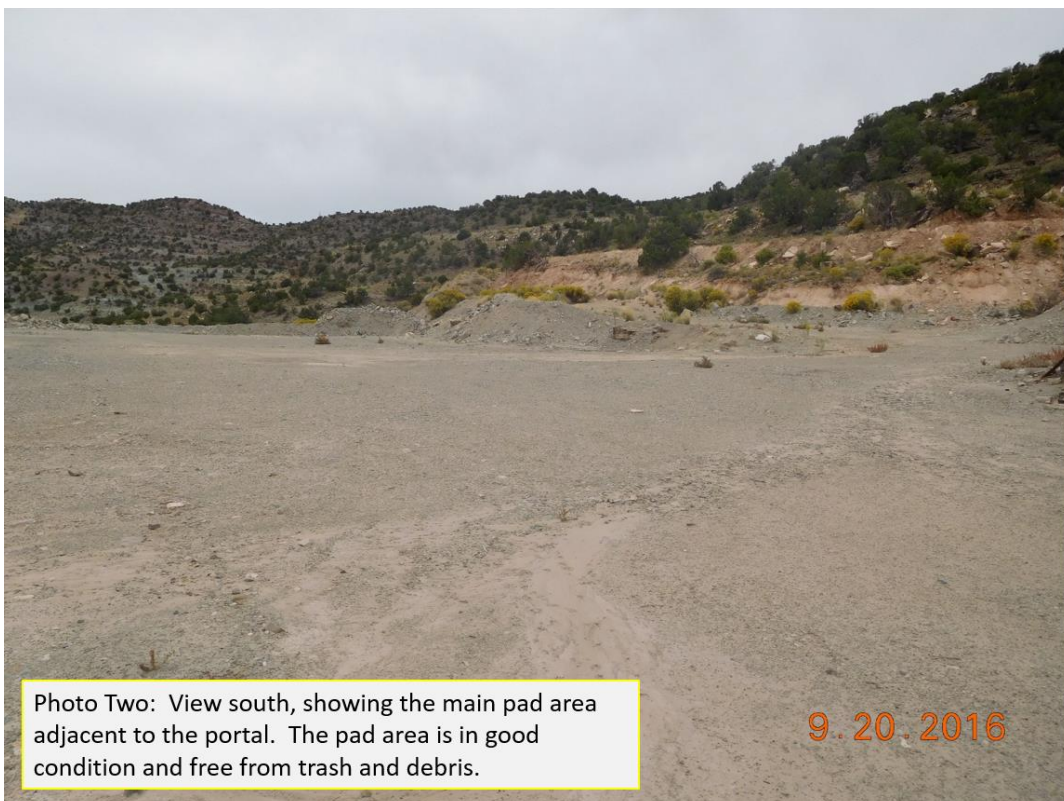
As seen in Photo One, the permit ID sign was observed at the entrance to the site. The permit boundary markers were also observed. All disturbances are contained within the permitted areas. The remote vent shaft sites were inspected at this time. All vent shafts are in good condition and show no signs of vandalism or unauthorized entry. The vents were all secured with a steel grate cover. The diversion ditches and storm water control devices are functioning as designed and no significant erosion was observed throughout the site. The main work area, adjacent to the portal and shops, appeared to be stable and in good condition. Photos Two and Three show the pad area. The portal located on this site has been backfilled and secured. Photo Four shows the earthen cover placed over the portal. No evidence of vandalism or attempted unauthorized entry to the portal was observed during the inspection.
