Bowie No. 2, 3Q Gob & Pond Inspection Report

Re: Bowie Resources, LLC, Bowie No. 2 Mine
Coal Mine Waste Banks & Instrumentation Monitoring
Pond Quarterly Inspections
Permit C-1996-083

Coal Mine Waste Bank Nos. 1, 2, & 3 Inspections - 3rd Quarter 2016

Subject: Summary of Instrumentation Monitoring
3rd Quarter 2016
Bowie Coal Waste Disposal Area No. 2
Paonia, Colorado

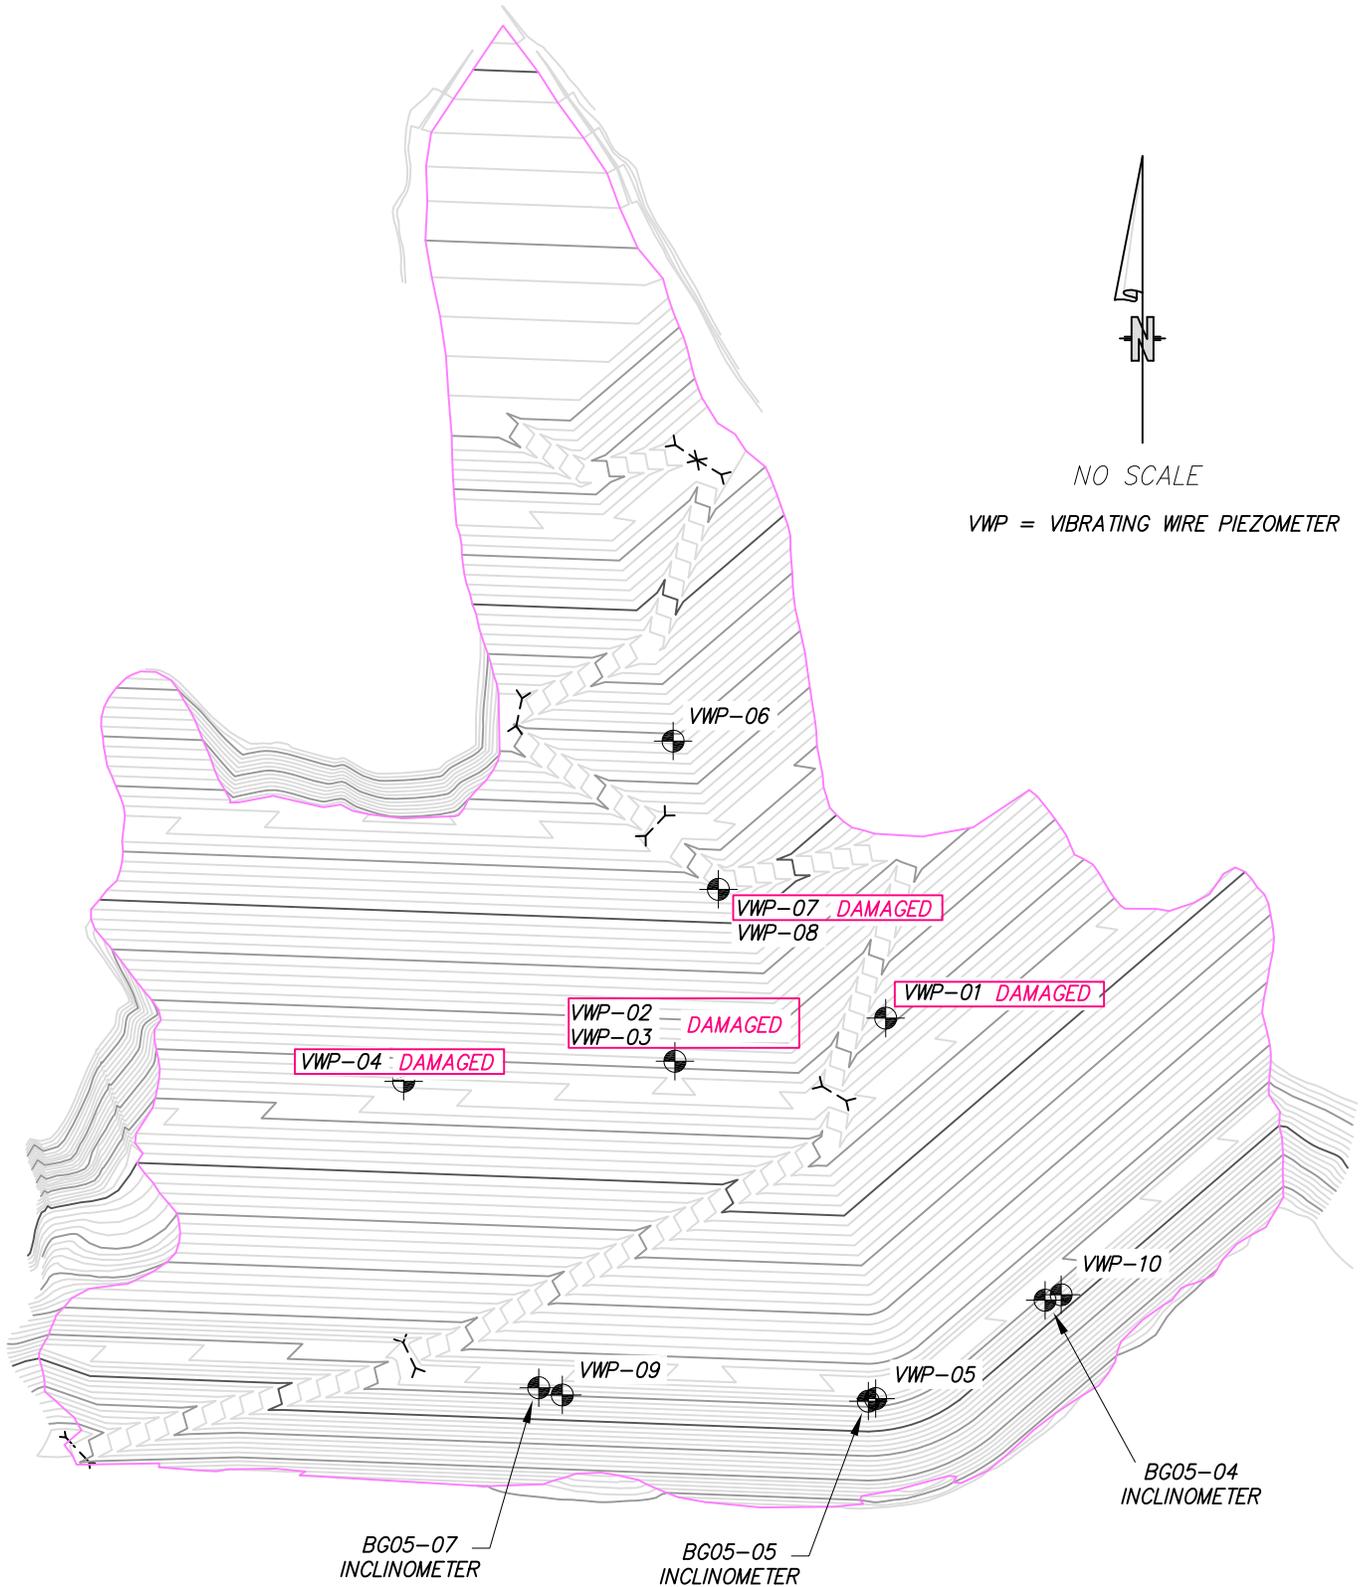
INSTRUMENTATION SITE PLAN

The physical locations of the piezometers are shown on the attached Instrumentation Site Plan, Drawing 1. The graph of historical data through 5-21-14 is presented for reference as Figure 1. A graph of active piezometers only is presented as Figure 2.

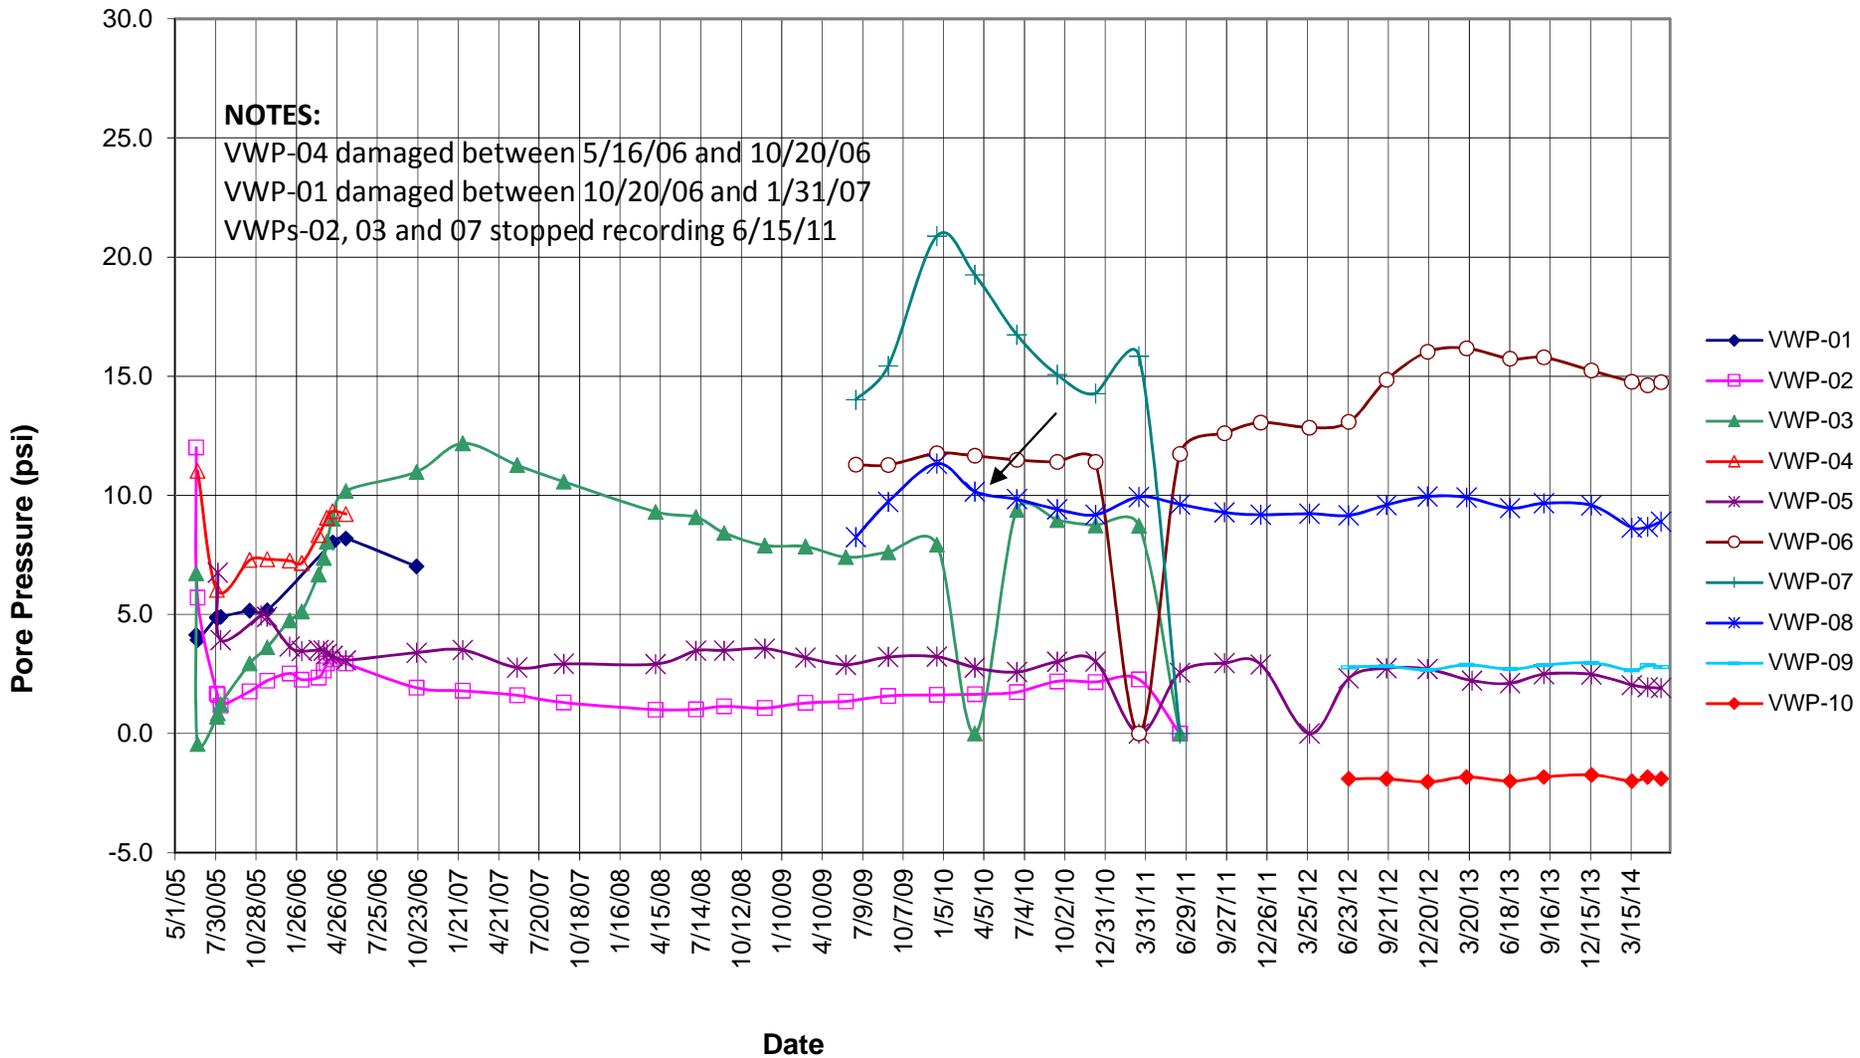
FIGURE 1

Active and Damaged Vibrating Wire Piezometer Data

Inception through 5-21-14
