**COLORADO**Division of Reclamation,
Mining and Safety

MINERALS PROGRAM INSPECTION REPORT**PHONE: (303) 866-3567**

MINE NAME: Sunnyside Gold Mine	MINE/PROSPECTING ID#: M-1977-378	MINERAL: Lead, zinc, copper, iron	COUNTY: San Juan
INSPECTION TYPE: Multi Person Inspection	INSPECTOR(S): Lucas J. West, Russ Means	INSP. DATE: October 3, 2016	INSP. TIME: 12:00
OPERATOR: Sunnyside Gold Corp	OPERATOR REPRESENTATIVE: Larry Perino	TYPE OF OPERATION: 112 - Hard Rock Regular Operation	
REASON FOR INSPECTION: Normal I&E Program	BOND CALCULATION TYPE: None	BOND AMOUNT: \$60,534.00	
DATE OF COMPLAINT: NA	POST INSP. CONTACTS: None	JOINT INSP. AGENCY: None	
WEATHER: Cloudy	INSPECTOR'S SIGNATURE:

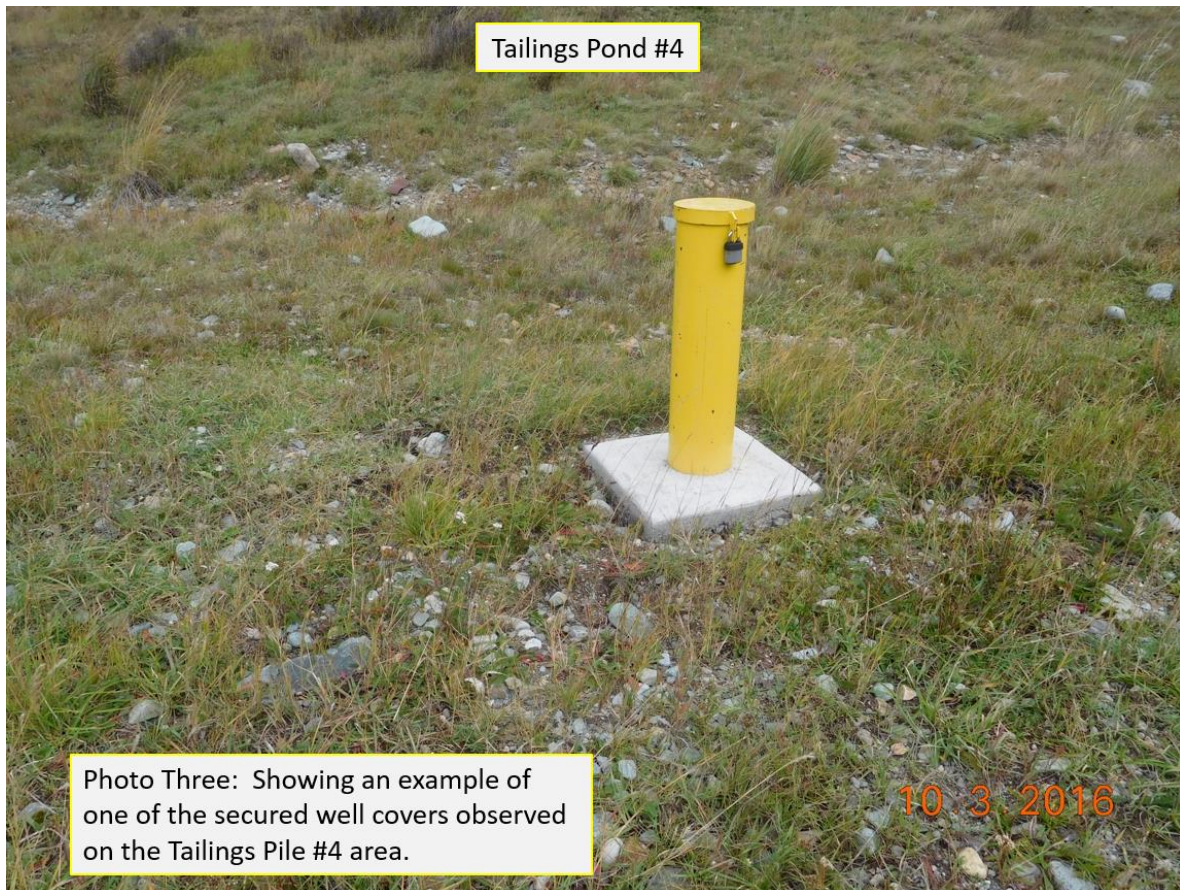
The side slopes and top of the constructed repository appear to be stable and are in good condition. Photos One and Two show the top of the repository which is well vegetated and showing signs of self-sustainment with previous years biomass observed. The operator expressed that vegetation management is ongoing and continuous, and evidence of chemical weed treatment was observed on site. 8 monitoring wells were observed on the top of the repository, all of which were properly collared and secured. Photo Three shows an example of the covers on the wells. The repository exhibits positive drainage and no impounded storm water or erosional issues were noted. The upland diversion ditch was inspected and appeared to be functioning as designed. The ditch is well vegetated, appears to be stable and can be seen in Photo Four.

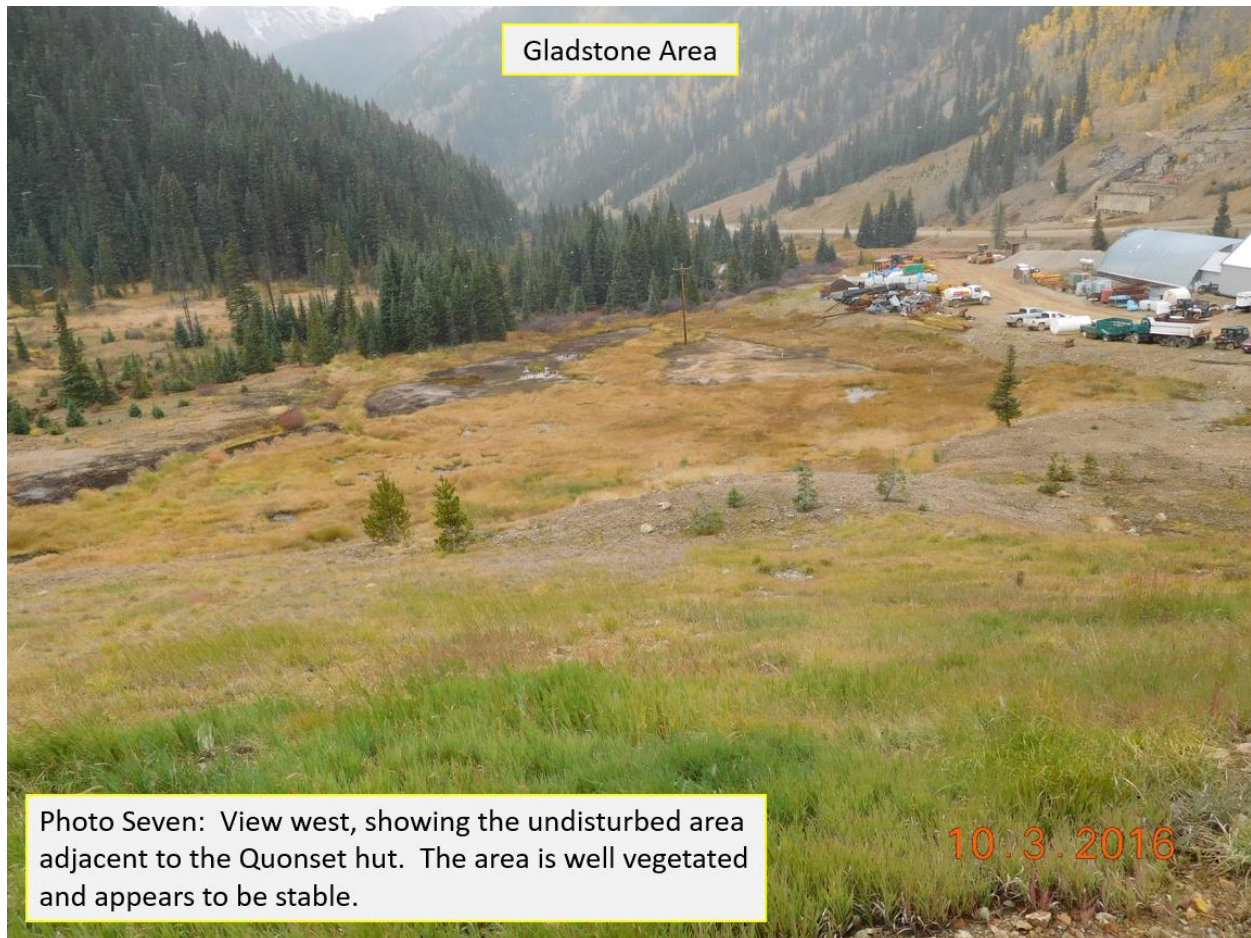
The majority of the Gladstone area has been re-disturbed for use in the EPA cleanup efforts in response to the Gold King spill. Photos Five and Six show the recently constructed facilities that include settling ponds, storage facilities, large Quonset hut, filter bags with secondary containment, as well as a sludge drying area. Approximately 80% of the permitted lands at the Gladstone area have been disturbed. A small area of the permitted lands adjacent to the Quonset hut was left undisturbed the EPA shown in Photo Seven. This area appears to be stable and in good condition. The vegetation in the area is in similar, if not better, condition than the adjacent undisturbed lands and appears to be well established, diverse and capable of regeneration. There were no noxious weeds, or significant erosion noted in this area.
