MINERALS PROGRAM INSPECTION REPORT**PHONE: (303) 866-3567**

MINE NAME: Hillyer Pit	MINE/PROSPECTING ID#: M-1982-011	MINERAL: Sand and gravel	COUNTY: San Juan
INSPECTION TYPE: Multi Person Inspection	INSPECTOR(S): Lucas J. West	INSP. DATE: October 4, 2016	INSP. TIME: 10:00
OPERATOR: Jo Ann Vota	OPERATOR REPRESENTATIVE: None	TYPE OF OPERATION: 110c - Construction Limited Impact

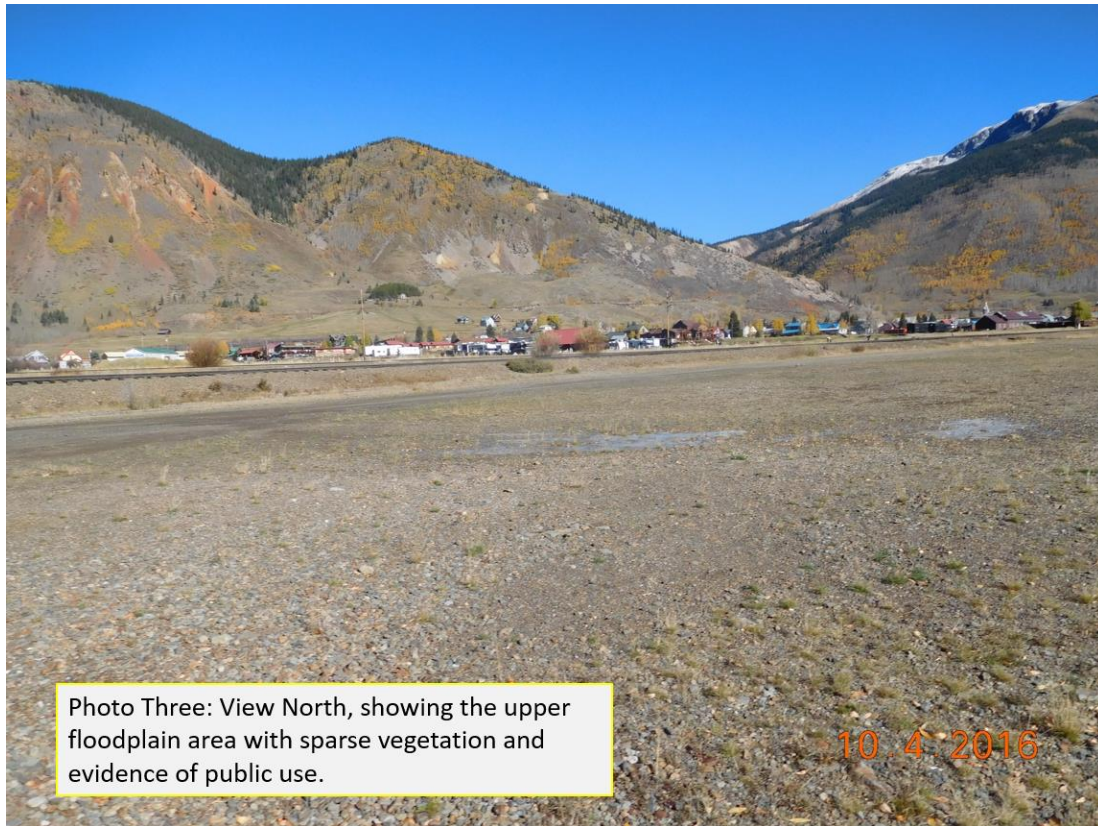
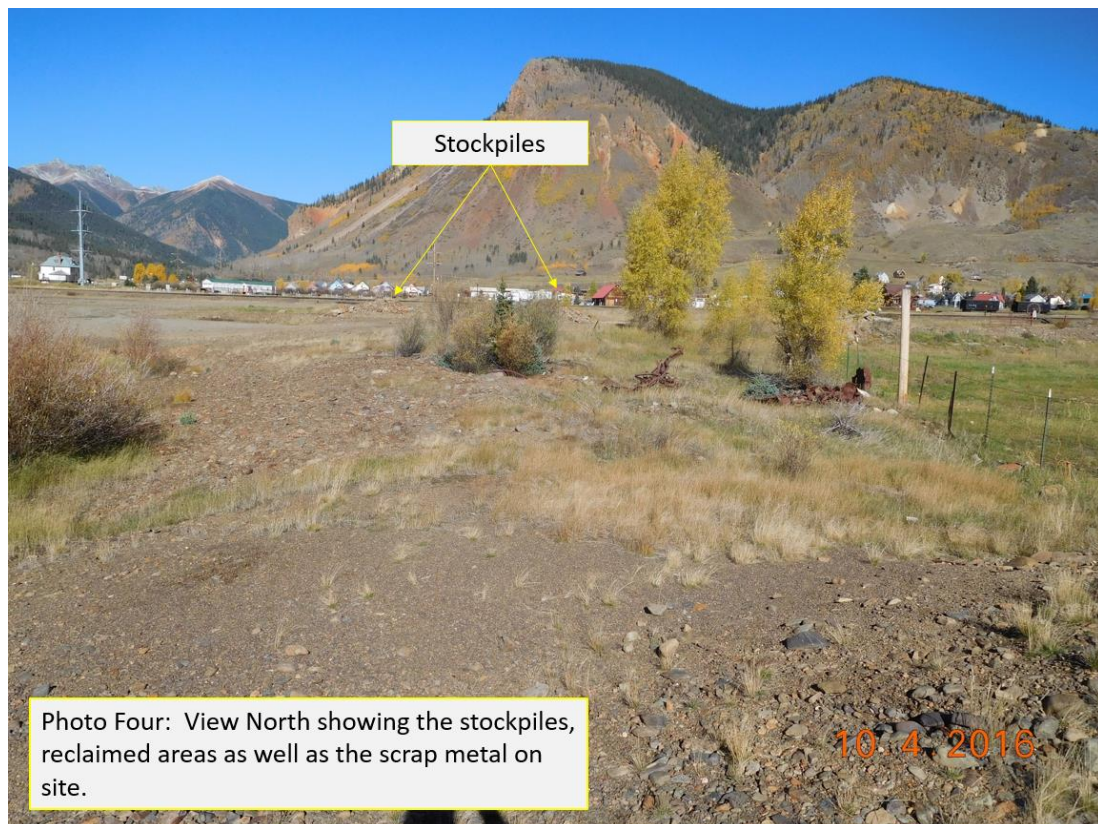
According to records kept by the Division all mining activity was concentrated to the areas of the west bank of the Animas River. The area now shows little signs of disturbance, shown in Photos One and Two. One small area of excavation was observed. The upper floodplain area appears to be stable and in good condition and erosion was noted during the inspection. The area has begun to revegetate itself with volunteer grasses however the vegetation is very sparse shown in Photo Three. Despite that lack of vegetation throughout the site, the affected lands appear to be stable and no signs of erosion were noted during the inspection. Two stockpiles of materials as well as one stockpile of recycled concrete remain on site. The stockpiles will need to be removed along with a general site clean-up during final reclamation of the site. Very little other reclamation tasks remain to be completed. Photo Four shows the stockpiles, as well as the area requiring cleanup of scrap metal within the permitted areas. The area on the west bank of the Animas River no longer needs to be regraded. Evidence of public use of the land included fire rings and vehicle tracks.
