MINERALS PROGRAM INSPECTION REPORT
PHONE: (303) 866-3567

MINE NAME: San Acacio Gravel Pit	MINE/PROSPECTING ID#: M-1999-024	MINERAL: Gravel	COUNTY: Costilla
INSPECTION TYPE: Monitoring	INSPECTOR(S): Lucas J. West	INSP. DATE: October 6, 2016	INSP. TIME: 09:24
OPERATOR: Costilla County	OPERATOR REPRESENTATIVE: Trinidad Martinez	TYPE OF OPERATION: 112c - Construction Regular Operation	
REASON FOR INSPECTION: Normal I&E Program	BOND CALCULATION TYPE: IT.Bondcalculationtype.CD.Desc	BOND AMOUNT: \$0.00	
DATE OF COMPLAINT: NA	POST INSP. CONTACTS: None	JOINT INSP. AGENCY: None	
WEATHER: Clear	INSPECTOR'S SIGNATURE:

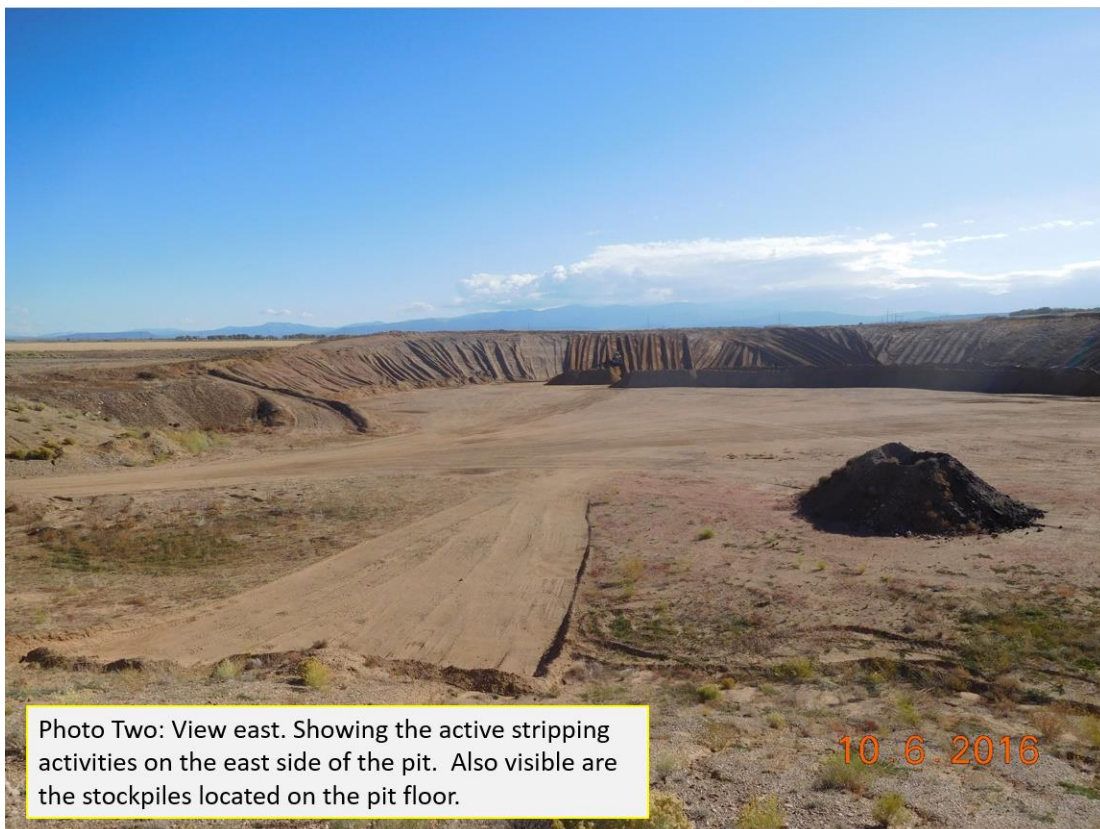
Proper mine identification signage was posted at the entrance to the site, shown in Photo One. The site was active during the inspection and a dozer and front end loader were engaged in stripping activities at the time of the inspection. There are currently approximately 15 Acres of the 76 Acre permitted area disturbed by mining activities. The stripping activities can be seen in Photo Two. The inactive side slopes have been relaxed to approximately a 3H: 1V slope, appear to be stable and are in good condition. Photo Three shows an example of the side slopes that show no evidence of slumping, settling or erosion. Several stockpiles of material and overburden were located on the pit floor. All stockpiles observed appeared to be stable and in good condition. The pit floor is exhibiting positive drainage and shows no signs of significant erosion, settling or slumping. The pit floor and stockpiles can be seen in Photo Four.
