# MINERALS PROGRAM INSPECTION REPORT PHONE: (303) 866-3567

MINE NAME:		MINE/PROSPECTING ID#:	MINERAL:	COUNTY:	
Costilla County Pit 1		M-1977-044	Sand and gravel	Costilla	
INSPECTION TYPE:		INSPECTOR(S):	INSP. DATE:	INSP. TIME:	
Monitoring		Lucas J. West	October 6, 2016	10:15	
OPERATOR:		OPERATOR REPRESENTATIVE:	TYPE OF OPERATION:		
Costilla County		Trinidad Martinez	110c - Construction Limited Impact		
REASON FOR INSPECTION:		BOND CALCULATION TYPE:	BOND AMOUNT:		
Normal I&E Program		None	No Bond Held		
DATE OF COMPLAINT:		POST INSP. CONTACTS:	JOINT INSP. AGENCY:		
NA		None	None		
WEATHER:	INSPECTOR'S SIGNATURE:		SIGNATURE DATE:		
Clear			October 26, 2016

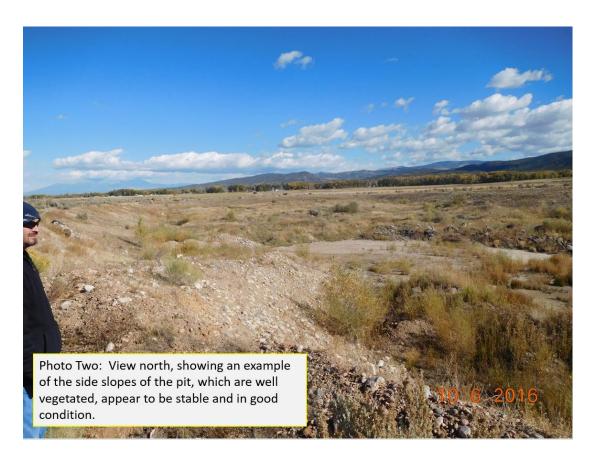
Proper mine identification signage was posted at the entrance to the site and can be seen in Photo One. The permit boundaries were properly outlined with fence lines and earthen berms. The site was not active during the inspection, nor was any equipment observed on site during the inspection. It is clear the site has not been active for many years, and on site discussions with the operator confirm that, indicating the pit is used but activity is very seldom. The side slopes of the pit appear to have been mined and relaxed to approximately a 3H:1V slope and appear to be stable. The slopes are well vegetated with volunteer species, appear to be in good condition and an example of the slopes can be seen in Photo Two. The pit floor was observed to be in good condition, shown in Photo Three. Several stockpiles of various sized materials were noted on the pit floor, all of which appear to be stable and in good condition. Impounded storm water was observed in the south end of the pit, discussions with the operator indicate that the impounded storm water was in response to a recent precipitation event and the pit is typically well drained. No evidence of continued saturation was observed during the inspection. A small stockpile of recycled concrete and other building materials was located near the access road to the pit floor. Discussions with the operator indicated that the materials are temporarily being stored on site, the presence of these stockpiles are not considered a problem at this time.
