MINERALS PROGRAM INSPECTION REPORT

MINE NAME: Mesita Hill Pit	MINE/PROSPECTING ID#: M-1977-227	MINERAL: Volcanics (Ash, Cind	COUNTY: Costilla
INSPECTION TYPE: Monitoring	INSPECTOR(S): Lucas J. West	INSP. DATE: October 6, 2016	INSP. TIME: 12:30
OPERATOR: Super Ex. LLC.	OPERATOR REPRESENTATIVE: Bill Tezak	TYPE OF OPERATION: 112c - Construction Regular Operation

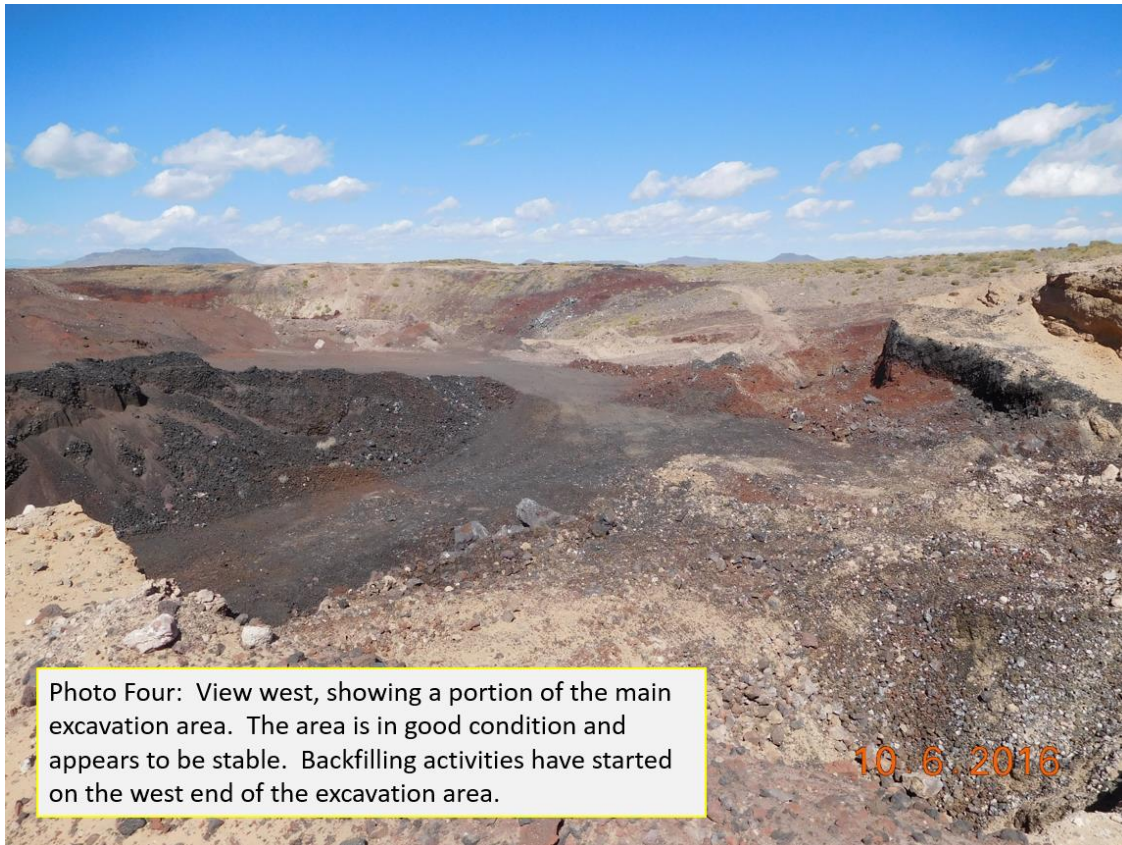
The site was not active during the inspection, however several pieces of equipment including dump trucks, conveyors and a dozer were present during the inspection. Very little mining activity has taken place since the completion of the Succession of Operator (SO), the majority of the activity has been site clean-up and investigatory work. Several stockpiles of materials of different colors, as well as the crusher fines and topsoil stockpiles were observed on site. Examples of the stockpiles can be seen in Photos Two and Three. The previous operator had active excavations taking place in several small pits throughout the site, however the current operator is focusing on the main pit near the center of the site. The excavation area can be seen in photo Four and on site discussions with the operator indicate that backfilling of certain areas of the main pit are on-going. A large pad area was used by the previous operator as the location of the crusher which was observed to be in good condition and appeared to be stable. The area, shown in Photo Five, was sparsely vegetated despite having been seeded in recent years.
