MINERALS PROGRAM INSPECTION REPORT
PHONE: (303) 866-3567

MINE NAME: Costilla Pit	MINE/PROSPECTING ID#: M-1987-040	MINERAL: Sand and gravel	COUNTY: Costilla
INSPECTION TYPE: Monitoring	INSPECTOR(S): Lucas J. West	INSP. DATE: October 7, 2016	INSP. TIME: 08:00
OPERATOR: Southway Construction Company, Inc.	OPERATOR REPRESENTATIVE: None	TYPE OF OPERATION: 110c - Construction Limited Impact	
REASON FOR INSPECTION: Normal I&E Program	BOND CALCULATION TYPE: Complete Bond	BOND AMOUNT: \$40,354.07	
DATE OF COMPLAINT: NA	POST INSP. CONTACTS: None	JOINT INSP. AGENCY: None	
WEATHER: Clear	INSPECTOR'S SIGNATURE:

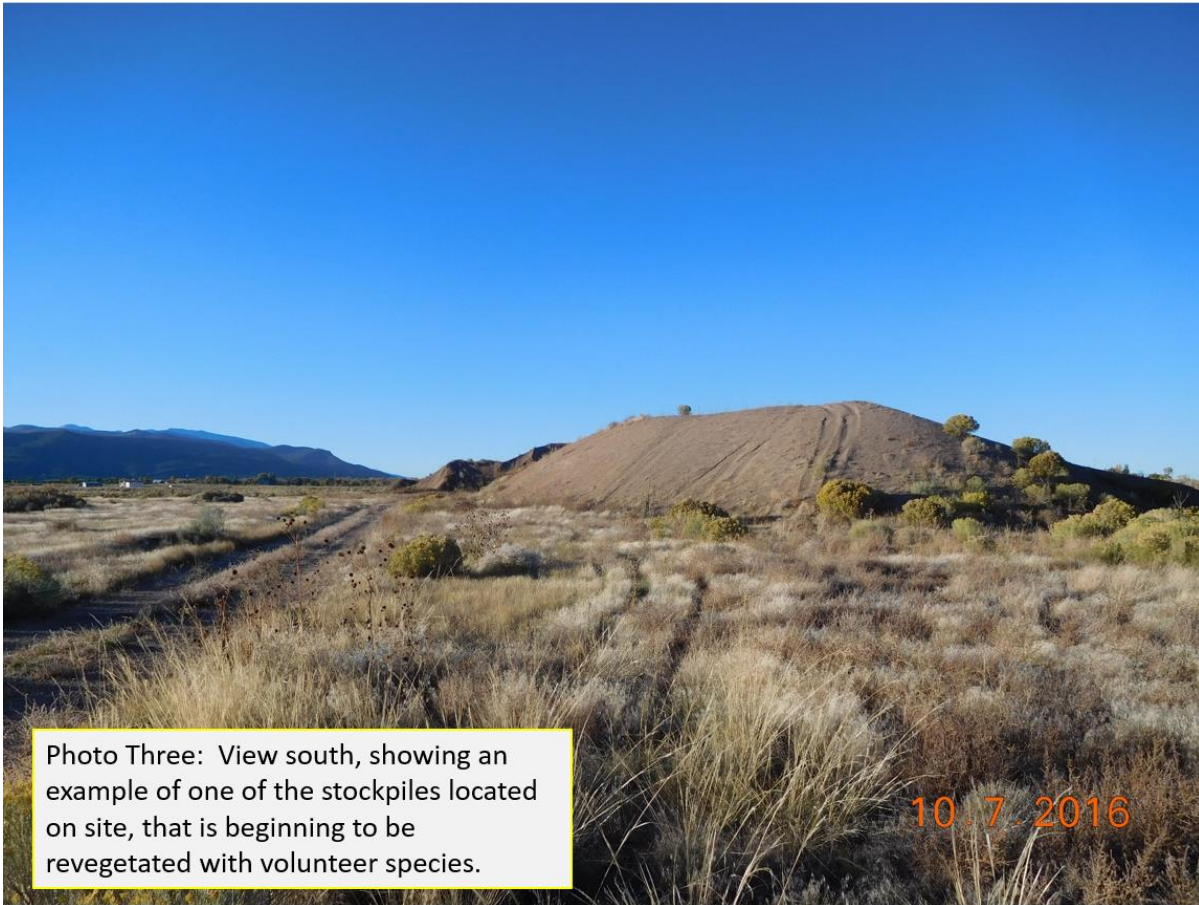
The overall footprint of the site is in good condition but could use some general site cleanup. The pit exhibits positive drainage with no signs of impounded runoff, or erosion noted during the inspection. All responses to this report should be directed to Lucas West at the Colorado Division of Reclamation, Mining and Safety at 1313 Sherman Street, Room 215, Denver CO, 80203, by phone at (970)-243-6368 or by email at lucas.west@state.co.us.
